PHOTOGRAPHIC EVALUATION REPORT

Mission 9035
30, 31 May
1, 2 June 1962 Z

FE NO. 31-62

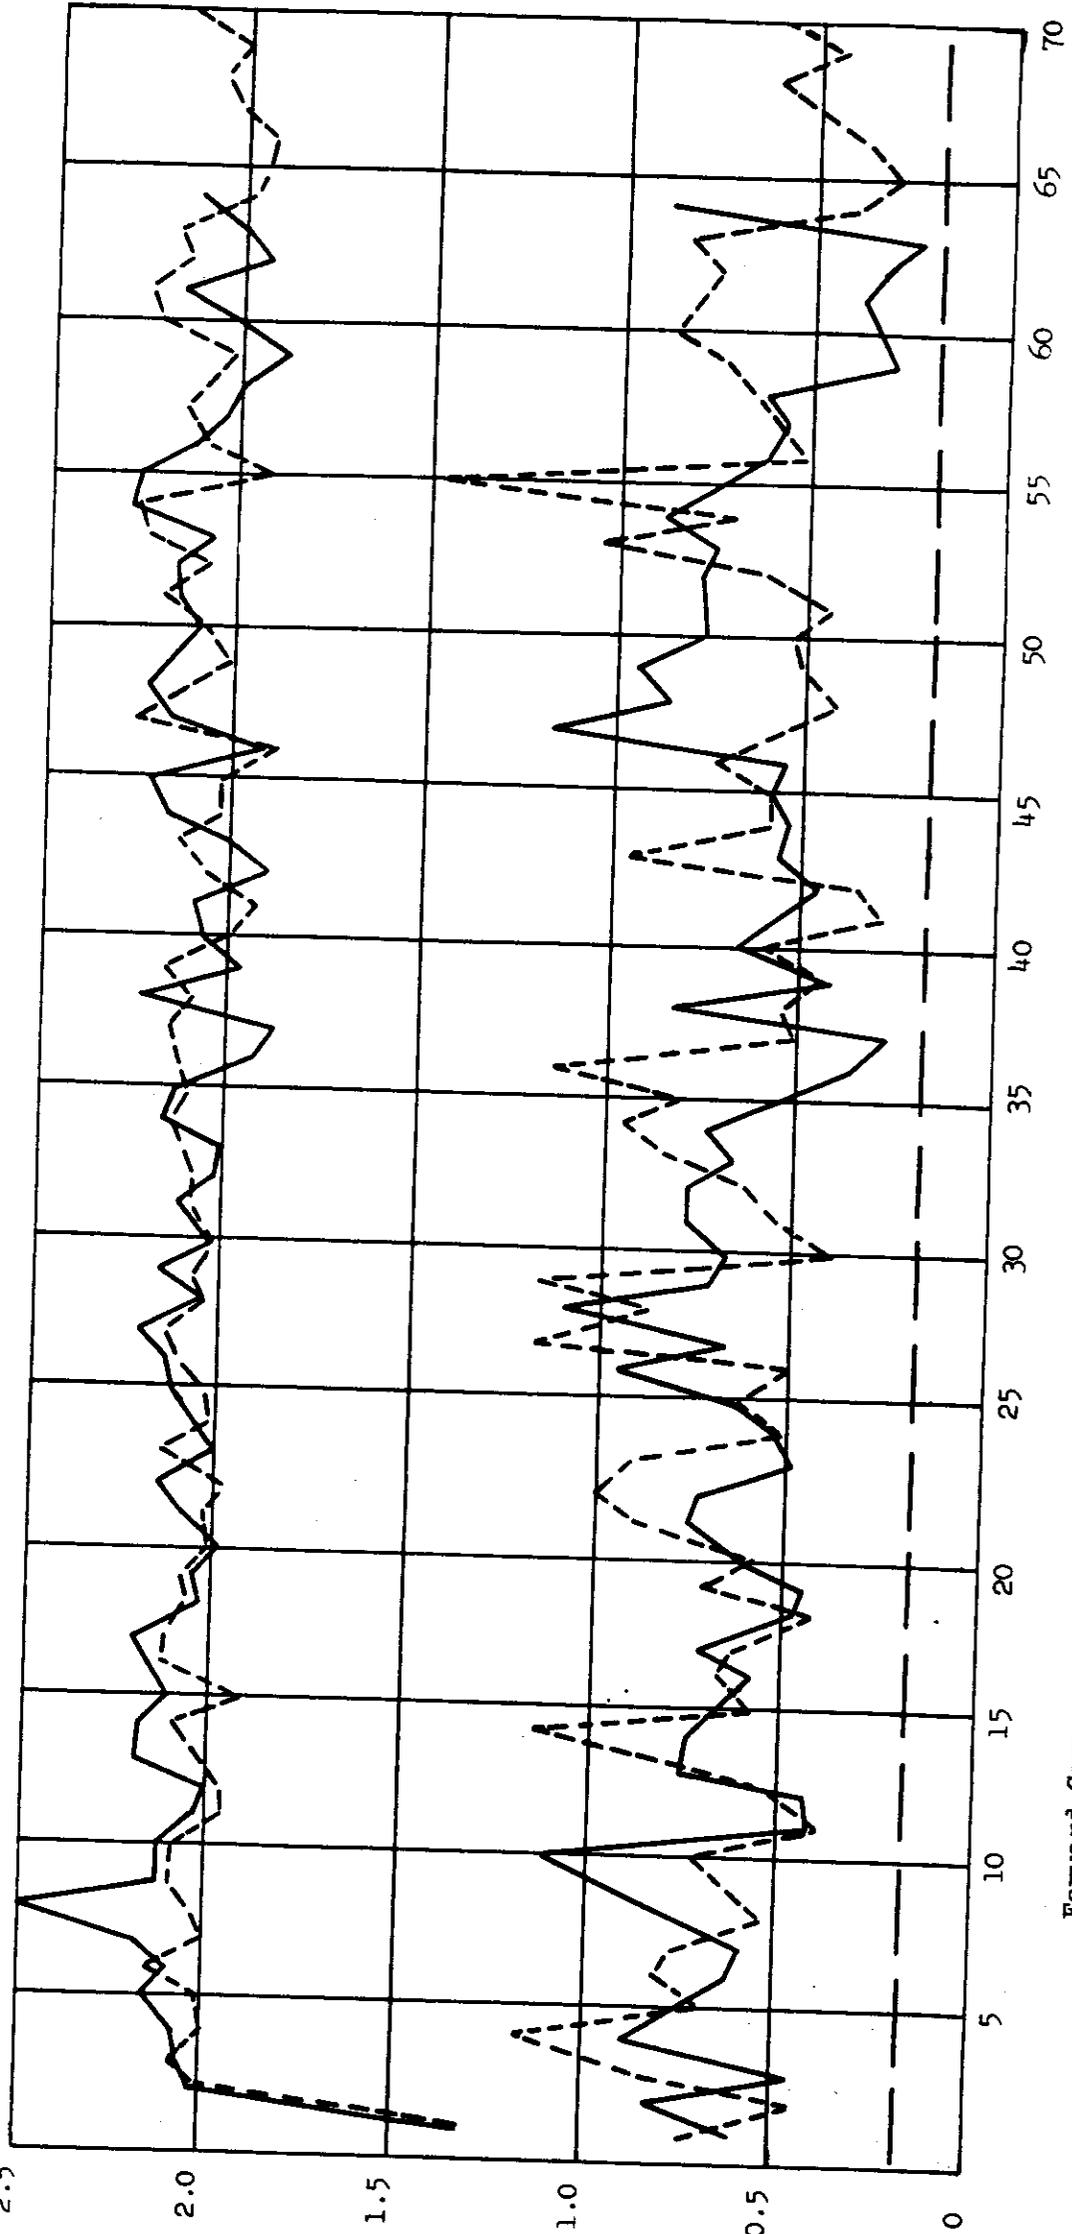
MISSION 9035 - DENSITY CHART
PART IV

Average D Max 2.09
 Average D min 0.66
 Average Gross Fog 0.18
 Range D Max 2.50 - 1.33
 Range D Min 1.16 - 0.23
 Overall Range 2.50 - 0.23
 Range Gross Fog 0.14 - 0.20

Average D Max 2.07
 Average D Min 0.69
 Average Gross Fog 0.18
 Range D Max 2.27 - 1.31
 Range D Min 1.48 - 0.29
 Overall Range 2.27 - 0.29
 Range Gross Fog 0.20 - 0.17
