PHOTOGRAPHIC EVALUATION REPORT

Mission 9039
21 July 1962 Z

FE NO. 37-62

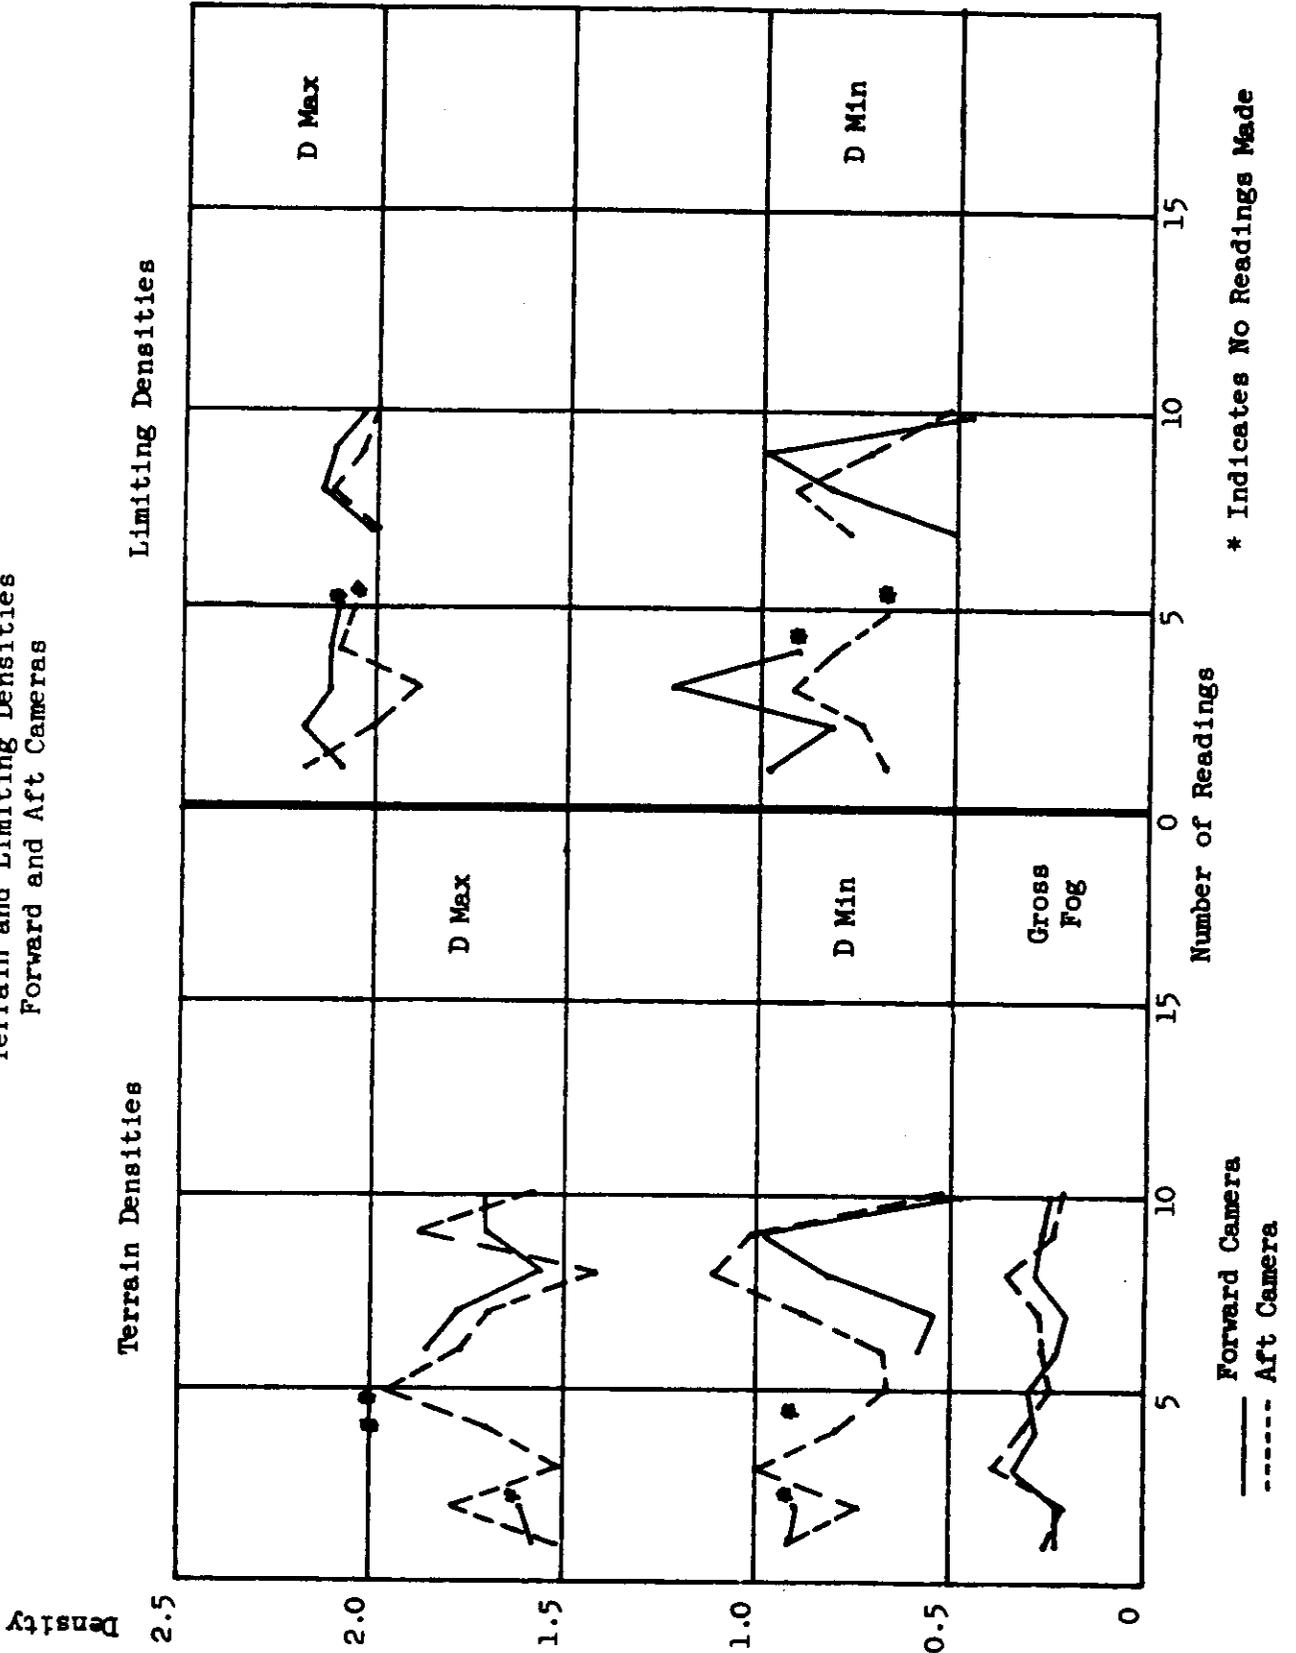
Mission 9039
Terrain and Limiting Densities
Forward and Aft Cameras

<u>Terrain</u>	<u>Limiting</u>
Average D Max	1.72	2.10
Average D Min	0.77	0.79
Range D Max	2.00 - 1.56	2.18 - 2.01
Range D Min	0.98 - 0.48	1.24 - 0.82
Overall Range	2.00 - 0.48	2.18 - 0.82

Average Gross Fog 0.26
Range Gross Fog 0.34 - 0.21

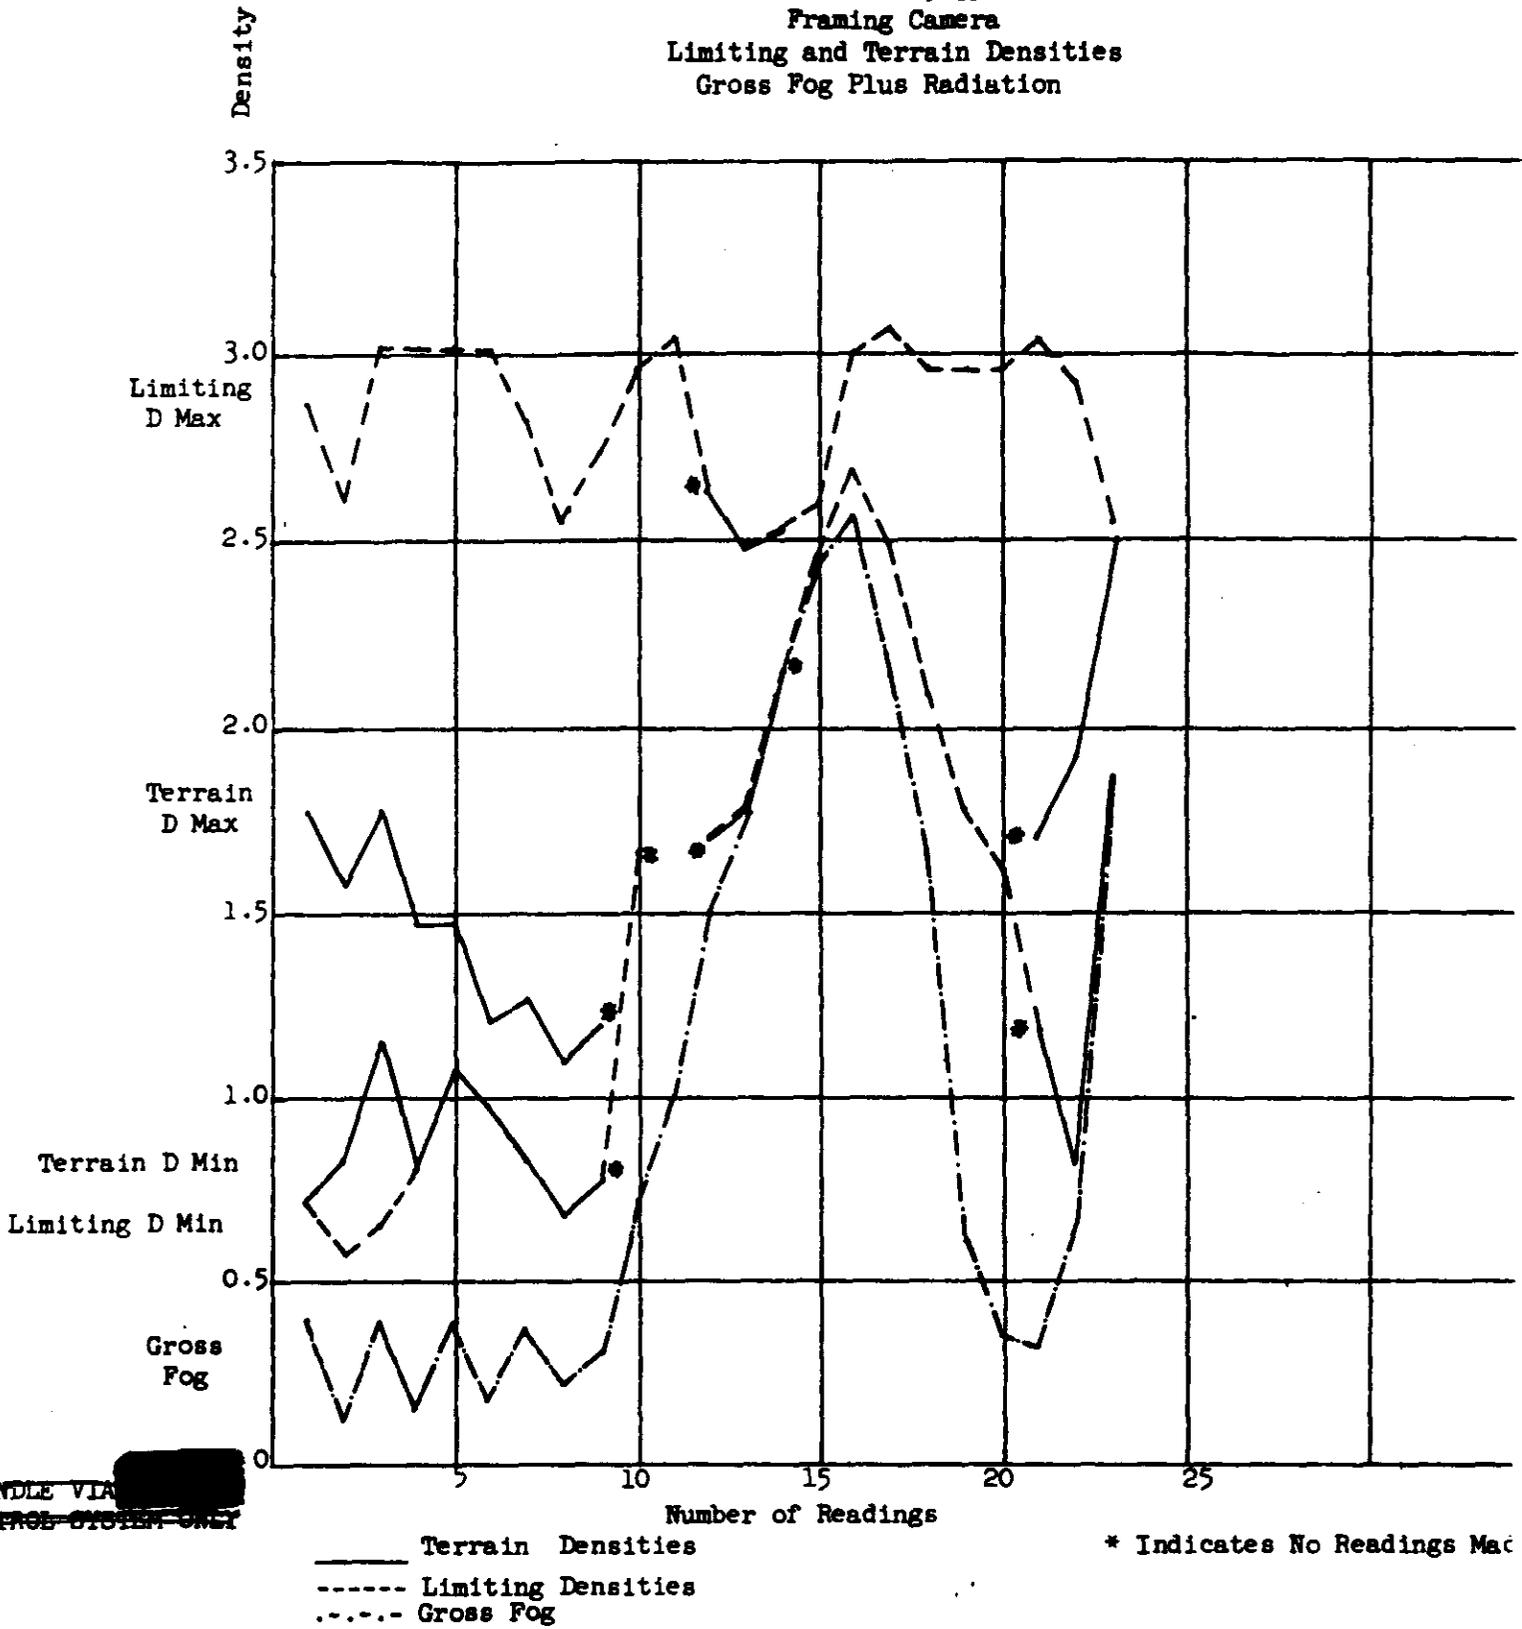
Mission 9039
Framing Camera
Limiting and Terrain Densities
Gross Fog Plus Radiation

Note: Excessive fog is due to exposure to radiation

Terrain	Limiting
Average D Max	1.78	2.84
Average D Min	1.16	1.39
Range D Max	2.64 - 1.10	3.06 - 2.48
Range D Min	2.16 - 0.68	2.69 - 0.58
Overall Range	2.64 - 0.68	3.06 - 0.58

Average Gross Fog (Center Reading) 1.05
 Range Gross Fog (Center Reading) 2.56 - 0.13
