30 December 1963

Subject: FILM CONDITION IN RECOVERED M-26 SRV

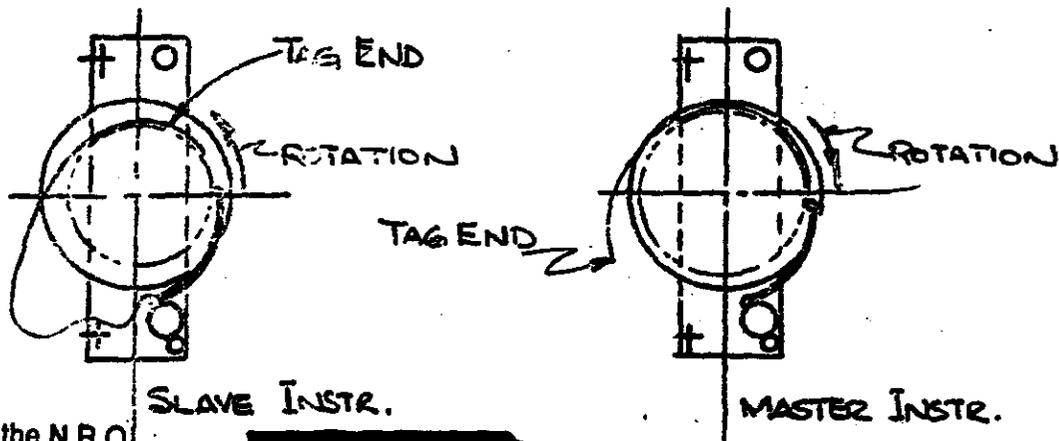
The tag end of film on the master spool felt clean and square cut. The tag end of the slave spool was very tattered and damaged for an estimated 10 inches.

It is felt the tattering is caused by the following:

1. Extended operation of the cassette after cutter operation or supply run-out.
2. The mechanical configuration of the puck-arm to cassette rotation.

3. The noted deterioration of tag end is not new. This condition has been noted often.

The indicated tag end length, due to mirror image puck-arm design, is not desirable. The offset position of the roller on the puck-arm is not desirable.

The S/I cassette-puck-arm assembly design must be reviewed. The unit should be redesigned to provide center of film roller contact to aid tracking, and provide identical puck-arm to direction of rotation configuration.
