3 December 1964

Subject: MISSION 1013 EXCESSIVE SPLICE ADHESIVE

# MISSION 1013-1

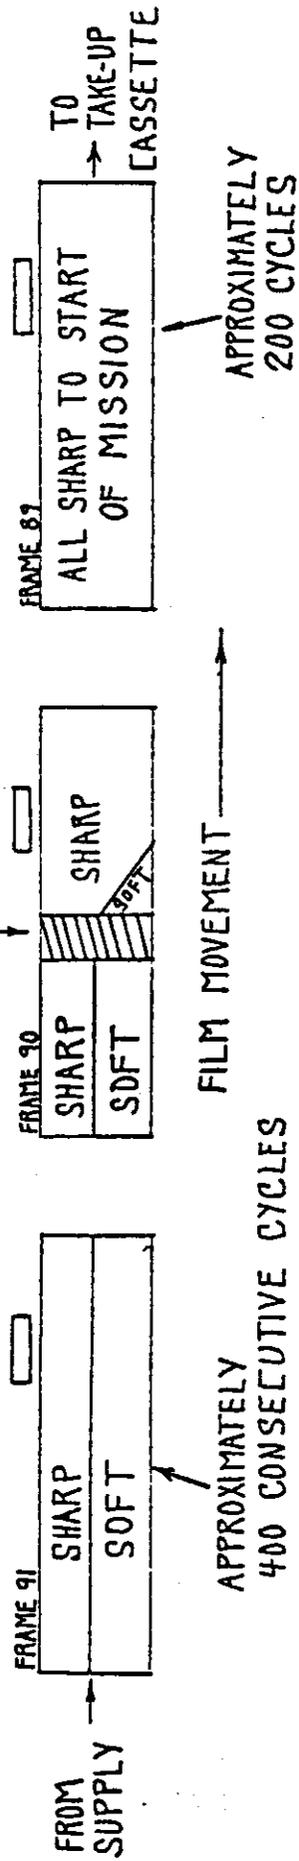
FIGURE NO. 1: AFT LOOKING CAMERA: PHOTOGRAPHIC DEFINITION VS E.K. CO. SPLICE PASSAGE.  
PASS 24

Aft camera terrain photography was consistently sharp prior to the time the first Eastman Kodak splice passed thru the platen of instrument 159 during pass 24, frame 90. Beginning with frame 90 and immediately thereafter, aft camera photography became soft with low definition over 50 to 60% of each format area for approximately 400 consecutive photographs where weather permitted detailed evaluation.

Figure No. 1 shows the general character of photography before, during, and after passage of the first Eastman Kodak splice thru the aft looking camera.

Measurements show that at the time the splice entered the aft camera platen area, the film shifted laterally toward the rail on the timing track

side of the format by about 0.012 inches. Subsequent measurements made at random intervals from pass D-24 to D-47 indicate that the film path generally continued to be laterally displaced toward the timing track rail and never fully recovered.

An abnormally large quantity of adhesive appeared to be present at the edges of the Eastman Kodak splice. Additional adhesive appeared to have transferred to the original negative 75 and 120 inches ahead of the splice. It is concluded that the adhesive was transferred to the original negative at Eastman Kodak prior to flight during splicing and spooling operations. The adhesive 75 inches ahead of the splice corresponds to one film wrap on the supply spool and is accompanied by static marks that outline the dimensions of the splice. The adhesive 120 inches ahead of the splice partially fills the voids observed in the adhesive layer at the splice.

It can be speculated that some of the excessive adhesive transferred to a part of the aft camera film transport and exposure mechanism, which cause film mis-tracking and soft low definition.

It is requested that you take the necessary action to prevent the re-occurrence of the subject problem in the future.
