PHOTOGRAPHIC EVALUATION REPORT MISSION 1046

SPECIAL STUDY: COMPARISON OF
SO-230 & 3404 FILM TYPES FROM
MISSION 1102-2

PHOTOGRAPHIC EVALUATION REPORT

MISSION 1046

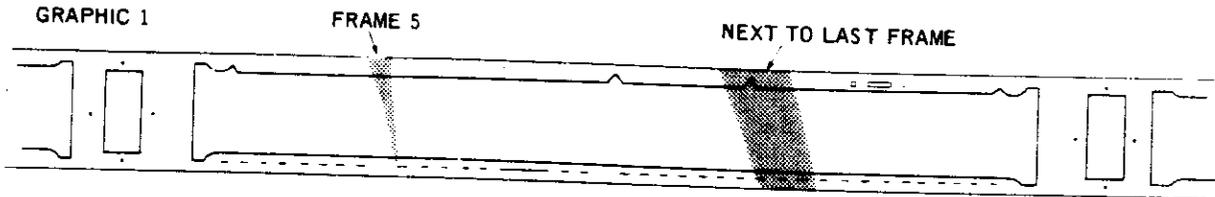
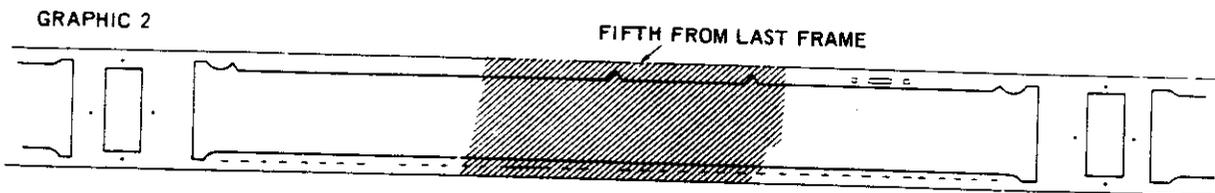
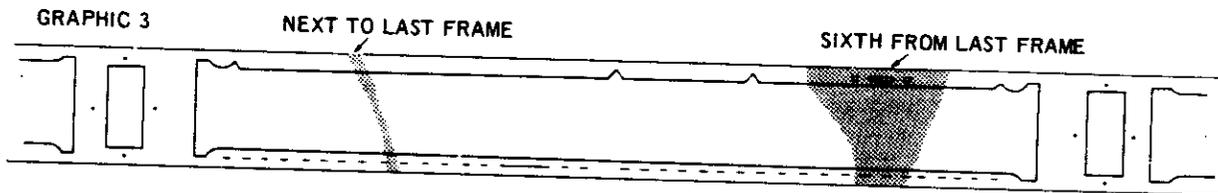
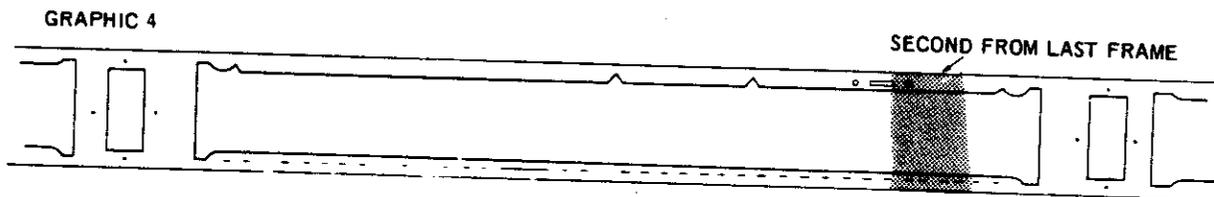
3. Graphic Display (Mission 1046)

a. Light Leaks: Light leak induced fog patterns appear more often and are of greater severity than on the more recent missions of this system. The fogging that occurred near the intermediate roller assembly is especially severe when there is a long sit period between camera operations. The fog patterns correlated directly with the duration of camera sit periods. The major fog patterns occurred on the last, first and fifth from last frame, and fifth frame of most passes. The more severe fog patterns cause some degradation to the imagery. The fog patterns are illustrated on Graphics 1 and 2, page 10.

The patterns illustrated below are referenced in the text of this report.
