PHOTOGRAPHIC
EVALUATION REPORT

MISSION 1047

JANUARY 1969

NATIONAL PHOTOGRAPHIC INTERPRETATION CENTER

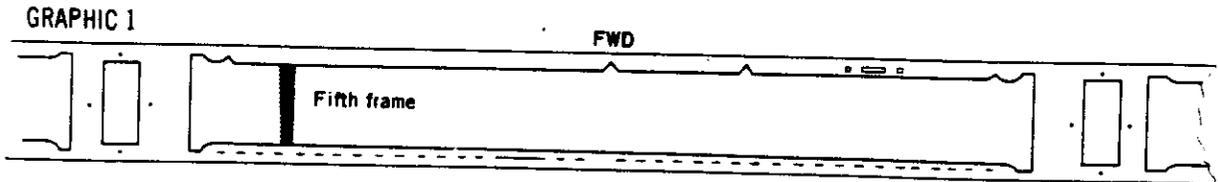
4. Imaged Degradations:
 - a. Light Leaks: Light leak induced fog patterns are imaged on the fifth and sixth frame from the end of most camera operations. These fog patterns are minor, and their density varies with camera-off durations. The fog patterns are illustrated on Graphics 1 and 2, page 9.
