PHOTOGRAPHIC
EVALUATION REPORT
MISSION 1048

FEBRUARY 1969

NATIONAL PHOTOGRAPHIC INTERPRETATION CENTER

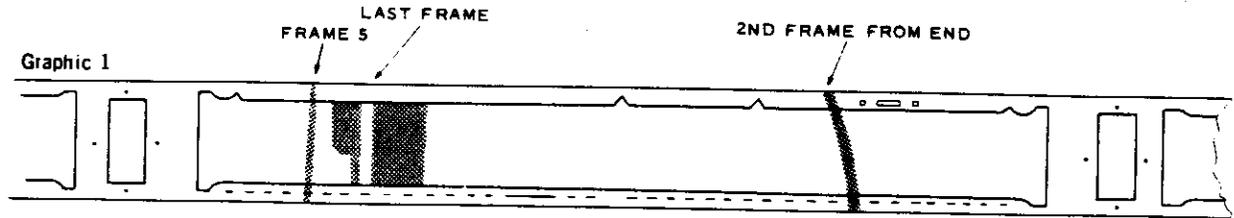
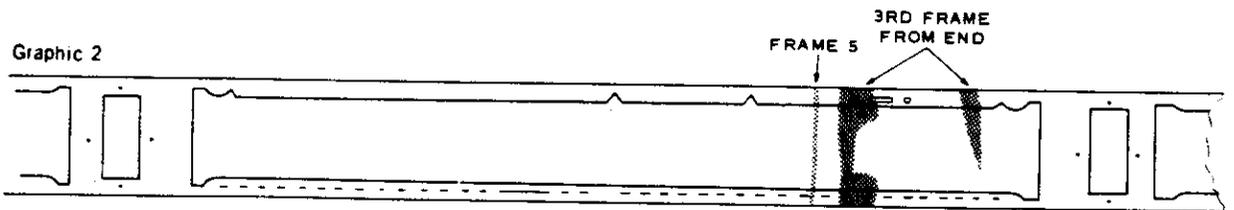
b. Static: A few instances of dendritic static traces are present along the edge of the film from Mission 1048-1 (Examples: Frames 75-35, pass 84D). Traces of corona static are detectable at random throughout the record from Mission 1048-2. The traces are easy to detect within areas of low density and contrast, and their frequency and intensity increase slightly as the mission progresses (Examples: Pass 164D, see Graphic No 1, page 12).

a. Light Leaks: A thin band of fog is present on the fifth frame from the beginning of most passes, (Example: Passes 16D and 180D) and on the third frame from the end of a few passes (Examples: Frame 8, pass 16D and frame 22, pass 135D). Faint equipment images are also present on the third frame from the end of a few passes (Example: Frame 8, pass 16D, see Graphic No 2, page 12).
