PHOTOGRAPHIC
EVALUATION REPORT

MISSION 1051

SEPTMBER 1969

NATIONAL PHOTOGRAPHIC INTERPRETATION CENTER

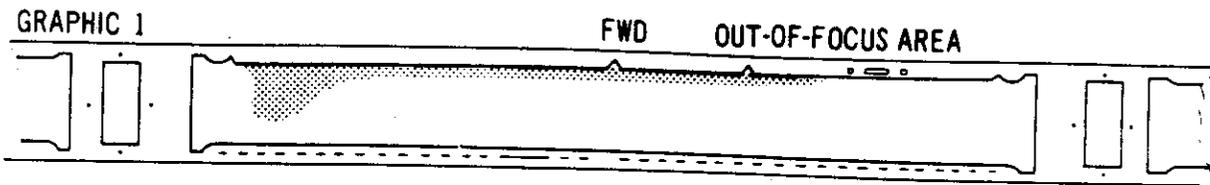
GRAPHIC 6

hibits some imagery comparable to an average 1000 series mission. Grossly out-of-focus imagery appears in approximately the same format position in each frame near the supply end along the frequency mark edge (see Graphic 6). Approximately 10 percent of the format is affected. Also, isolated soft spots are randomly located throughout the record. In general, the imagery is soft, lacking crispness and overall edge sharpness.

OUT-OF-FOCUS AREA
