POST FLIGHT EVALUATION
OF RECOVERED SRV HARDWARE

PROGRAM [REDACTED]

JANUARY, 1965

GENERAL (GE) ELECTRIC
Re-Entry Systems Department
A Department of the Missile and Space Division
3198 Chestnut Street
Philadelphia 4, Penna.

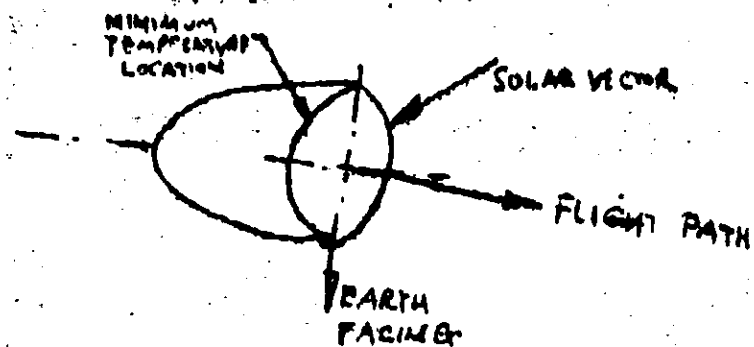
FIGURE 4

Minimum Temperature Location on Shield
During Earth-Oriented Orbital Flight

The minimum temperature region for earth-oriented flight was located on the debris and the cracks examined for charring along the edges down to the phenolic glass. Only one such crack was found in this region and upon examination of the rest of the shield circumference, only two or three other similar cracks could be found, randomly spaced around the circumference. Most of the cracks still had virgin material at the base next to the phenolic glass, indicating that these cracks occurred during the latter portion or subsequent to the re-entry heating period.

Based on the analytical predictions and on the fact that several cracks had charring along the edges down to the phenolic glass, the conclusion is reached that these cracks occurred in orbit. The random locations probably occurred due to the fact that the vehicle was stabilized in orbit for only the first four and latter two days. For most of the remaining days in orbit, the vehicle was probably tumbling. If, during this latter time, the vehicle was ^{subjected to oscillation or maneuvering} stabilized for three to five orbits, other portions of the circumference could also have been subjected to ^{very low} ~~this cold~~ temperature, thus producing the additional cracks. In any event, these meridional cracks, local to the stress relief grooves, produced by in-orbit cold temperatures, are not considered detrimental to the mission performance capability of the shield system.

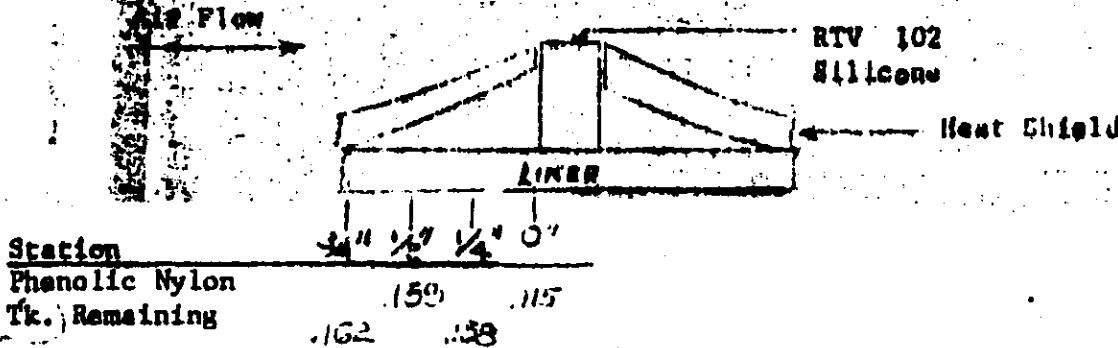
FIGURE 10

A profile view of the saw cut at Station 21 indicated that the local bond between the shield and liner had failed. This resulted in warping or curling of the phenolic nylon shield in the following manner:

SKETCH OF SHIELD CROSS-SECTION SHOWING EDGE CURLING

As the remaining thickness of the virgin phenolic nylon decreased ~~as you approached the saw cut~~, it can be concluded that the curvature was present during the heating period. The increased body angle with respect to the air stream resulted in a local pressure and heating increase which lead to greater depths of shield degradation. A similar conclusion was drawn from the recovered R/V 38.

The local bond separation at the stress relief grooves is probably the result of edge effects early in the environment. However, neither this nor the curling is considered detrimental to the mission performance capability of the system.

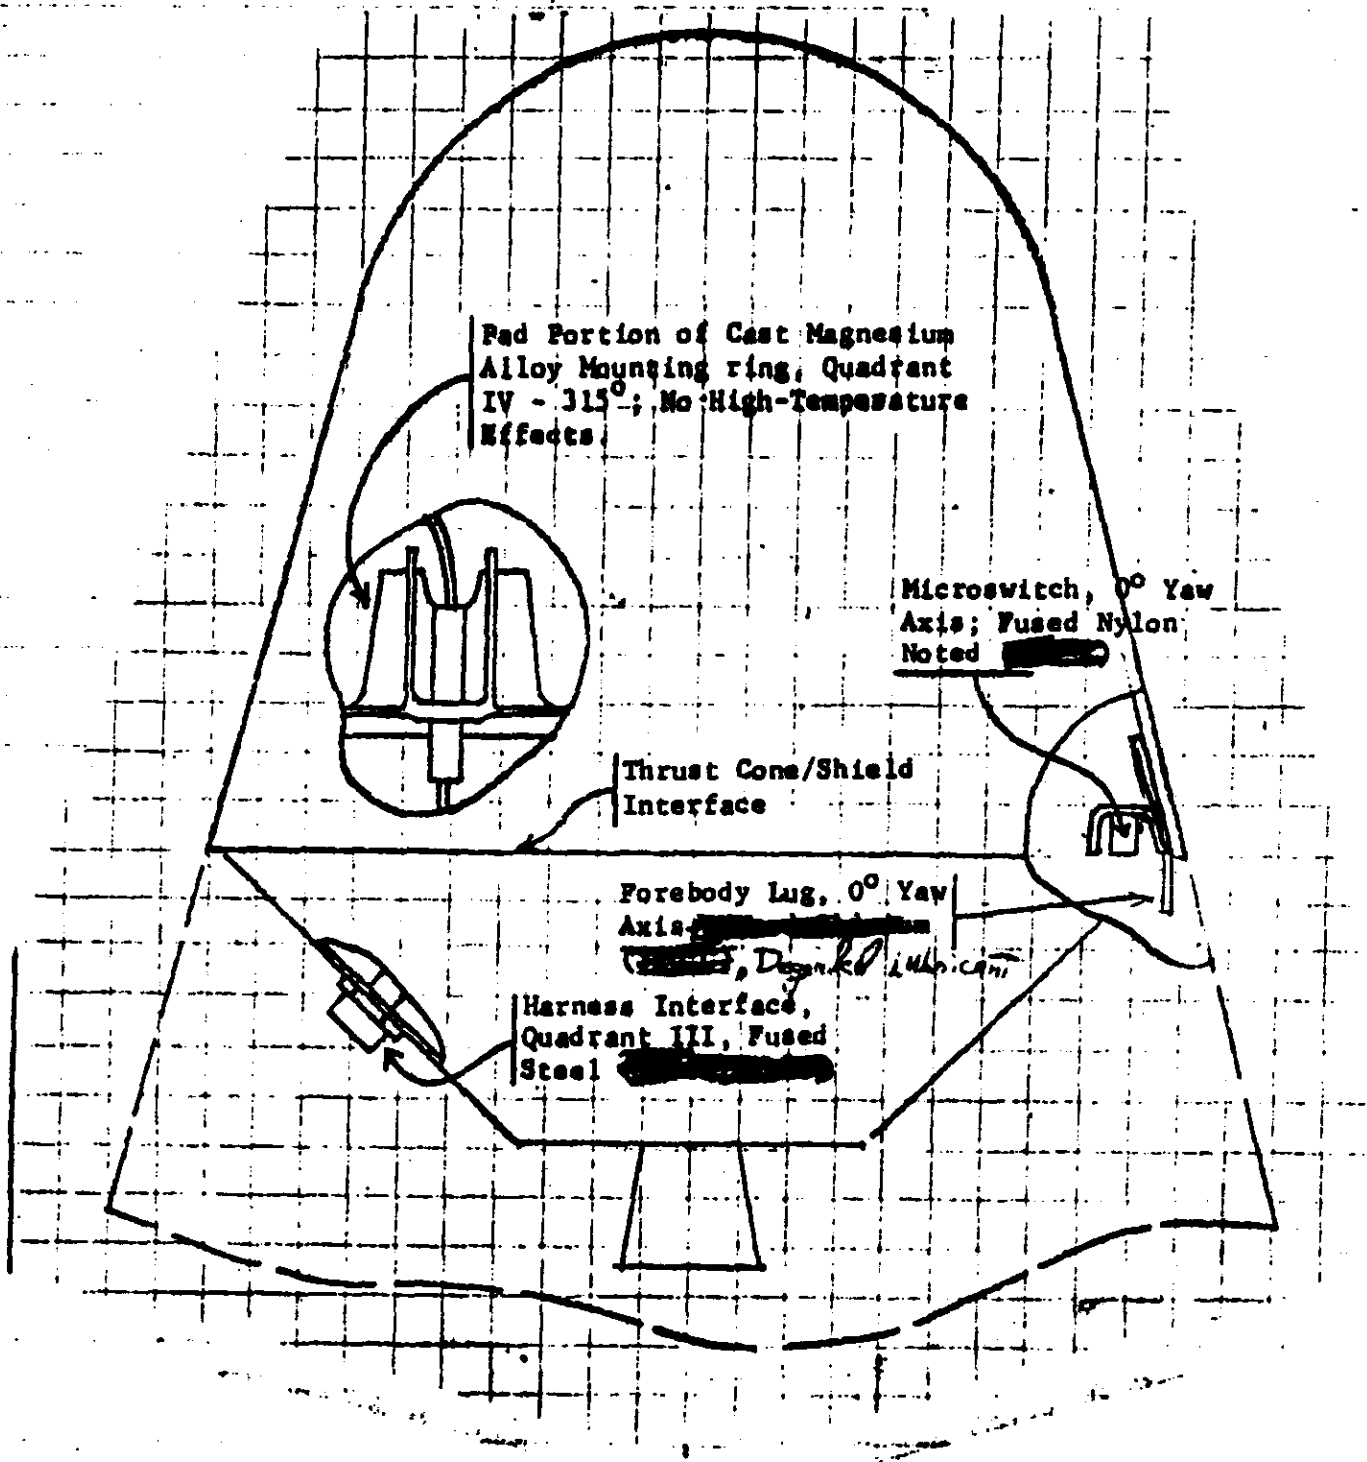
FIGURE 20

SRV LOCATION OF PARTS. SECTIONED
AND EVALUATED

Figure ²⁰ 15 is a schematic showing the location of the parts. The three items on the aft end of the vehicle showed indications of high temperature deterioration, whereas the cast magnesium alloy mounting ring, which is located approximately eight inches forward of the shield/thrust cone interface showed no signs of high temperature deterioration. Indications of corrosion apparently due to weathering, and not considered excessive for ^{Tropical} ~~the 30-day~~ exposure, were noted on the harness interface, forebody lug, and magnesium ring.
