PHOTOGRAPHIC EVALUATION REPORT
FORWARD CAMERA

Mission No: 9032
Film Type: J-23-7600
Camera No: 72 (Fwd)

Evaluation No: FE 29-62
Filter, Horizon: W 25

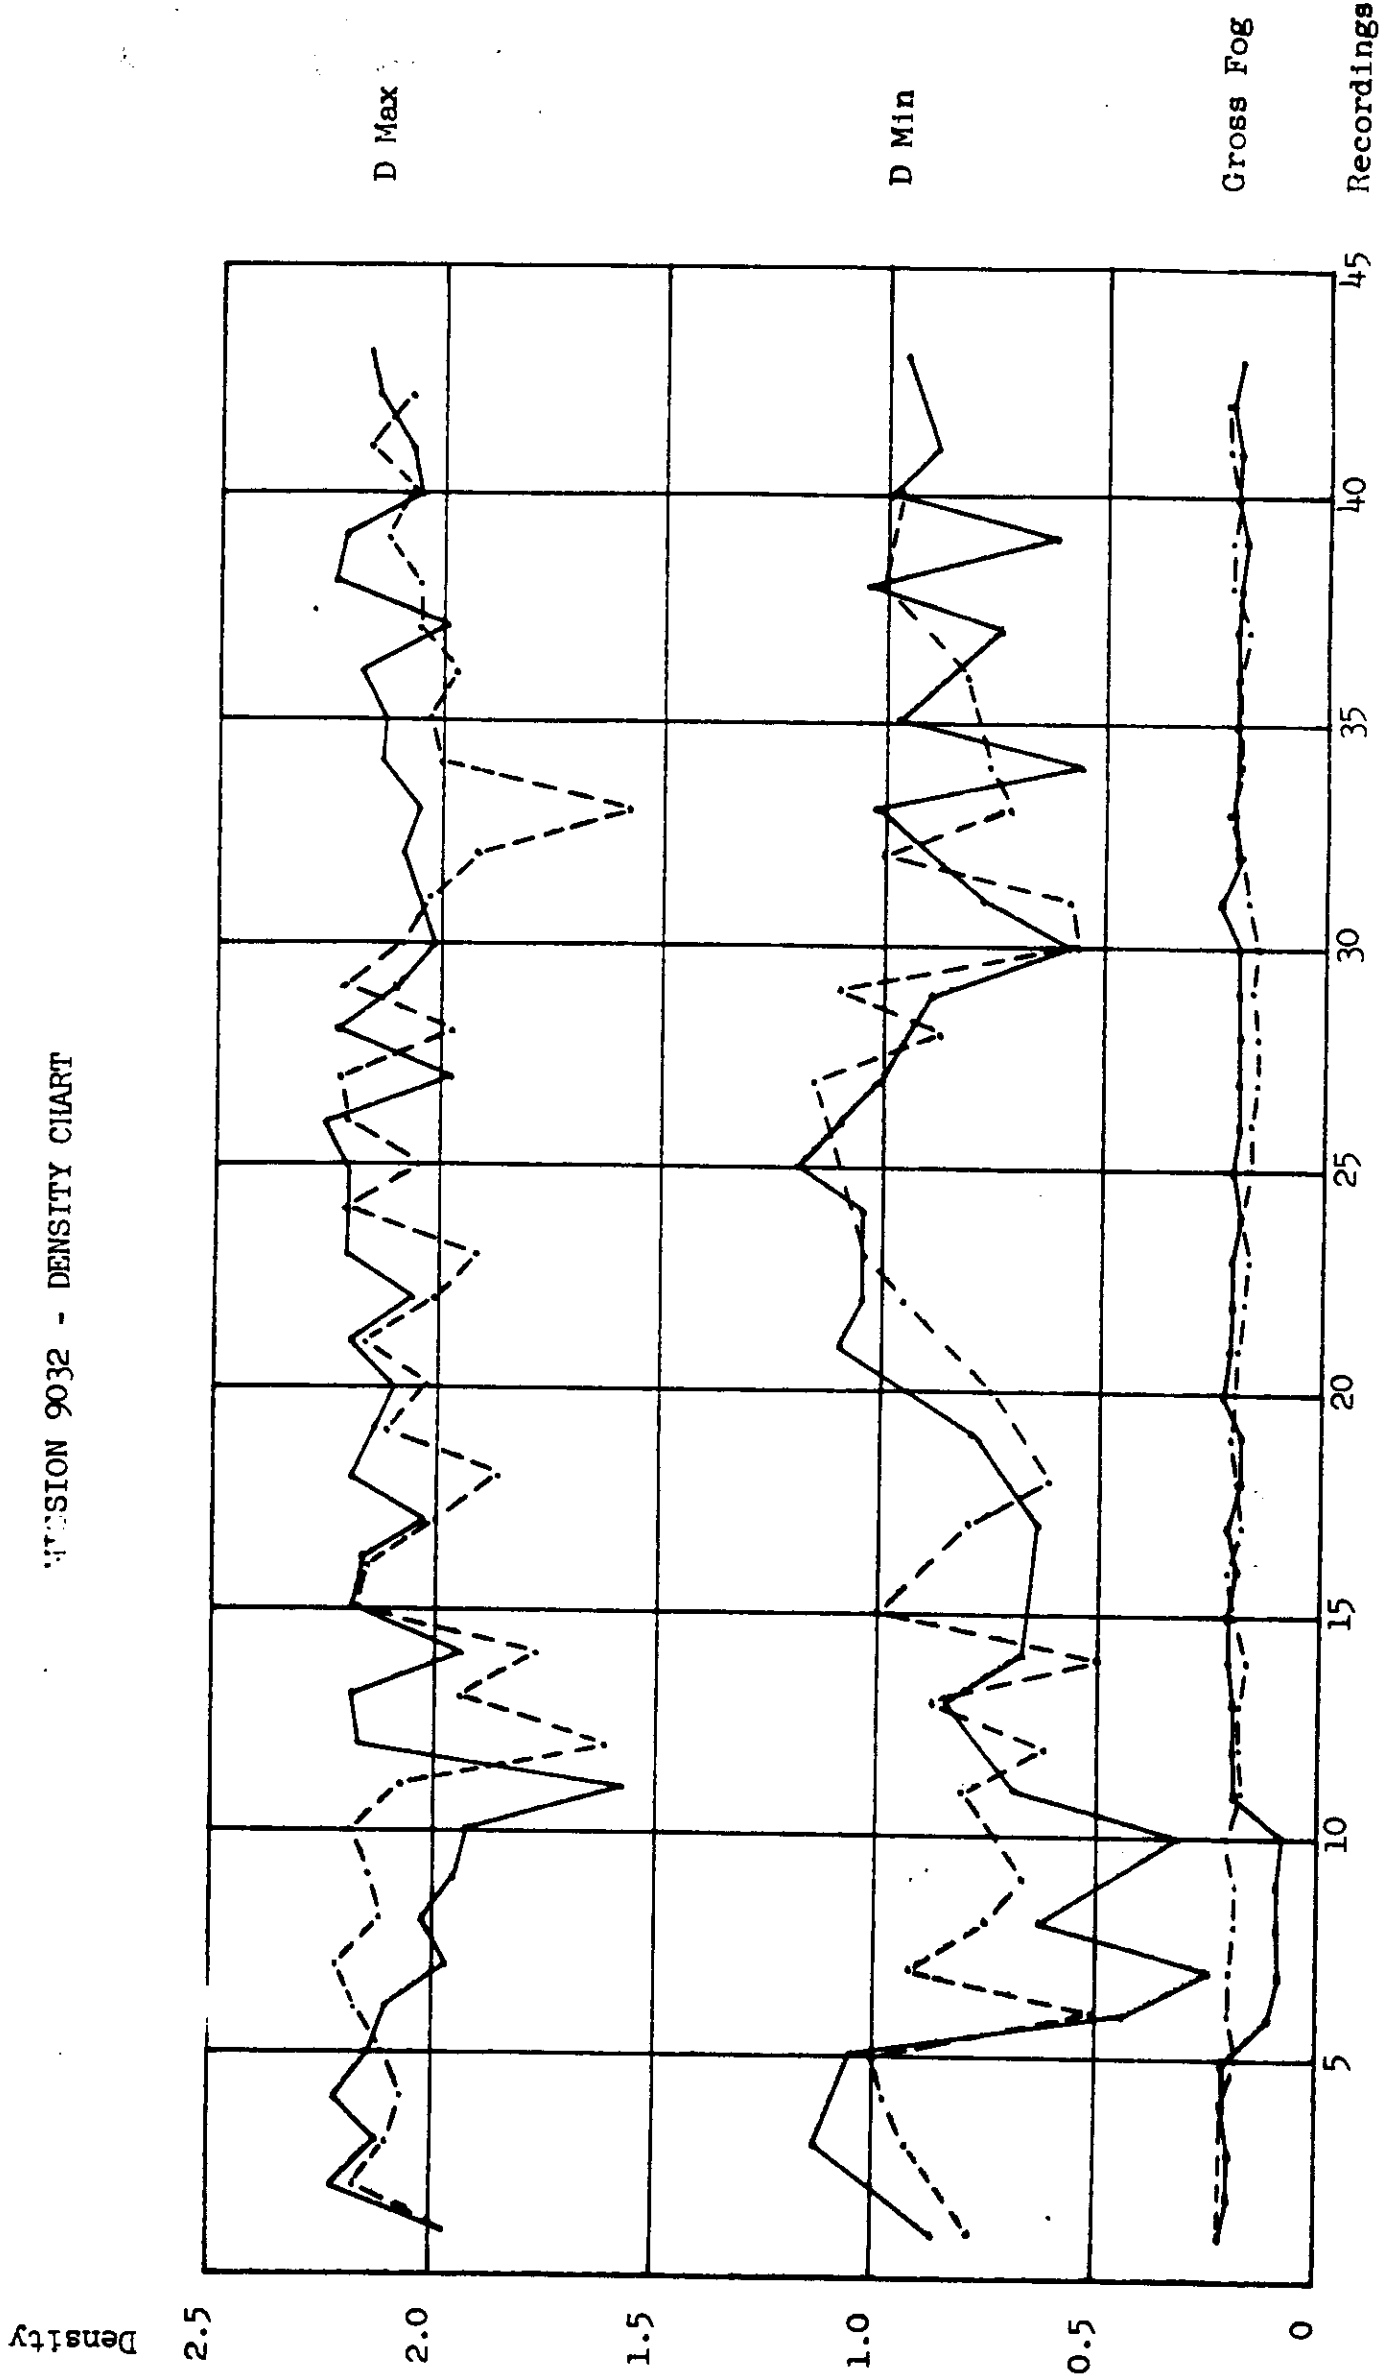
MISSION 9032 - DENSITY CHART

9. Density readings were made on every pass using the Eastman Kodak Reflection Transmission Color Densitometer, Model RT. Absolute values read for D Max and D Min, as well as Gross Fog and Sun Angle are as follows:

Average D Max 2.10
Average D Min 0.81
Average Gross Fog 0.18

Range D Max 2.25 - 1.56
Range D Min 1.18 - 0.24
Over-all Range 2.25 - 0.24
Range Gross Fog 0.23 - 0.08
