SYSTEM
PERFORMANCE EVALUATION REPORT

MISSION 8003

PERFORMANCE EVALUATION TEAM
REPORT NO. [REDACTED]

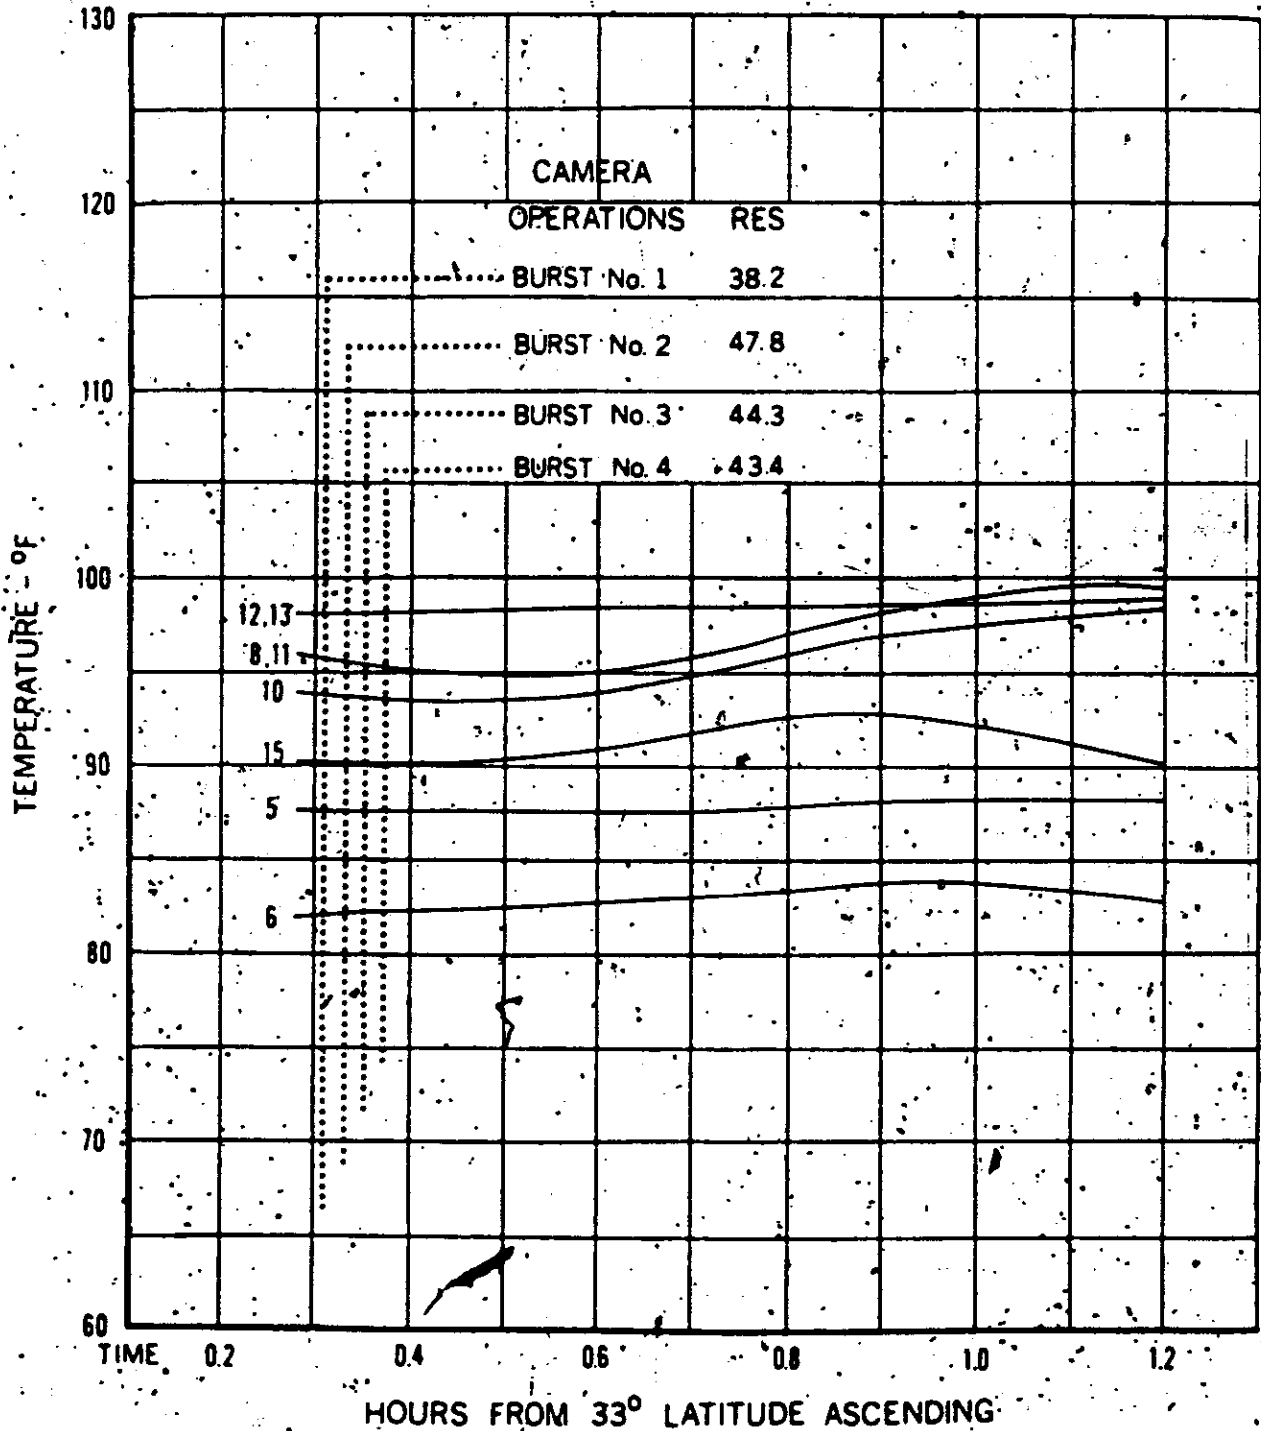
ILLUSTRATION 11

8. Another possible source of defocusing is a shift due to unpredicted and high temperatures at critical points in the optical system. Analysis of temperature data from the "on board" tape recorder is continuing to establish the precise time history of the thermal conditions which existed during flight. When this is completed, a more complete correlation with image quality (from RES measurement) can be accomplished. Flight instrumentation indicates that the lens was not in optimum focus due to the on-orbit temperature conditions. The most probable cause of quality degradation after Rev 9 is a shift of the lens elements at the high temperatures experienced on orbit. Attempts were made to correlate the on-orbit measurement with laboratory results which indicate that a total shift of approximately eight thousandths of an inch is probable, which could reduce the peak resolution by one third. These facts support the conclusion that the thermal conditions were the cause of the overall "softness" in image quality.

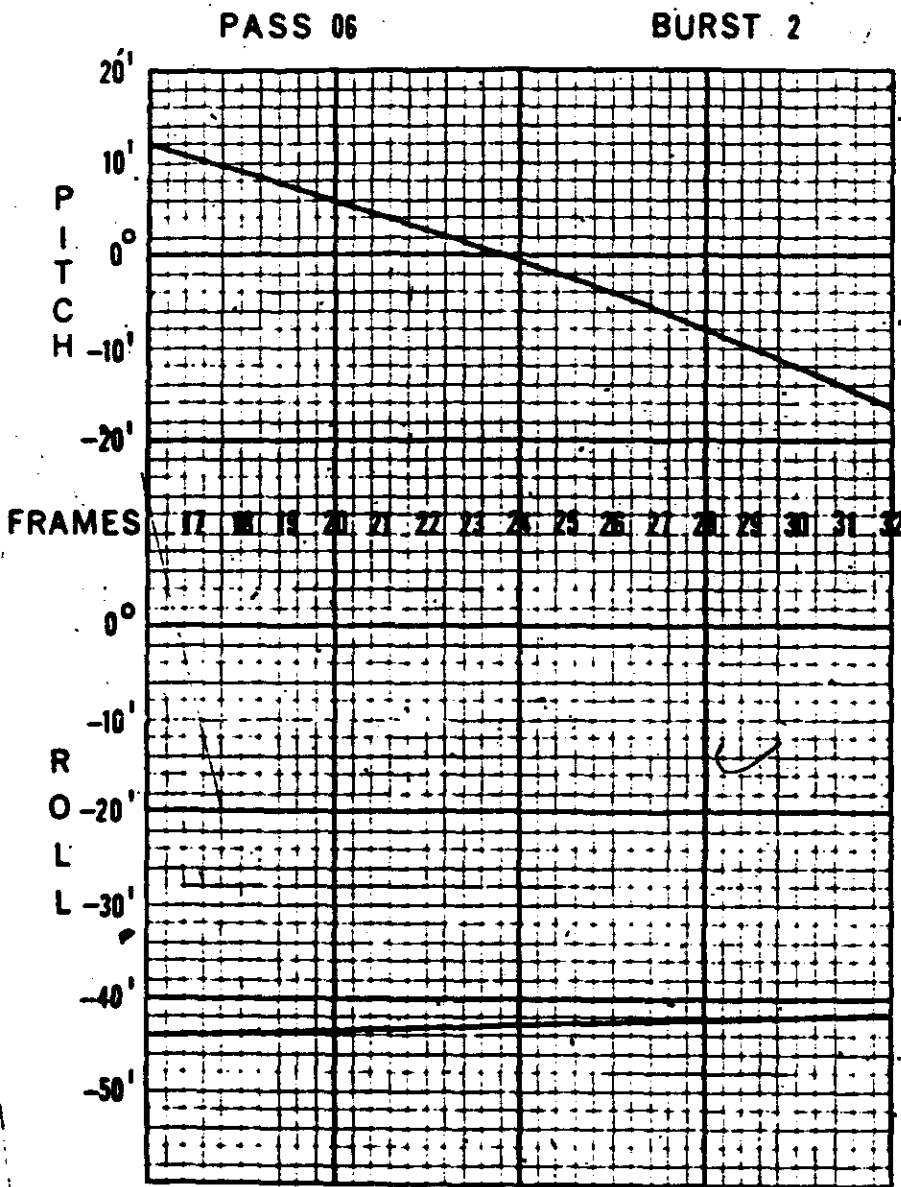
ILLUSTRATION 22

7. Pitch and roll as recorded in the data block have been plotted. Four samples are included in this report. They represent the best (D06-1), normal (D06-2), worst pitch (D14-2), and worst roll (D21-2) conditions (see Illustrations 21 through 24, pages 67 through 70).

PITCH RATE: 64 hr.
ROLL RATE: 3 hr.

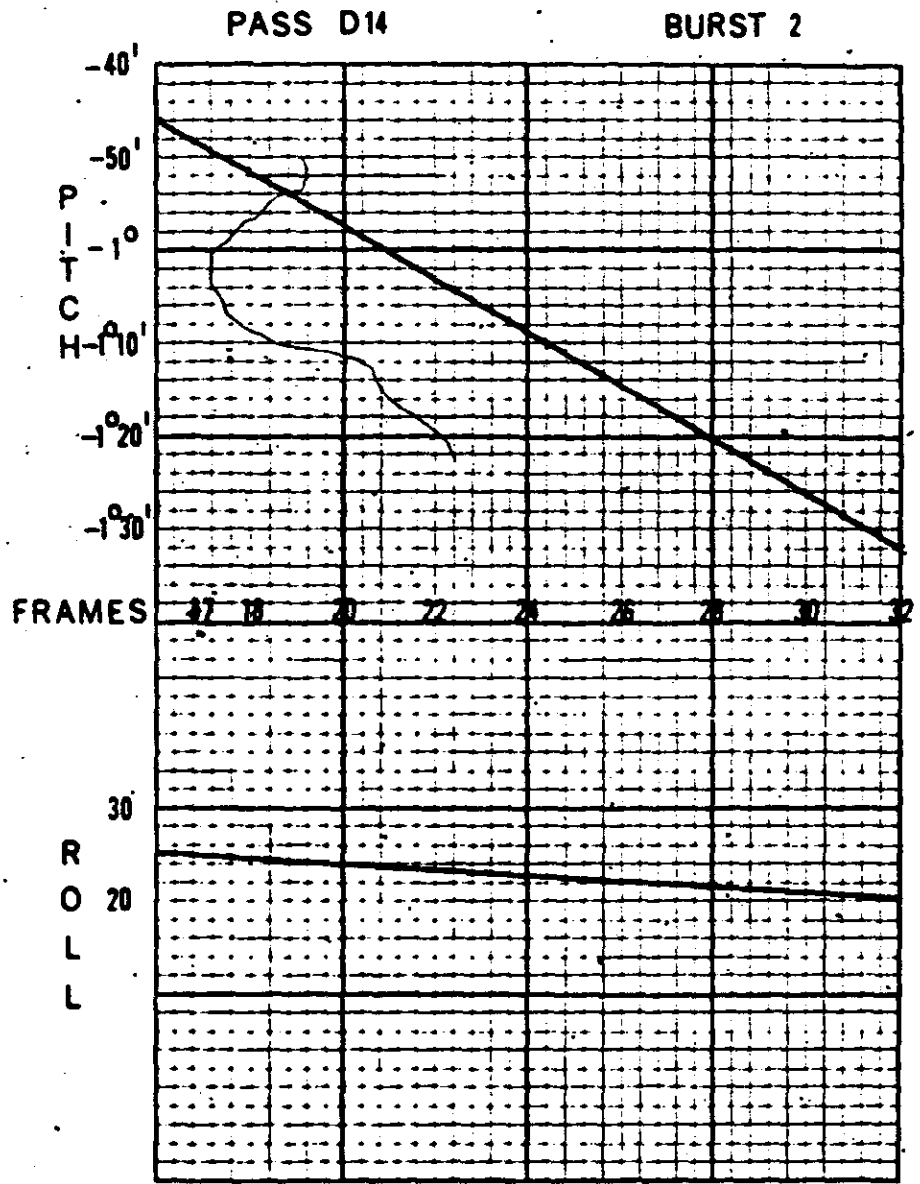
ILLUSTRATION 23

6. The most extreme errors in vehicle attitude are exhibited in passes D14 and D15. In pass D14 pitch error reaches a minus two degrees during operation 1, a series of six infrared coded bursts programmed to occur consecutively, and then recovers to nearly zero. A pitch rate of 150 degrees per hour occurs during this period. In pass D15 the error reaches minus 1 1/2 degrees near the end of operation 1. Pass D15 was a series of five monoscopic bursts programmed to occur consecutively. Highest pitch rate observed was 90 degrees per hour. It is possible that these pitch errors may be induced by the IIC air drive since

PITCH RATE: 129° hr.
ROLL RATE: 15° hr.

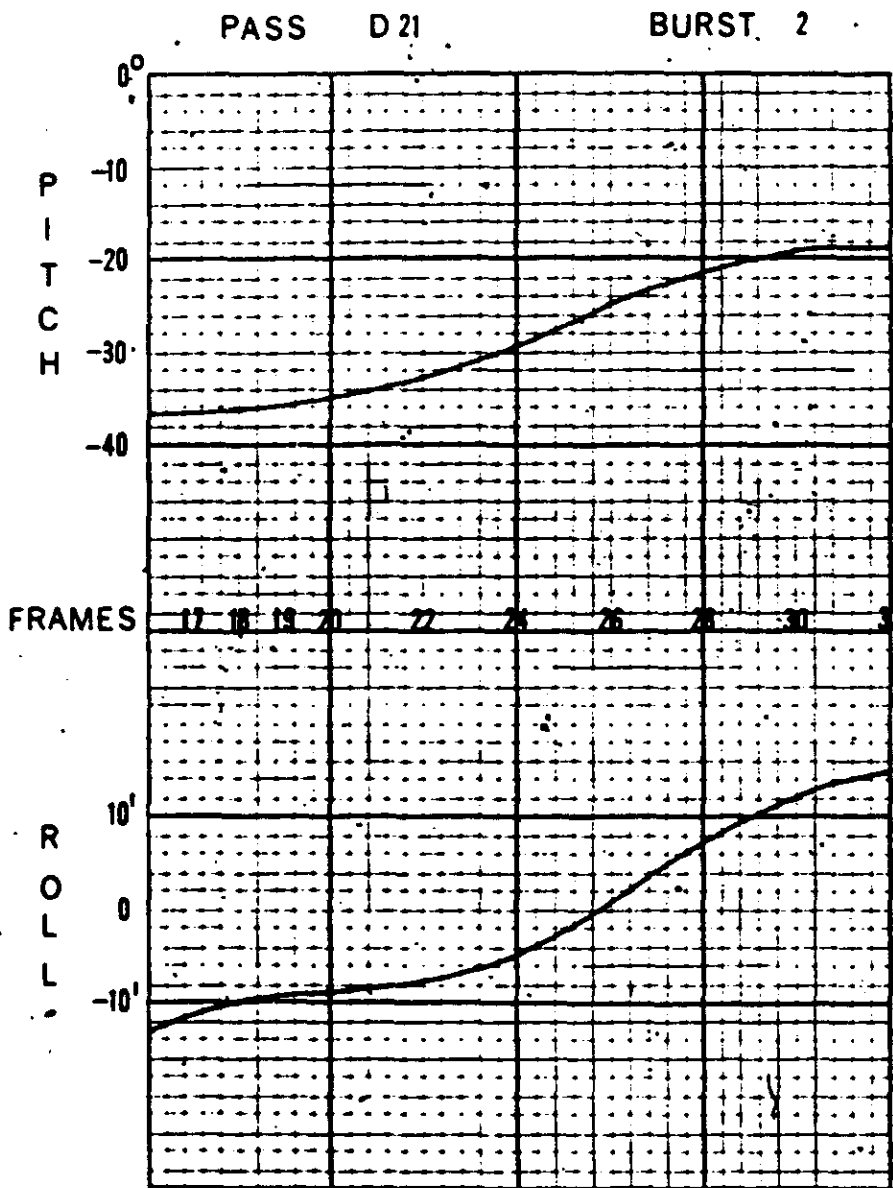
PITCH RATE: 60° hr.

ROLL RATE: 6.° hr.
