MURAL SYSTEM [REDACTED]

PERFORMANCE EVALUATION

REPORT

24 January 1964

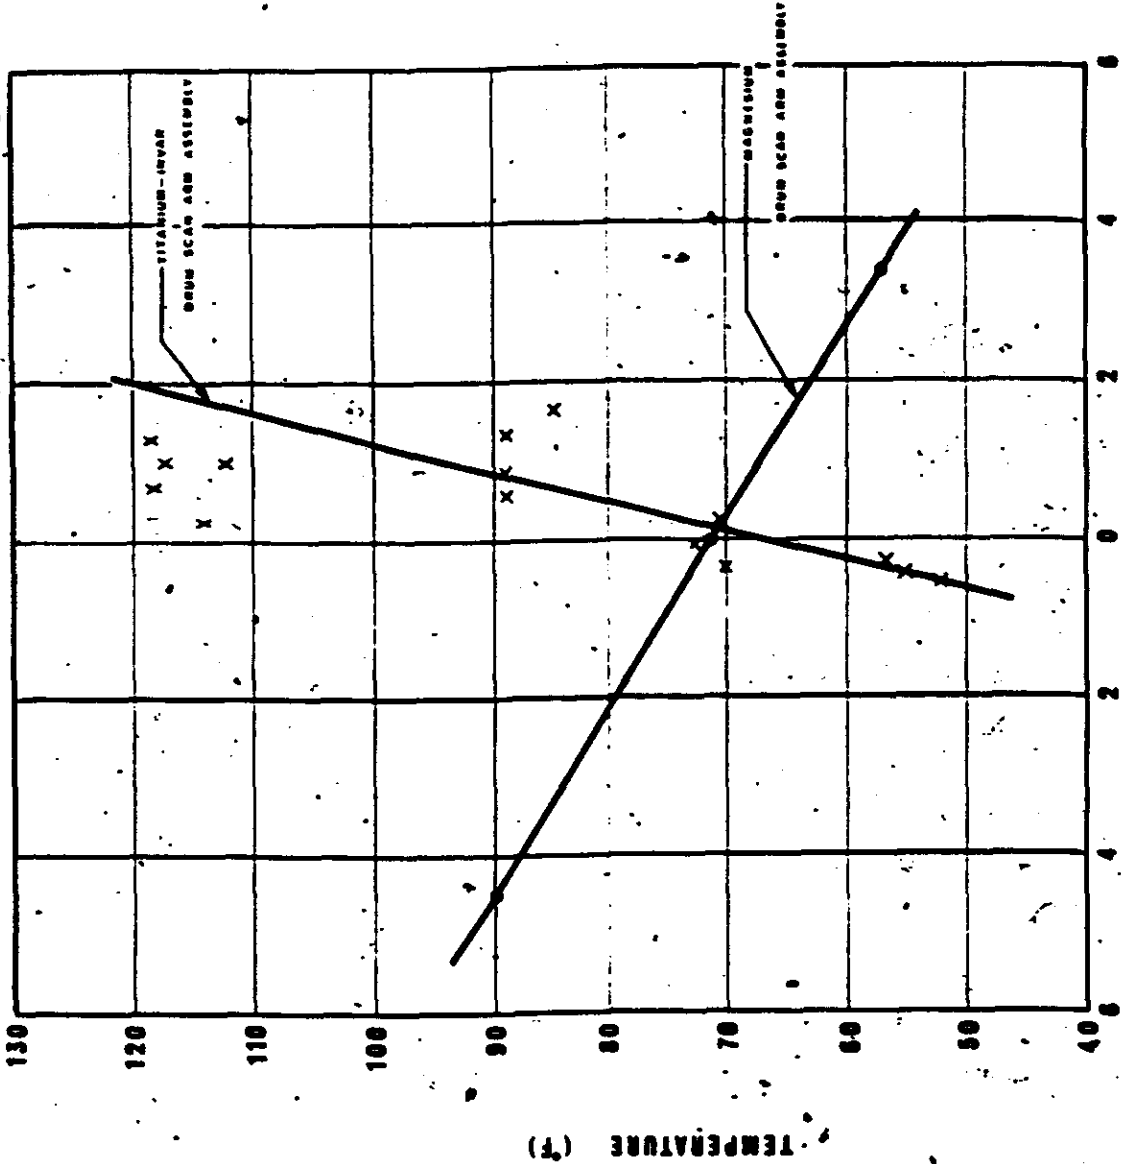
IMAGE PLANE SHIFT WITH TEMPERATURE CHANGE

Temperature variations of 30° to 40°F from nominal have been experienced during these missions. These changes from normal displace the film plane from the lens focal plane far in excess of the depth of focus. See Figure 9, Image Plane Shift with Temperature Change. The poor imagery was determined to be caused by the expansion or contraction of the magnesium drum-scan arm assembly. An invar titanium drum-scan arm assembly has been incorporated into the camera and now permits greater thermal variations before the film plane is displaced from optimum focus.

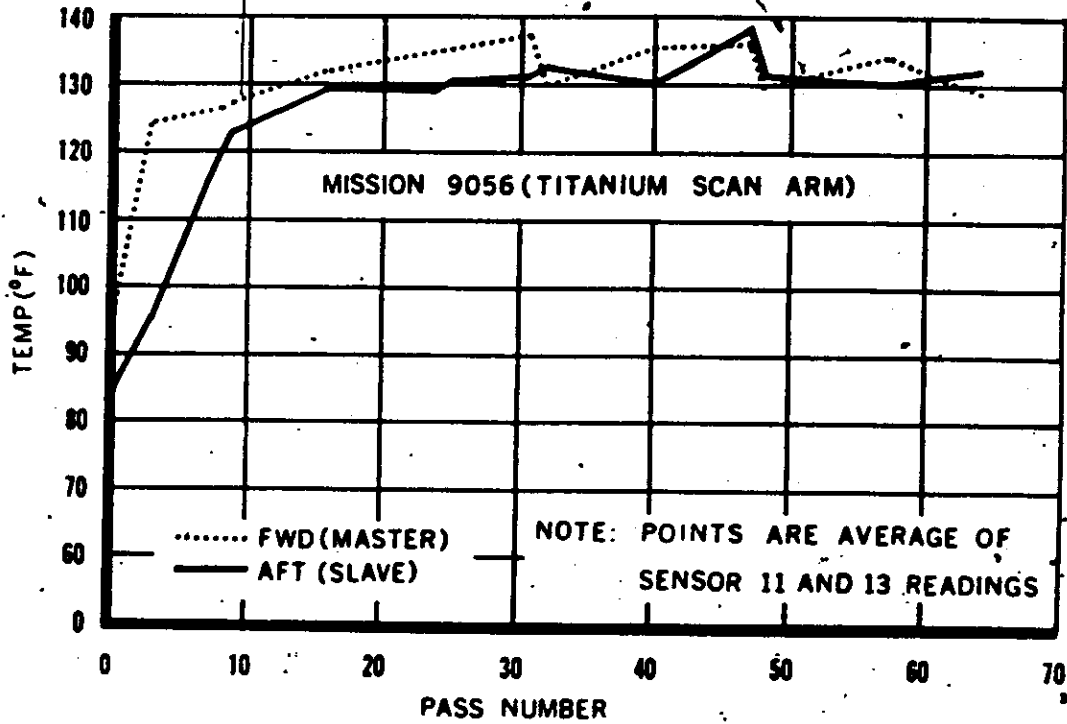
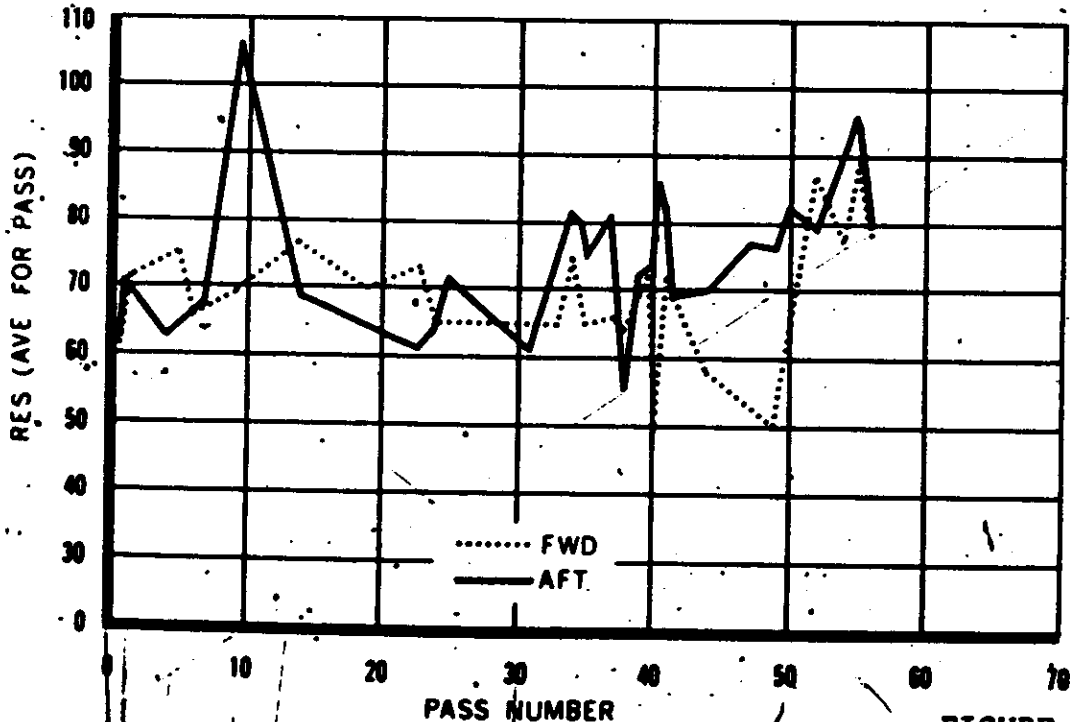
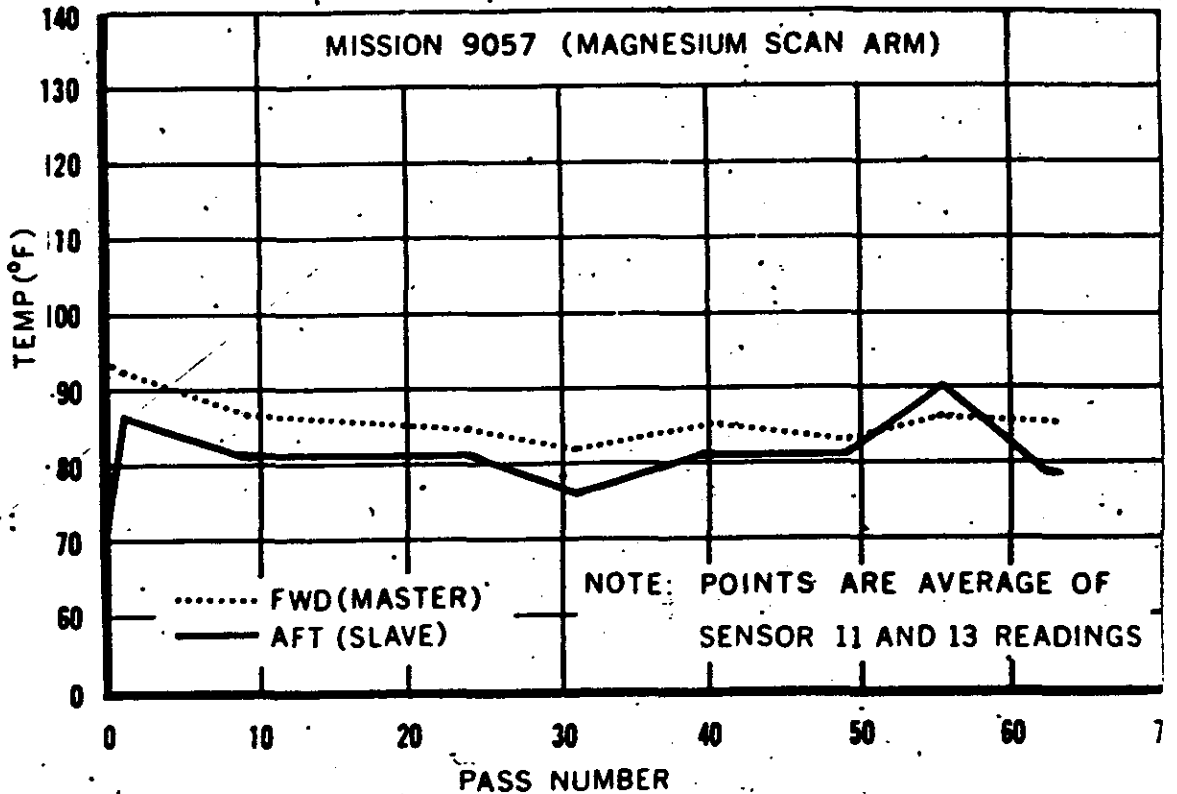
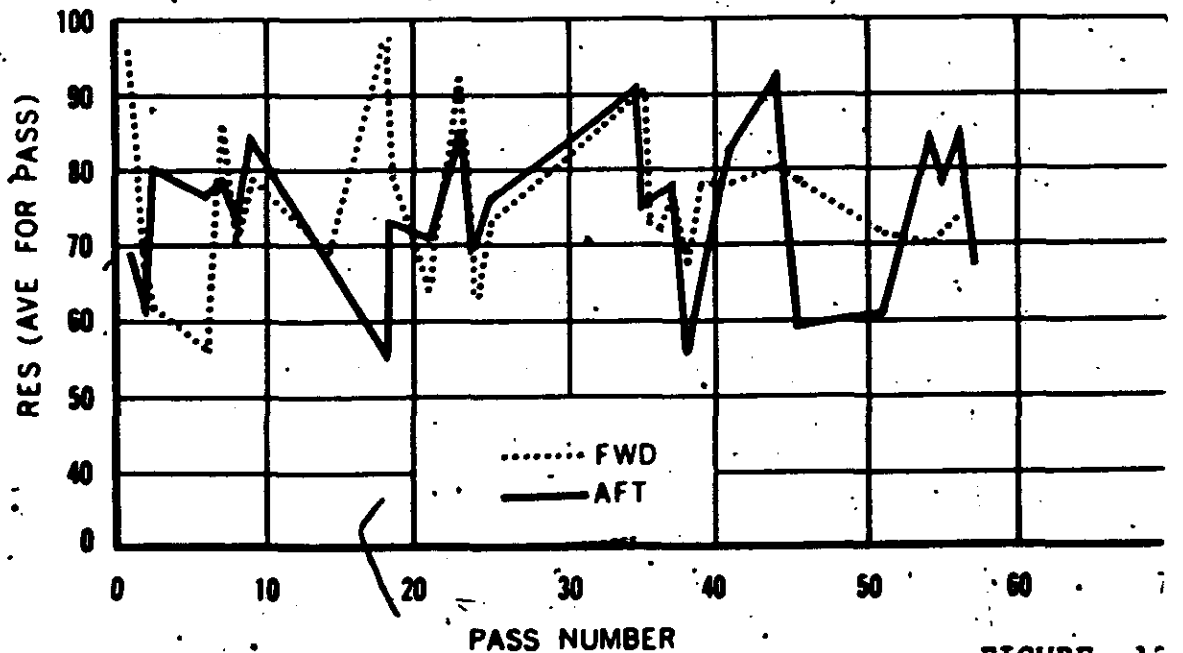
COMPARISON OF CAMERA TEMPERATURE WITH RES READINGS

Although the drum and stove temperatures are markedly different throughout the first few passes, RES data does not show any significant improvement as this difference is reduced. Instead, significant correlation does appear between RES values and average temperature, particularly on 1001-1 (magnesium scan arm) where average temperature rose from 75°F on Pass 0 to 105°F by Pass 9 (see Figure 13). Over the same period, RES dropped from about 80 to 50. Reference to the Lens System Thermal Response data (Figure 10) shows that a 30° temperature rise causes a focus error of about .008", sufficient to account for a 50% drop in resolution.

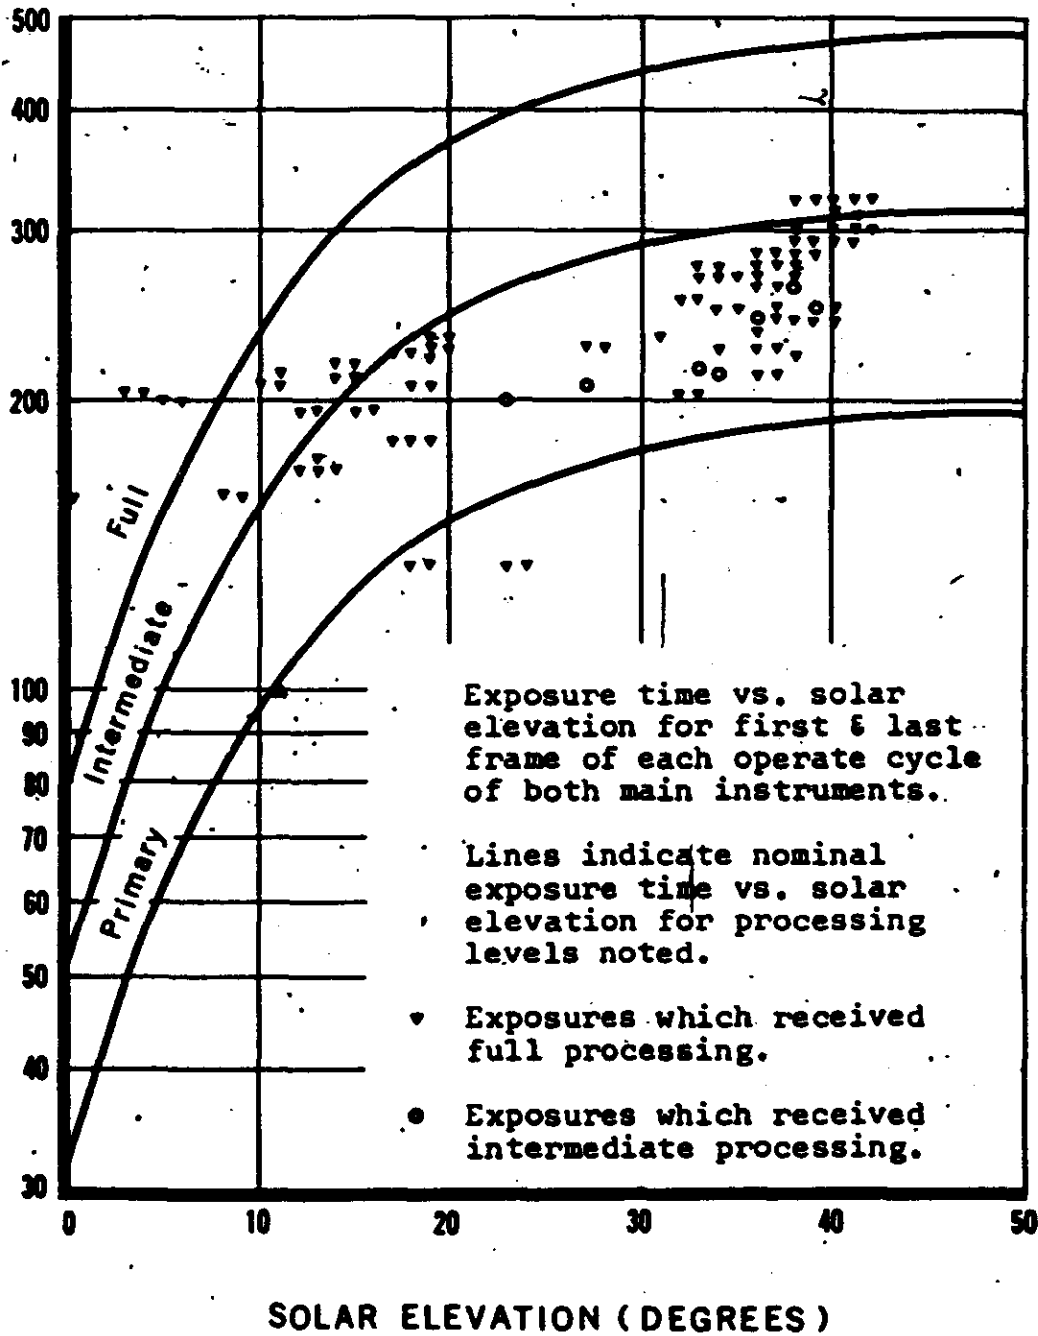
MISSION 9057 OPERATIONAL EXPOSURE POINTS

The operational exposure time is, as previously noted, selected to follow the intermediate processing curve. Figure 1 plots the actual exposure times versus solar elevation for the beginning and end of each operate cycle for Mission 9057. This plot is representative of Mural program operations. The figure does show that the majority of operate cycles were exposed within the range of the Intermediate curve. The original negative, however, received full processing for the majority of the mission which is excessive based upon the published processing data. Those few areas that did receive intermediate processing are well below the nominal Intermediate curve.

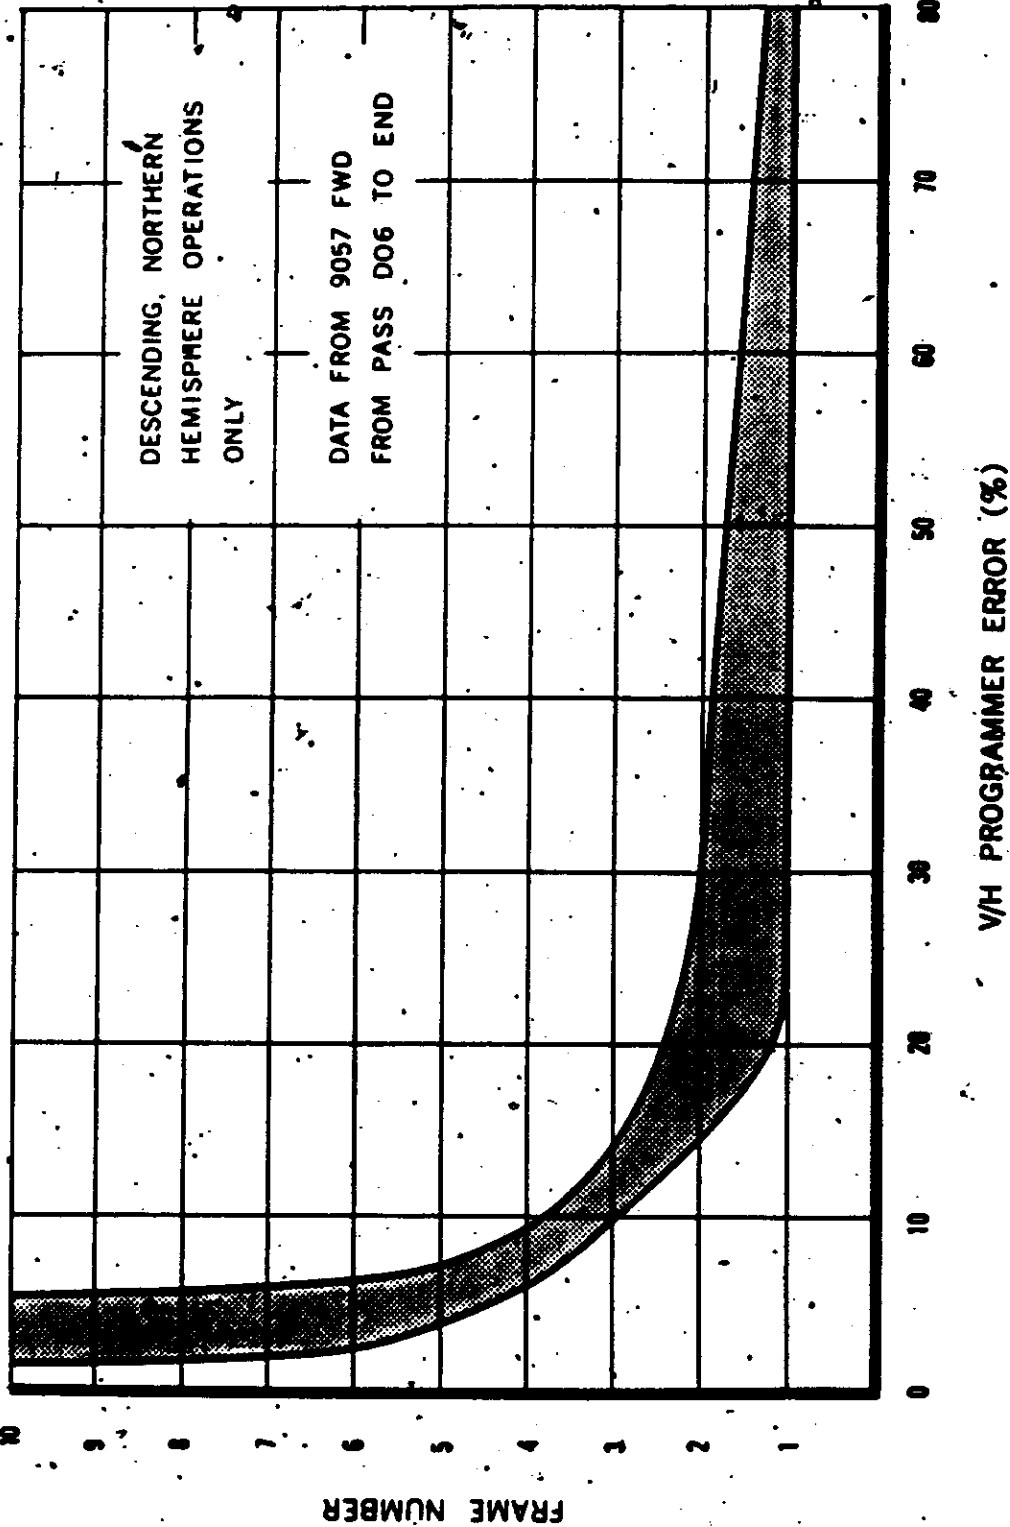
FIGURE 18

The evaluation of V/h programming errors was divided into two areas as significant errors were found during the first six to seven frames of photography of each operate cycle. Figure 18 shows the V/h error envelope for the first ten frames of all operate cycles for Mission 9057, Forward camera. These large errors are due to the camera system start-up and the time required to achieve proper operating speed. Nominal operating speed is reached by the sixth to seventh frame which normally is with the 25 second time pad allocated to the system.
