PHOTOGRAPHIC EVALUATION REPORT

MISSION 9048

24-29 NOVEMBER 1962 Z

NATIONAL PHOTOGRAPHIC INTERPRETATION CENTER

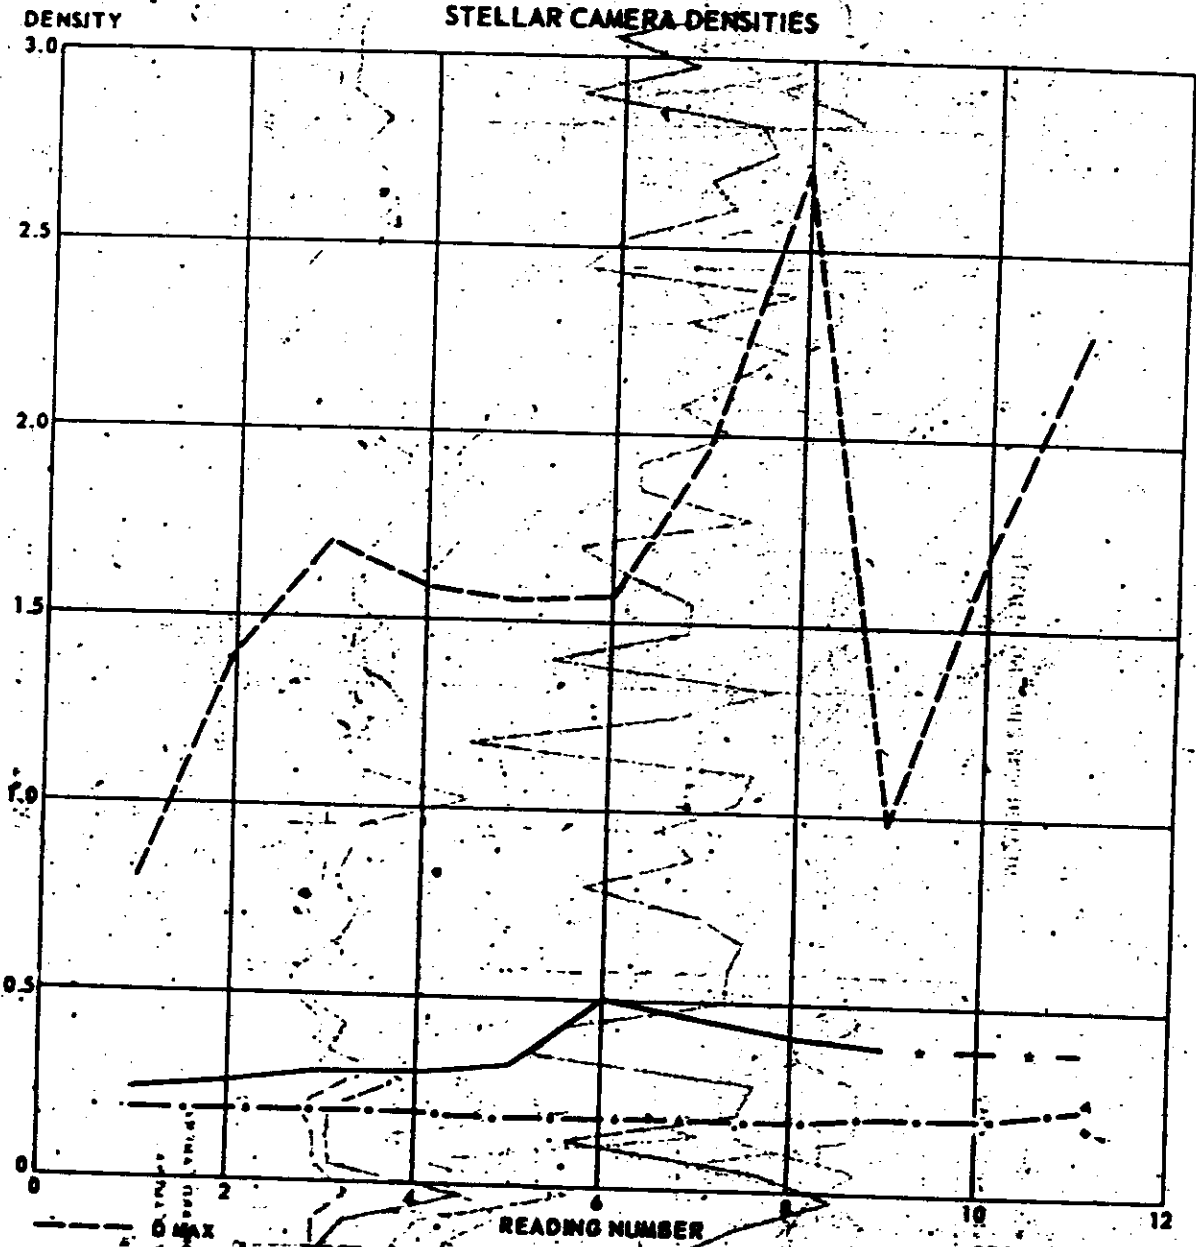
STELLAR CAMERA DENSITIES

NOTE: NO DENSITY READING TAKEN AFTER PASS 023 DUE TO SEVERE DEGRADATION CAUSED BY LIGHT LEAKS AND STATIC.
