PHOTOGRAPHIC EVALUATION REPORT

MISSION 9062

21 - 26 DECEMBER 1963

NATIONAL PHOTOGRAPHIC INTERPRETATION CENTER

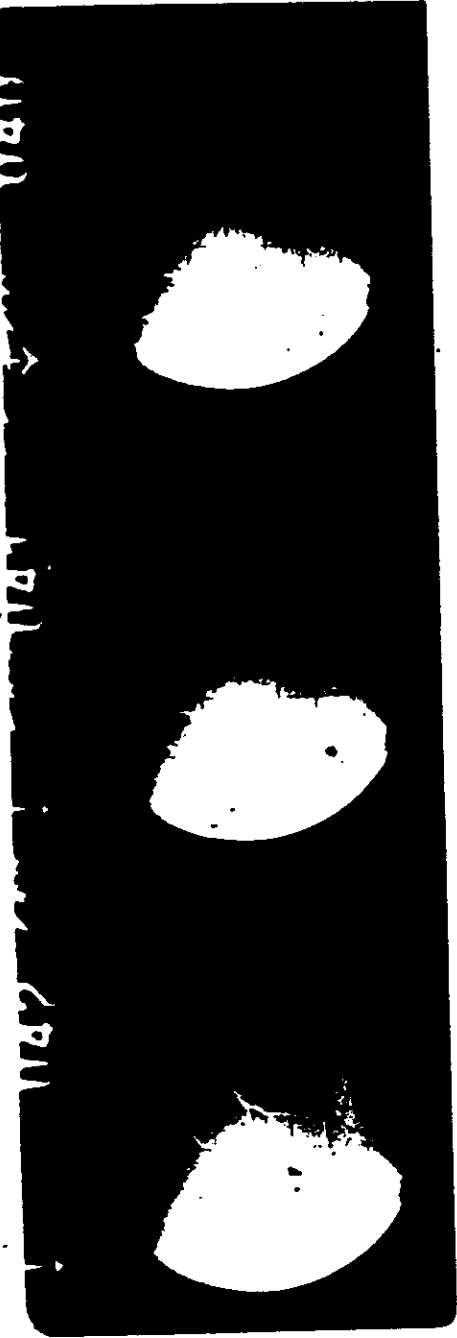
The edge of the film opposite the camera number contains a profusion of dendritic edge static. This static is in the border area and does not affect the formats. There are, however, large discharges of dendritic static within the formats of frames 40, 41, 42, and 393, and corona fog on frames 394 to 412.

FIGURE 8. DENDRITIC EDGE STATIC ON STELLAR INDEX PHOTOGRAPHY.

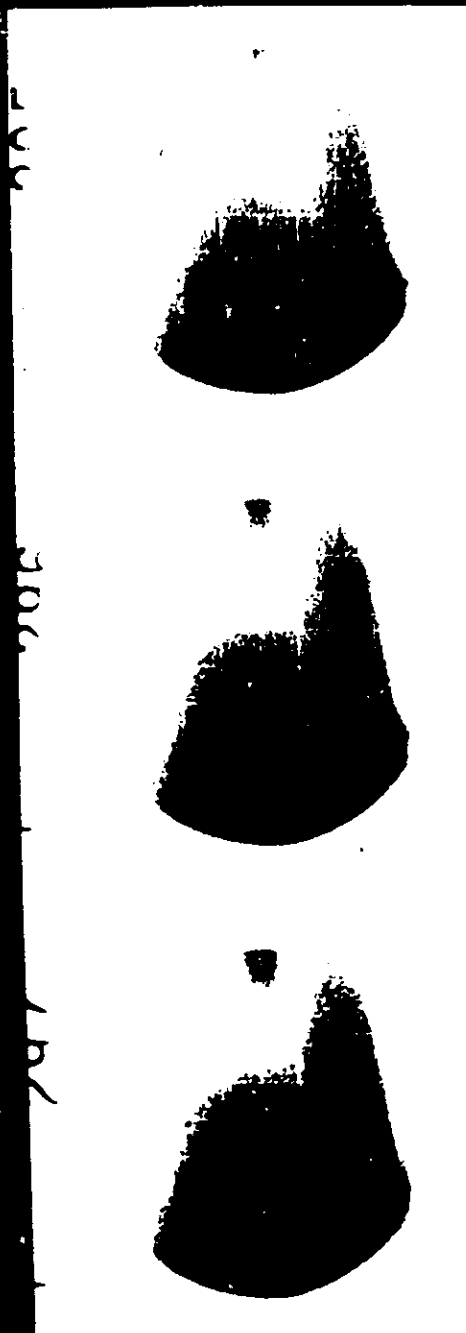
d. In most instances the stellar and index correlation and fiducial marks recorded too faintly to be used for their intended purpose.

FIGURE 9. AVERAGE STELLAR FIELD, INOPERATIVE CORRELATION LAMPS AND FLARE.

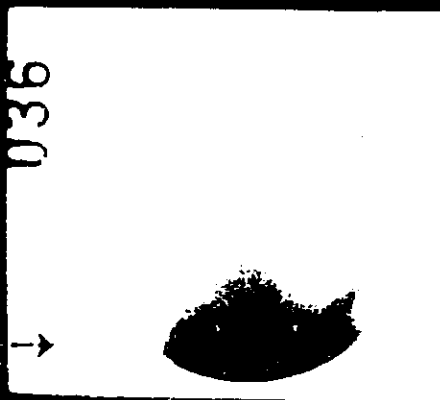
Foreign Matter Frames 36, 63, 75, 107, 109, 286, 287, 292.

FIGURE 11. FOREIGN MATTER.

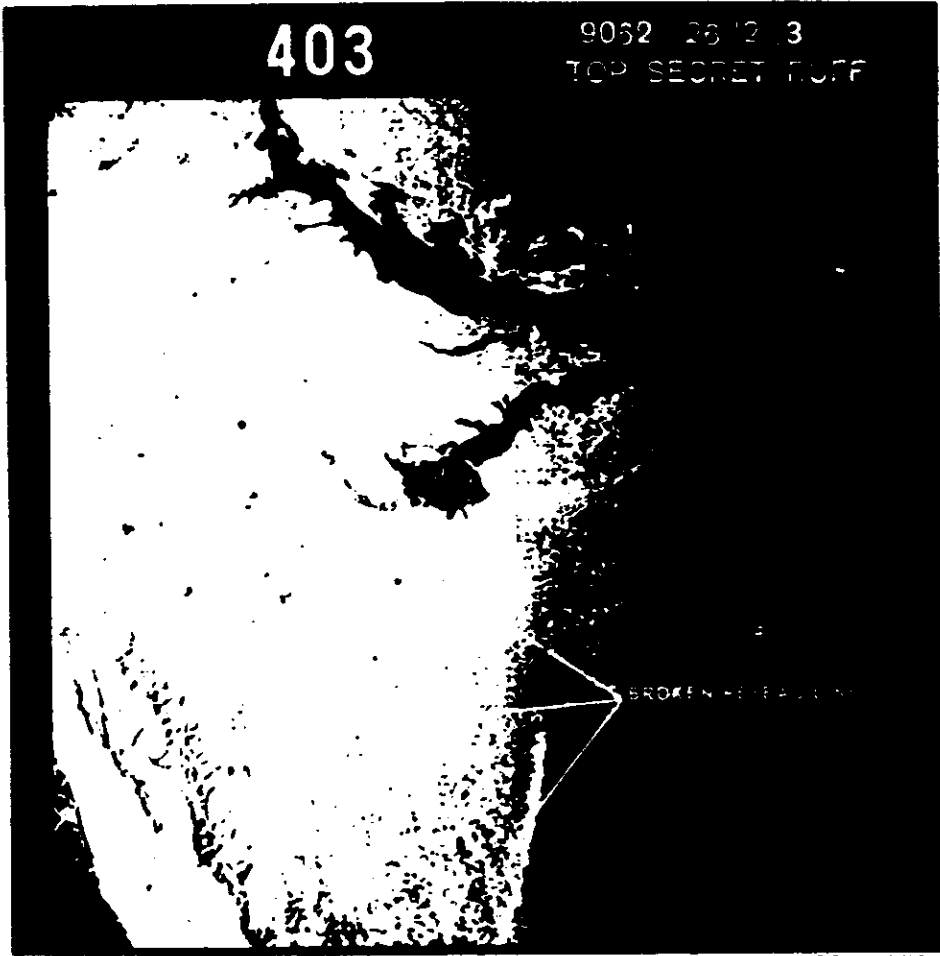
The grid is well defined in all frames. However, there are small gaps in the grid (Example: Frame 403)..

FIGURE 13. BROKEN RESEAU LINES, LIGHT LEAK, EFFECT OF SNOW ON PI SUITABILITY IN TERRAIN INDEX PHOTOGRAPHY.

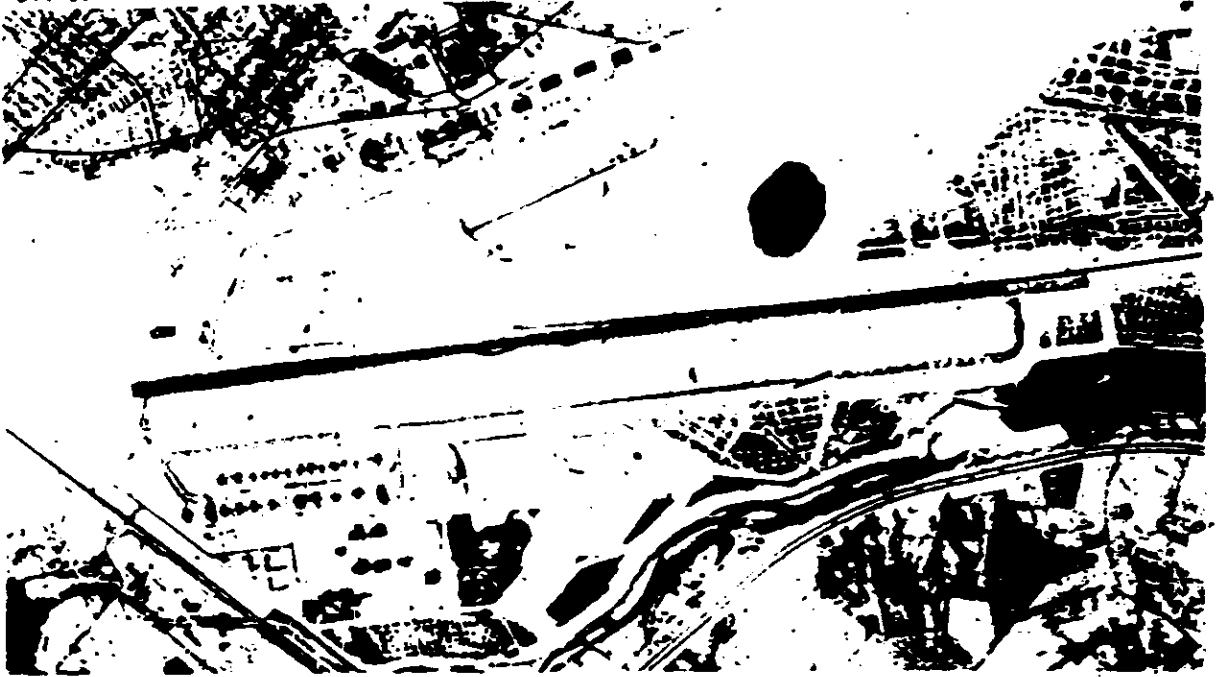
FIGURE 20. EFFECT OF SNOW ON PI SUITABILITY OF PANORAMIC PHOTOGRAPHY.

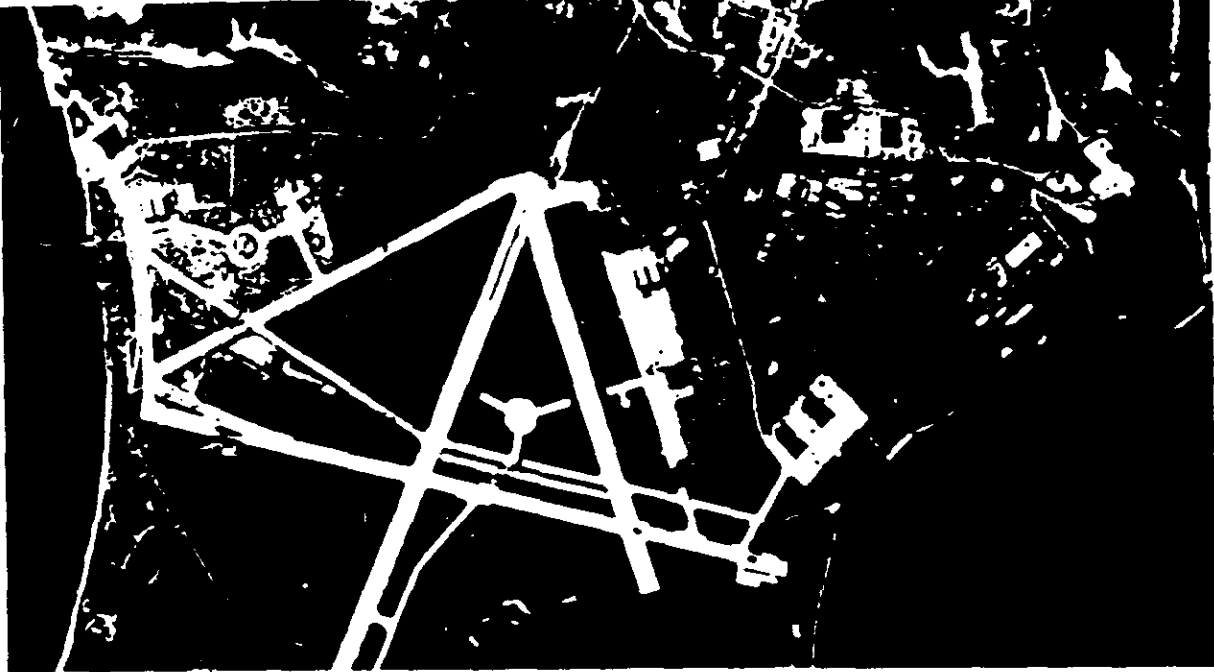
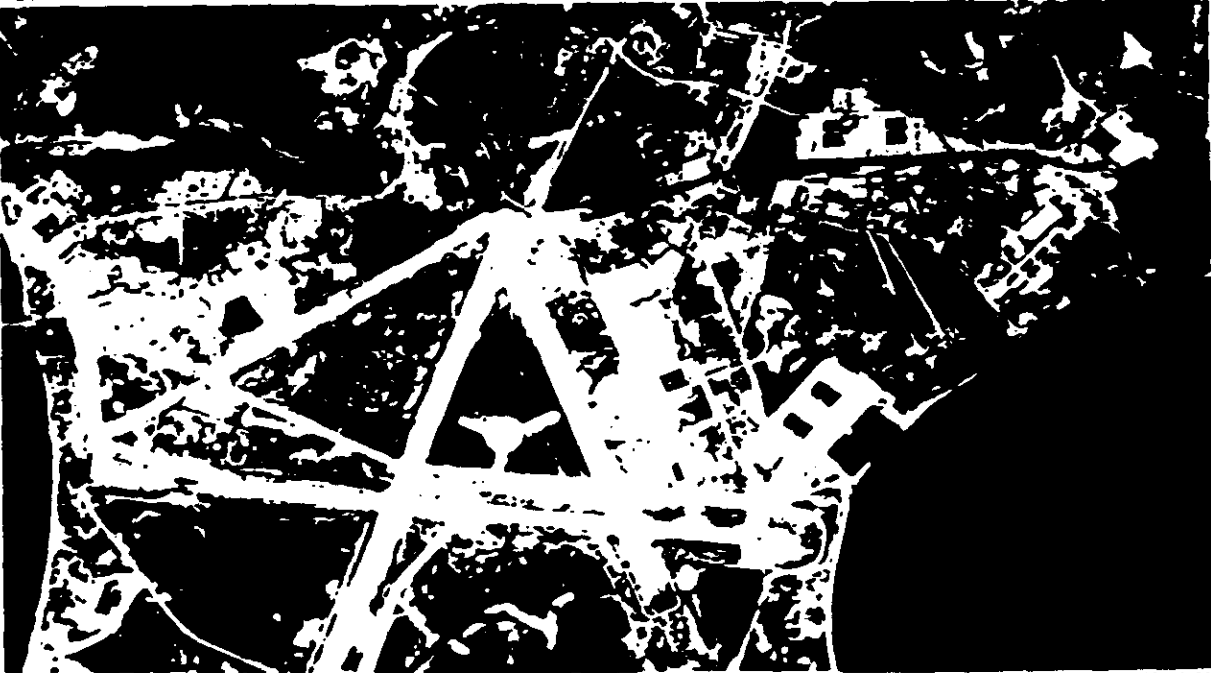
FIGURE 23. FWD CAMERA CORONA STATIC AND COMPRESSION ELONGATION DISTORTION (NOTE CIRCLES PATIENT NAS. MD.)
