CORONA J
PERFORMANCE EVALUATION REPORT
MISSIONS 1006-1 & 1006-2
FTV 1176 - J9

26 October 1964

This document is the final payload test and performance evaluation report for Missions 1006-1 and 1006-2 which was launched on 4 June 1964.

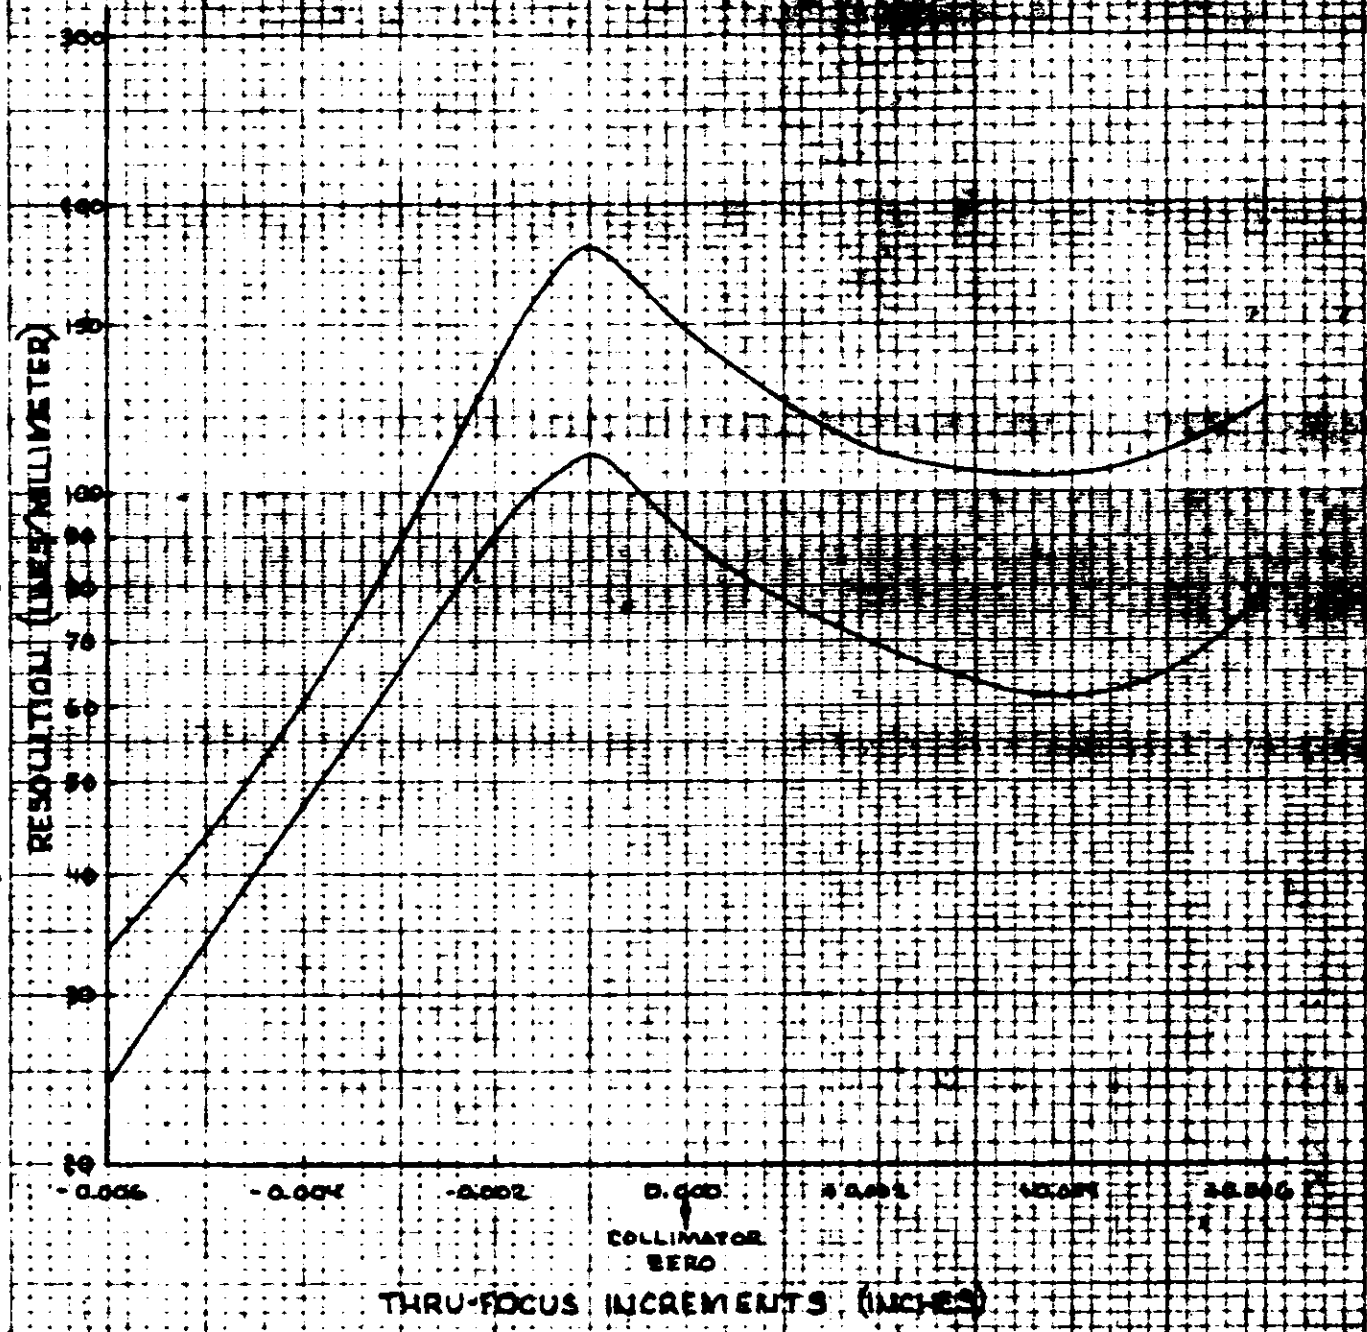
Figure 2

HIGH CONTRAST RESOLUTION 10 LINES/MM
LOW CONTRAST RESOLUTION 10.35 LINES/MM
