# PHOTOGRAPHIC EVALUATION REPORT

## MISSION 1006

### 5-12 JUNE 1964

NATIONAL PHOTOGRAPHIC INTERPRETATION CENTER

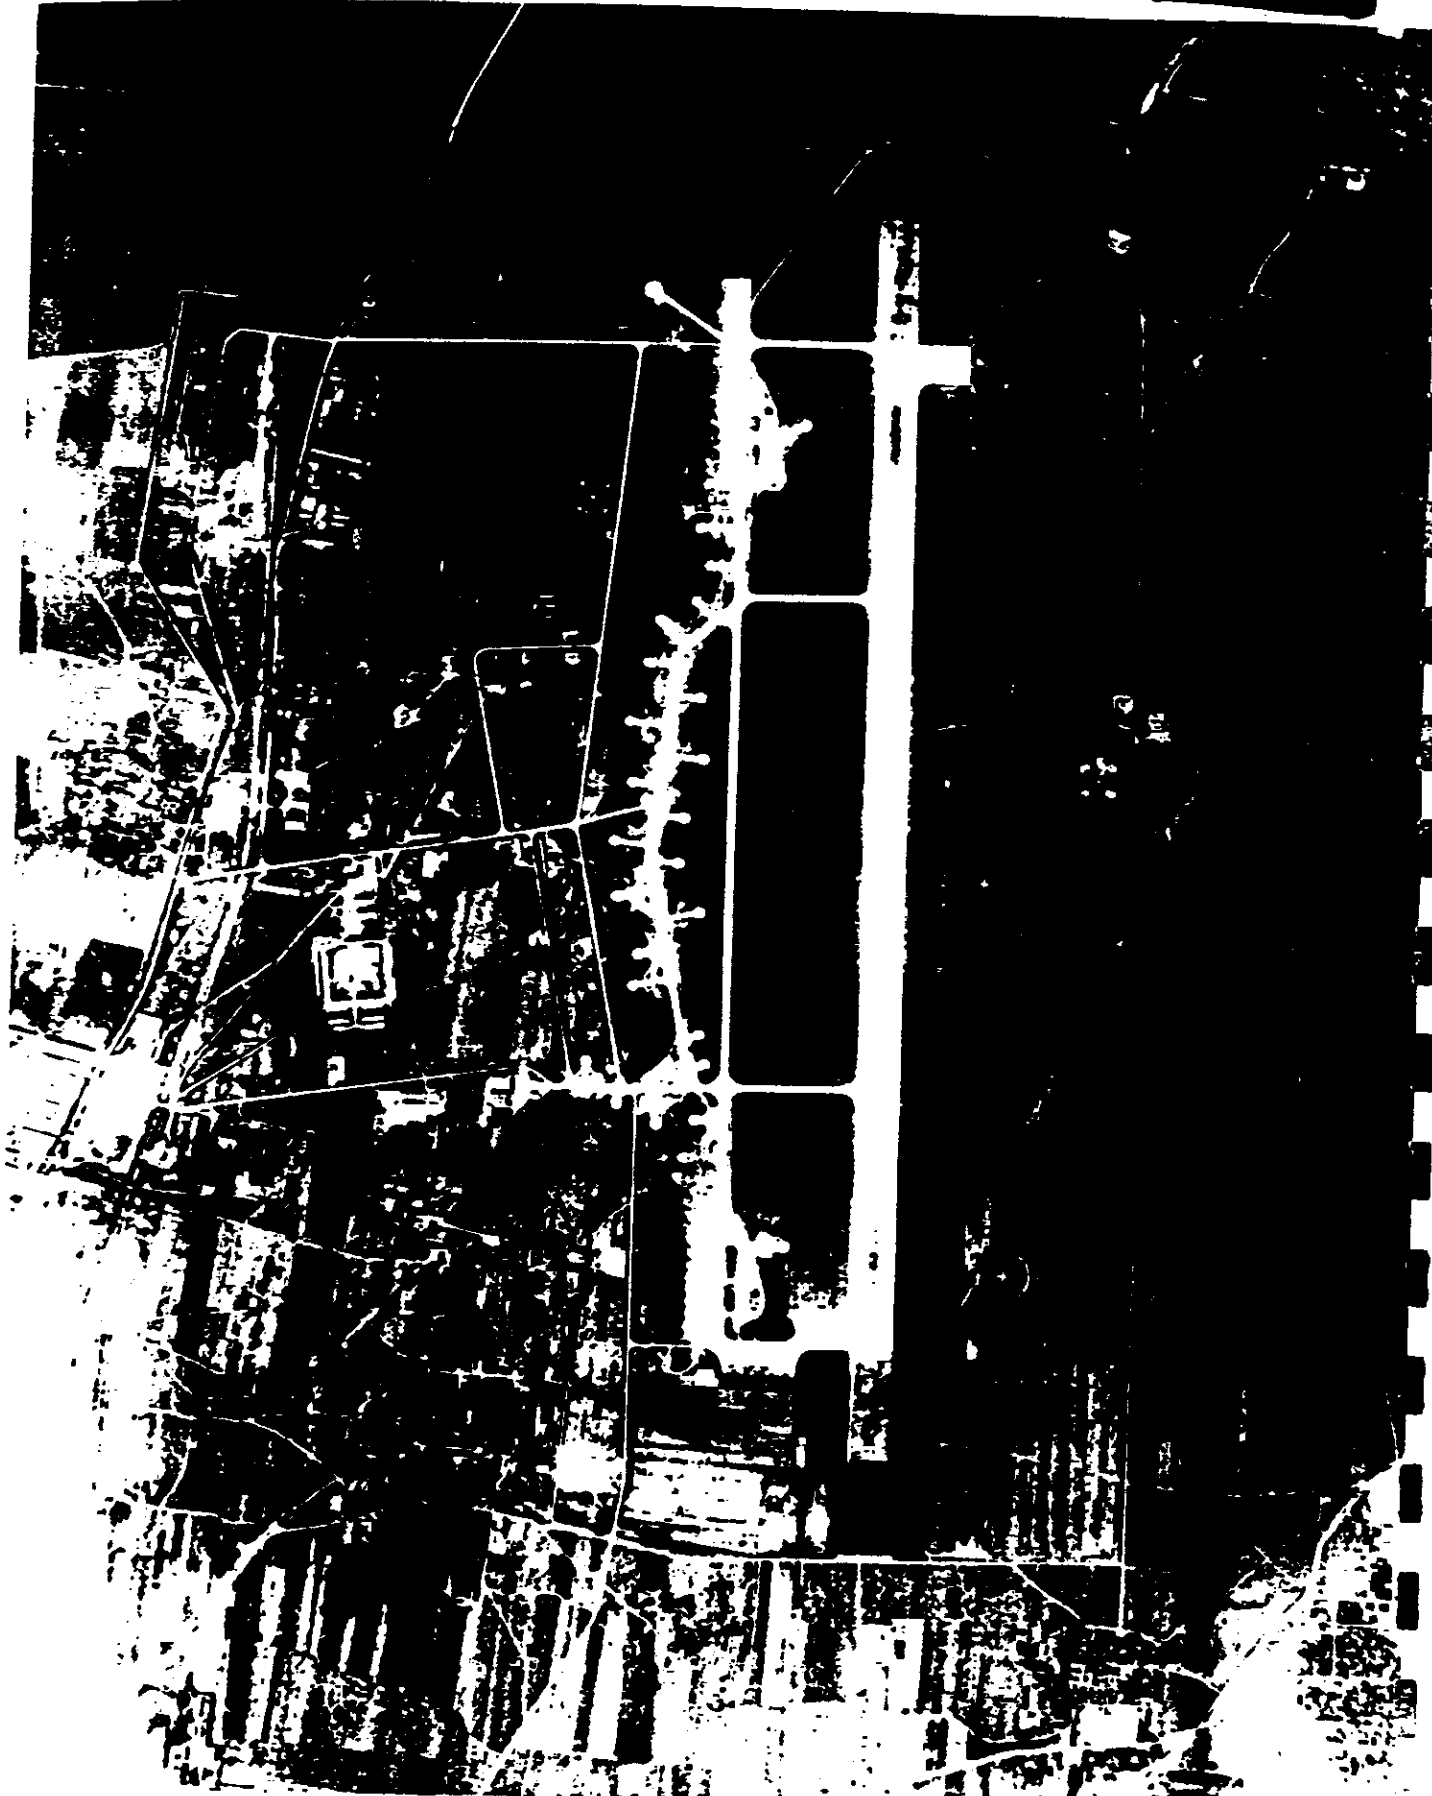
FIGURE 1. EXAMPLE OF IMAGE QUALITY - MASTER CAMERA.

The following two photographs show a comparison of image quality between the Master (FWD) and Slave (AFT) panoramic cameras.

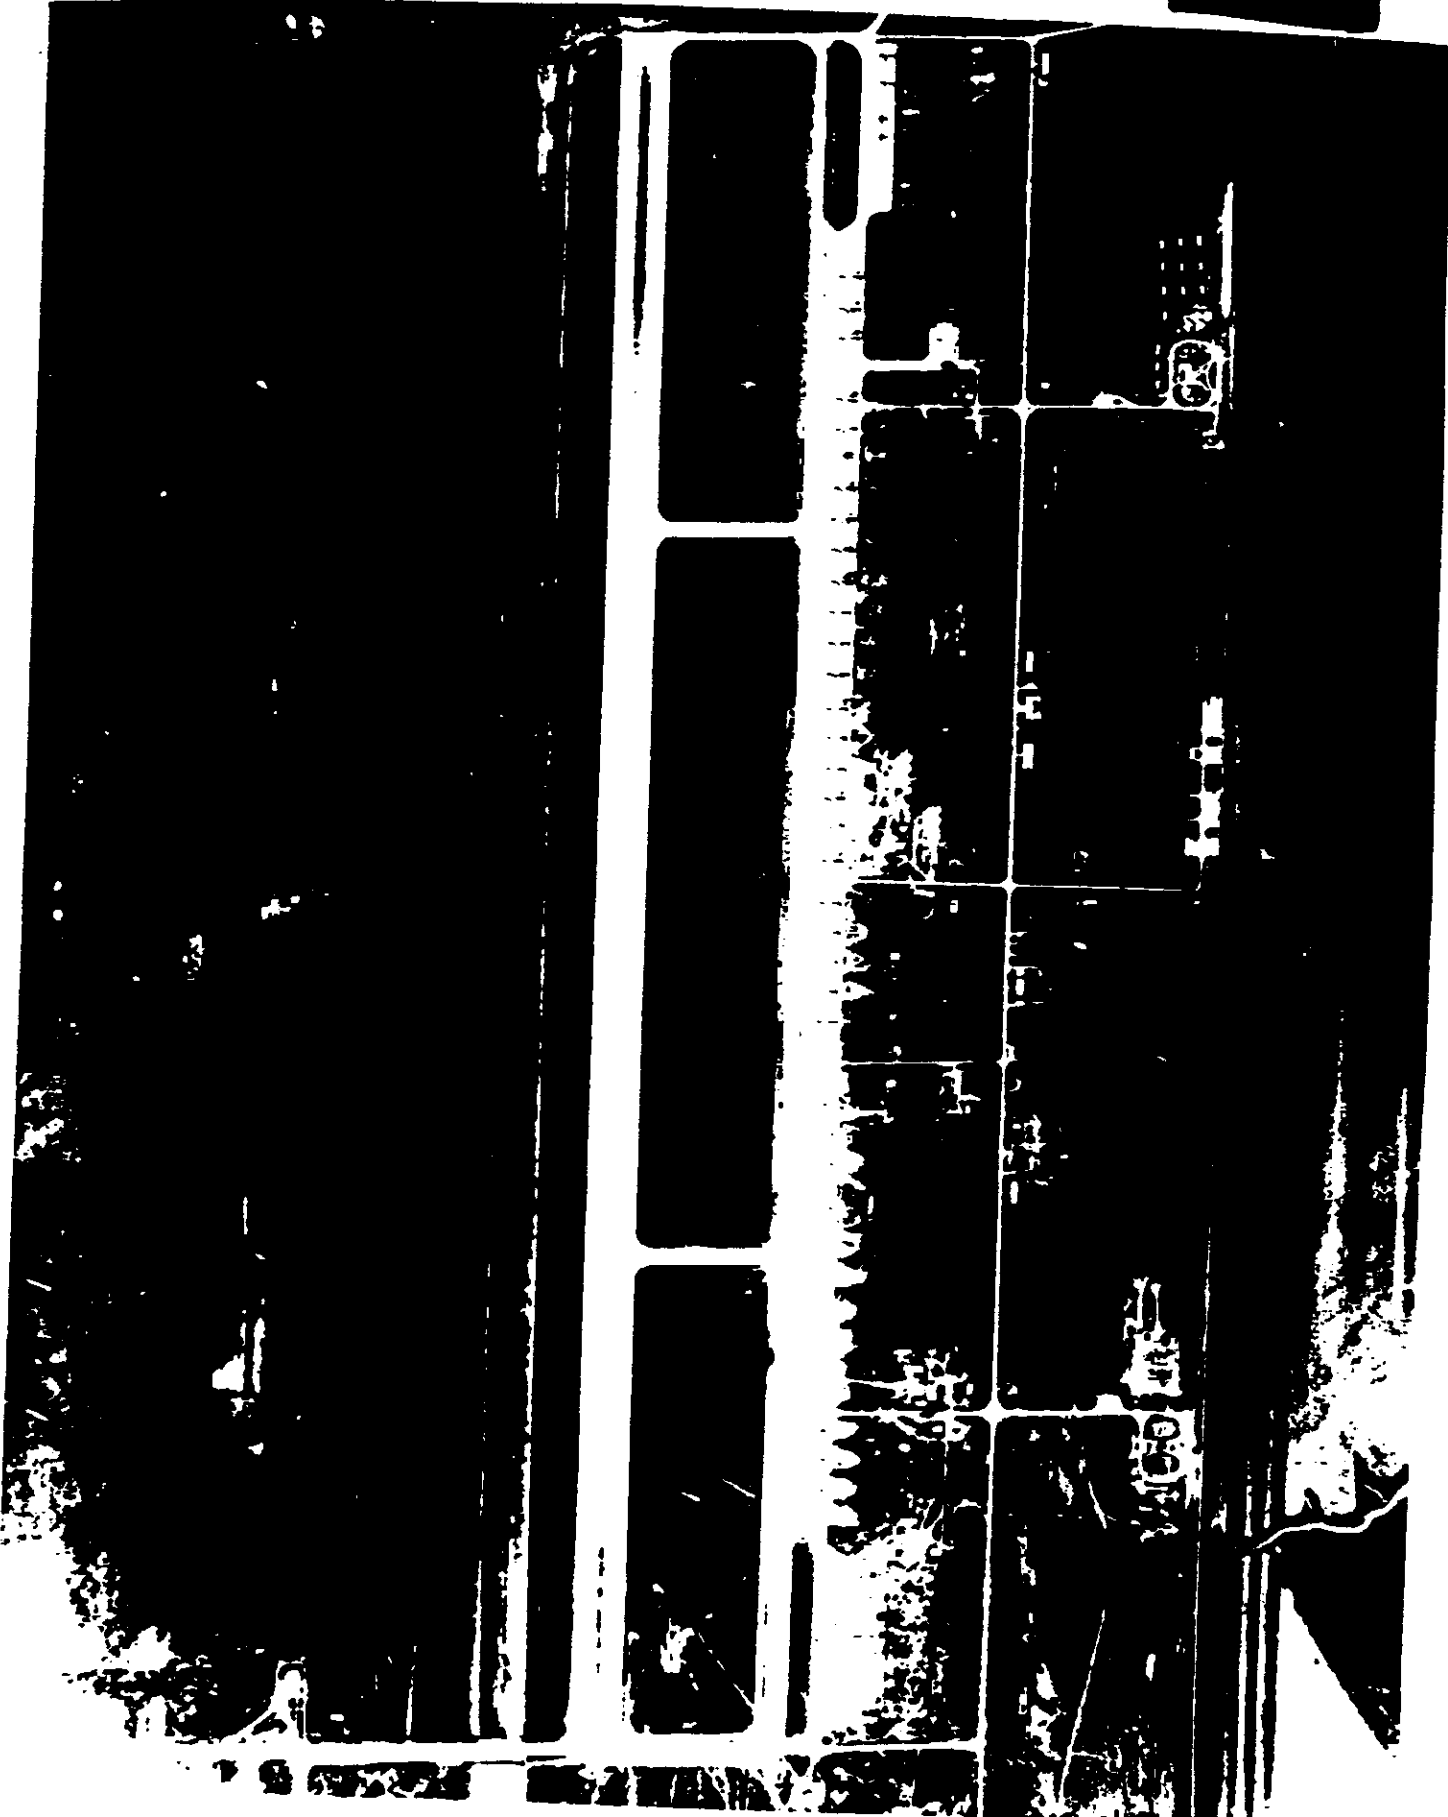
FIGURE 3. GOOD IMAGE QUALITY NEAR END OF MISSION.

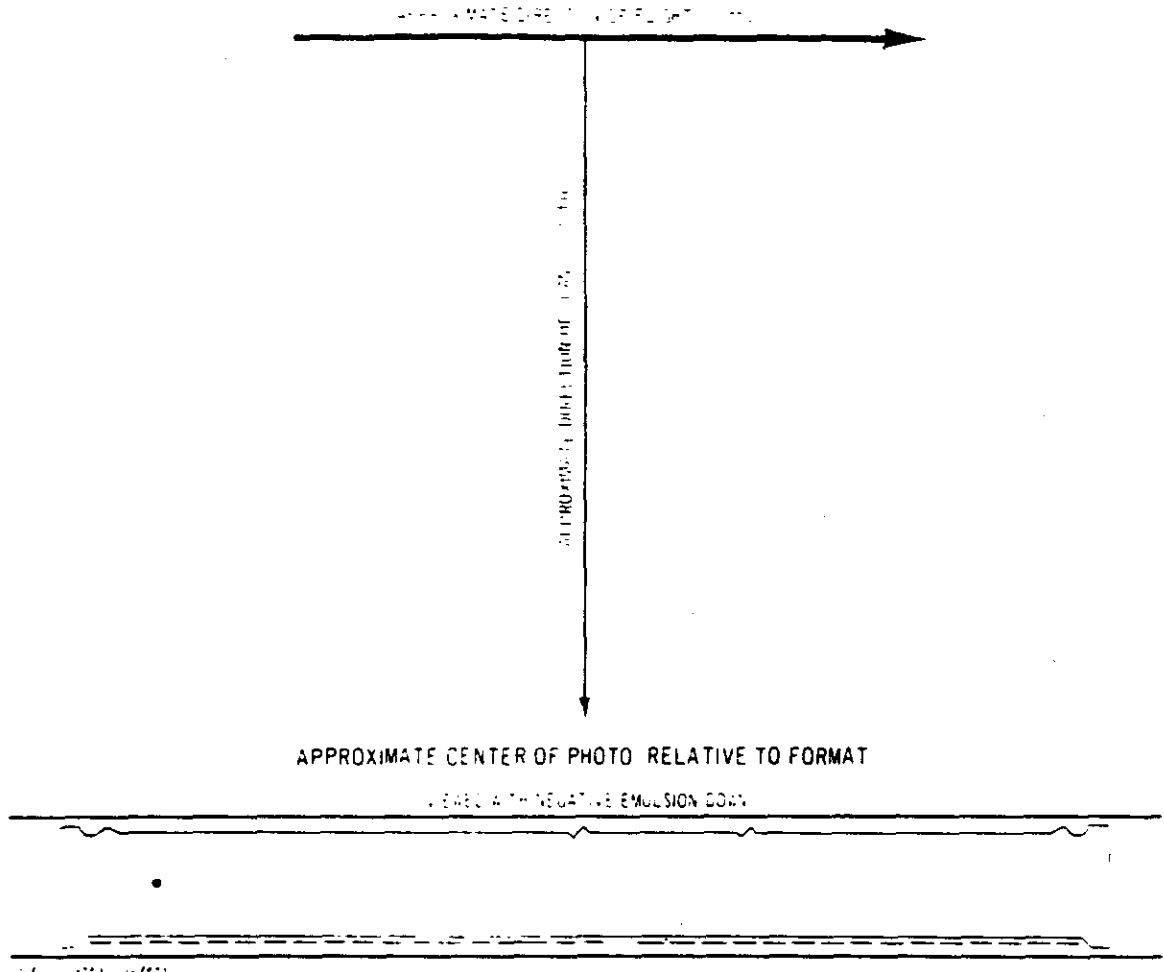
Flare at the supply end of pass 52D, frames 13-19, degrades the imagery in an area up to six square inches on each affected frame. The flare tends to be smeared along the major axis of each format and appears to be associated in that respect with "cloud smearing" as reported in previous missions.

FIGURE 4. EFFECT OF FLARE.

The following photograph shows the degradation of PI suitability caused by flare.

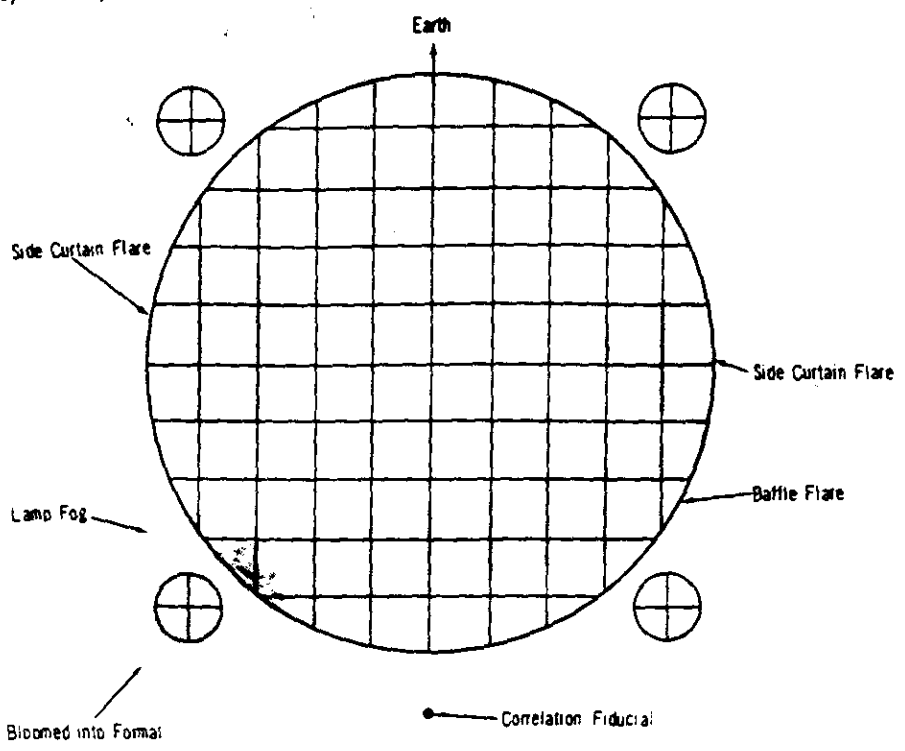
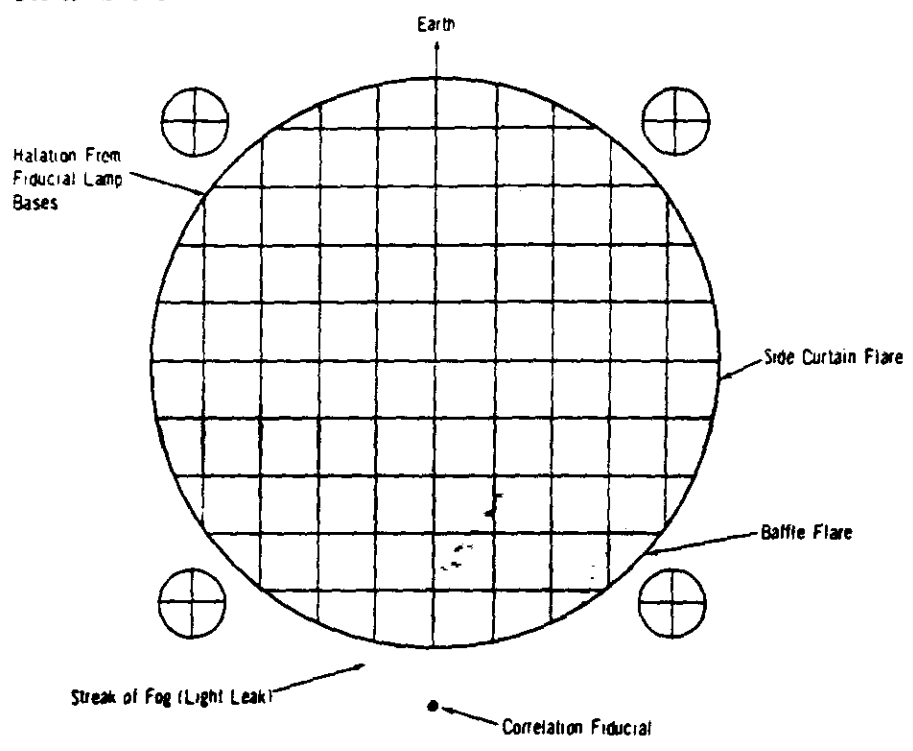
When viewing the film through the base, the fiducial to the right of the frame correlation fiducial is grossly overexposed. It is bloomed into the format and degrades the stellar imagery. Due to this flare and the more common flares (side curtain and earth flare) approximately 40 percent of each format is obscured.

Flare affects 30 percent of each frame. Semicircles, associated with the four fiducials, are imaged in the format of each frame. This is probably caused by halation from the mounting plates of the fiducial lamps.

FIGURE 9. TYPICAL STELLAR FORMAT FLARES AND DENSITIES.
