CORONA J

PERFORMANCE EVALUATION REPORT

MISSIONS 1007-1 and 1007-2

FTV 1609; J-07

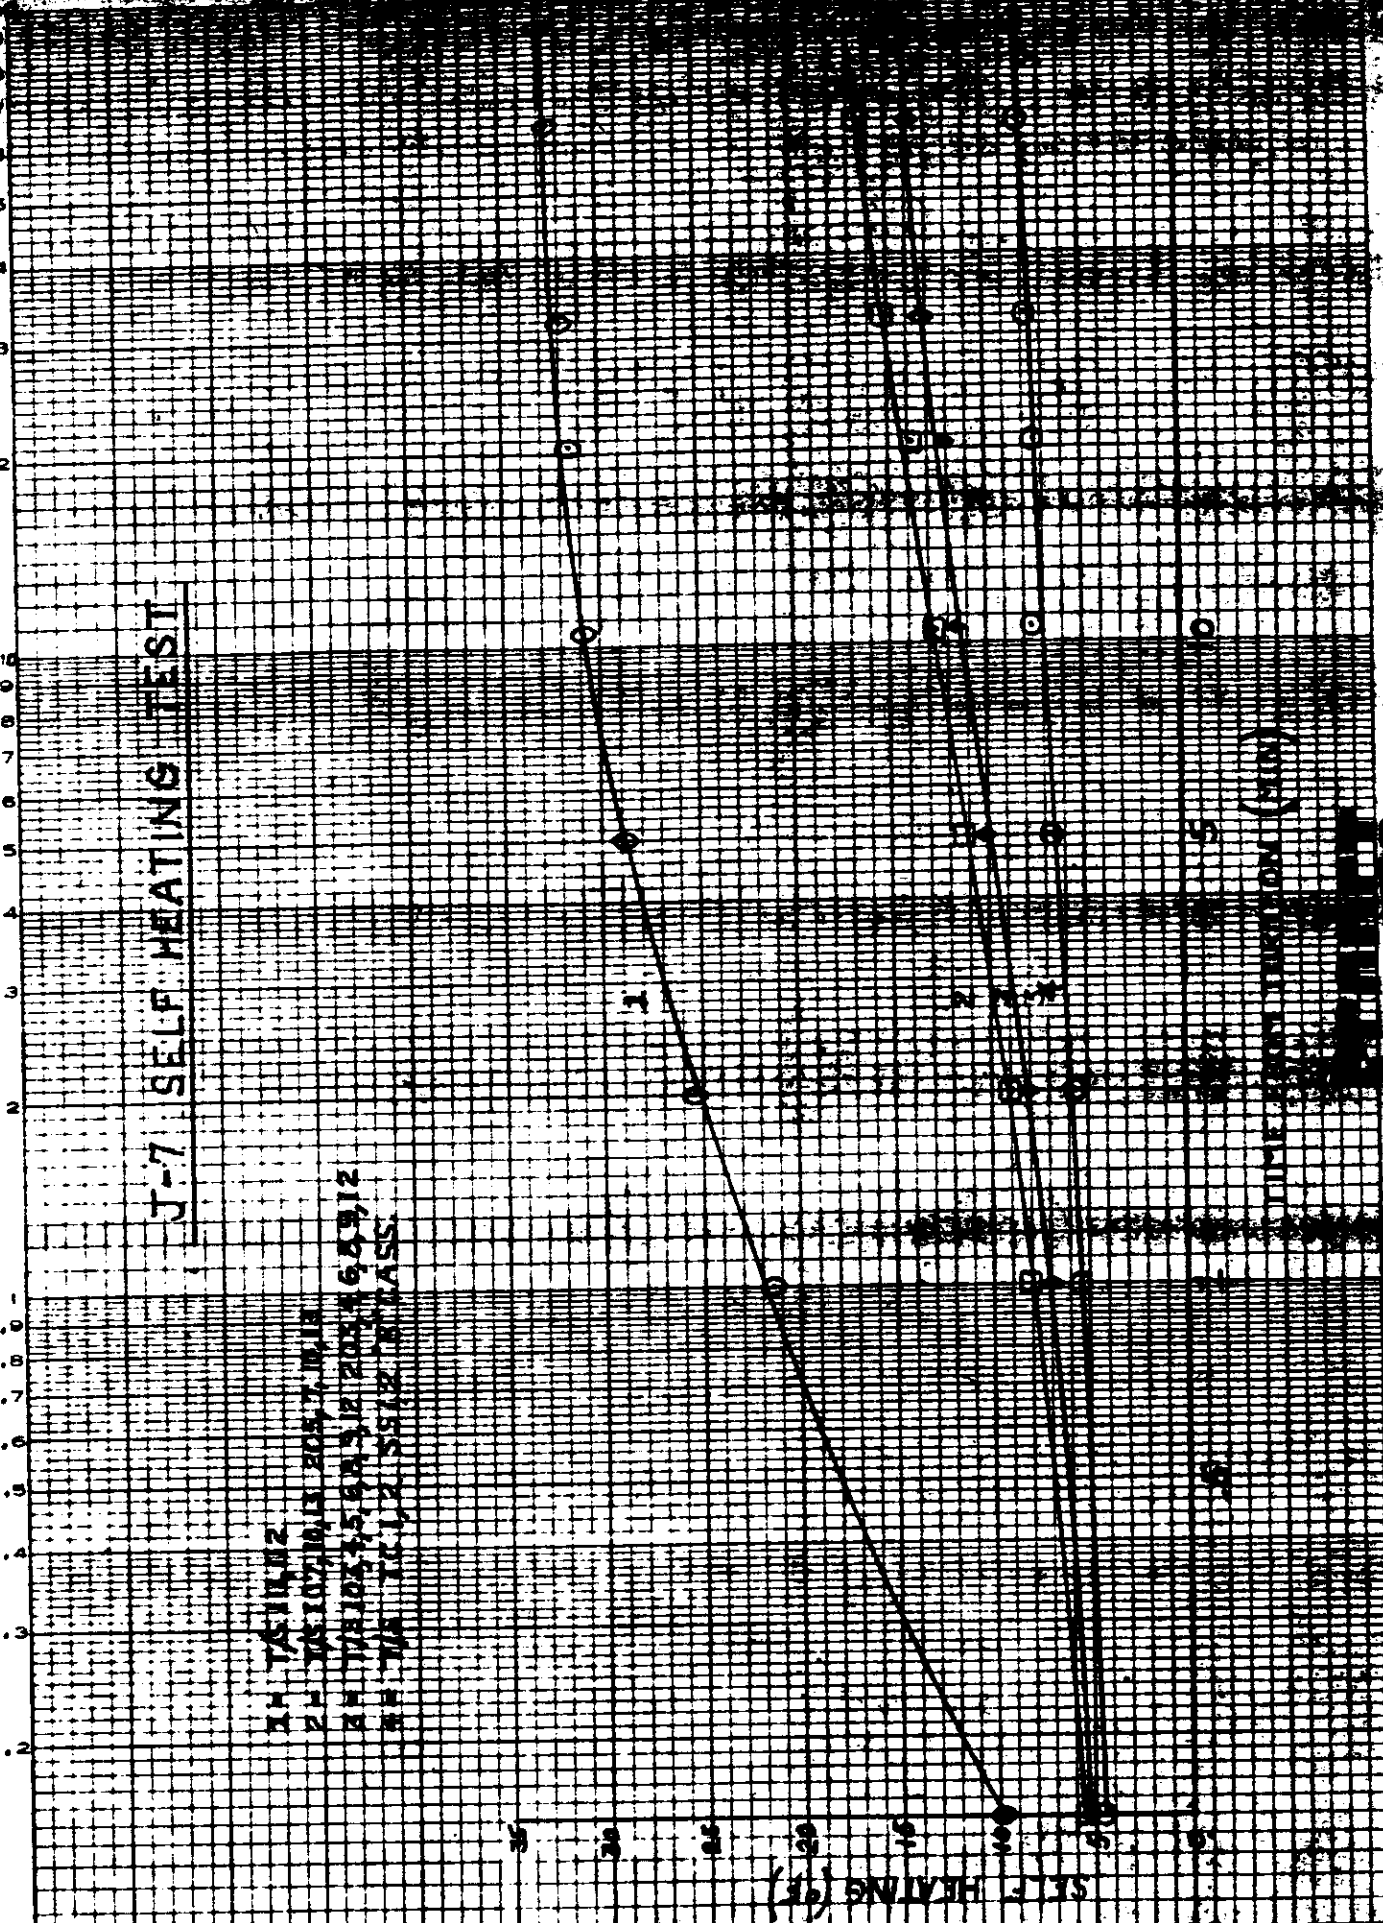
The thermal instrumentation system used in the system is subject to self-heating errors in the transducers, due to electrical power dissipation. The magnitude and characteristics of the self-heating errors have been demonstrated to be a function of time from excitation voltage on, the nature of the bond for each individual temp sensor, and the thermal mass of the component to which the sensor is bonded. A calibration of the self-heating characteristics of the installed temp sensors was conducted during the J-07 TASC Test No. 4. Figure 3-1 presents the results of this test. During the test, the time from excitation voltage on cannot be determined with certainty; therefore, accurate self-heating corrections cannot be applied to the TASC temperature data. Changes are in process to eliminate this problem. Following are representative thermal data (no self heating corrections applied):

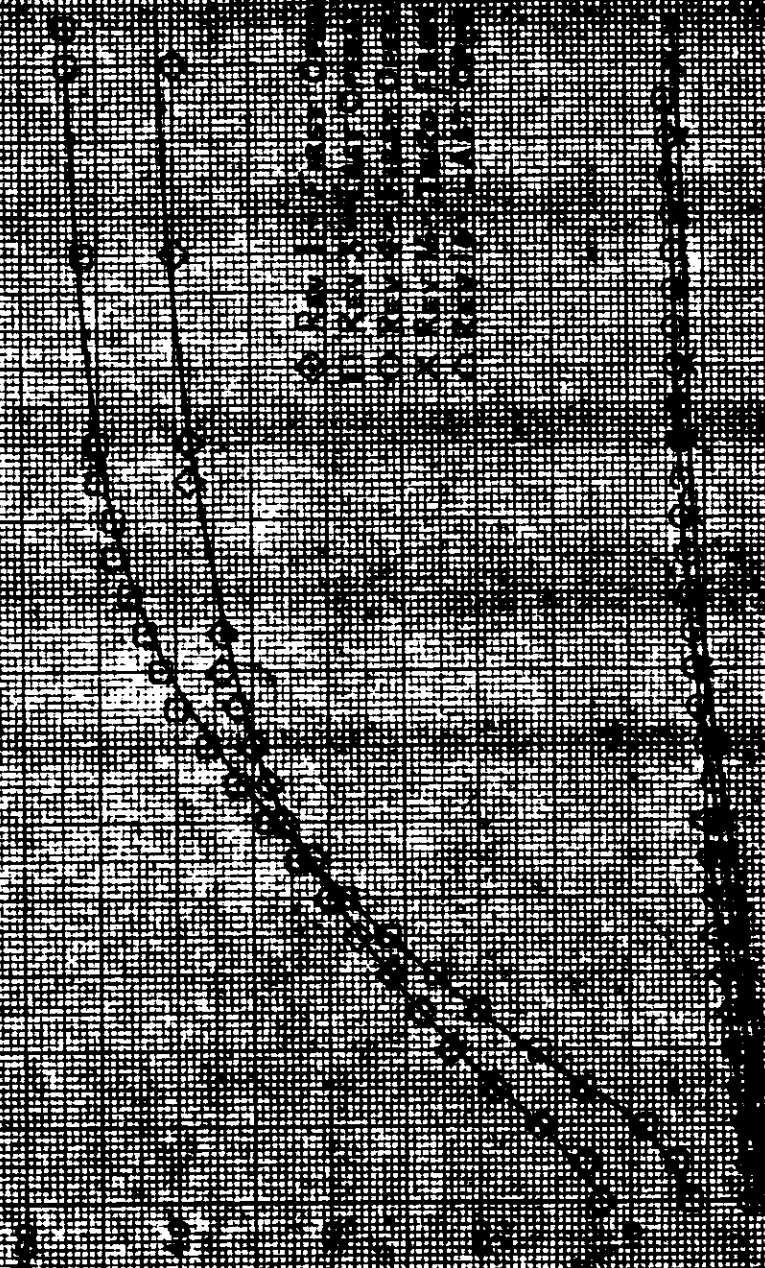
Figure 3-2  
9

Figure 3-2 presents representative pressure data obtained during the test. As indicated, the pressures attained were within the corona marking range.
