TECHNICAL PUBLICATION

PHOTOGRAPHIC EVALUATION REPORT

PHOTOGRAPHIC EVALUATION REPORT
MISSION 1010-1, 14-19 SEPTEMBER 1964
MISSION 1010-2, 19-23 SEPTEMBER 1964

NATIONAL PHOTOGRAPHIC INTERPRETATION CENTER

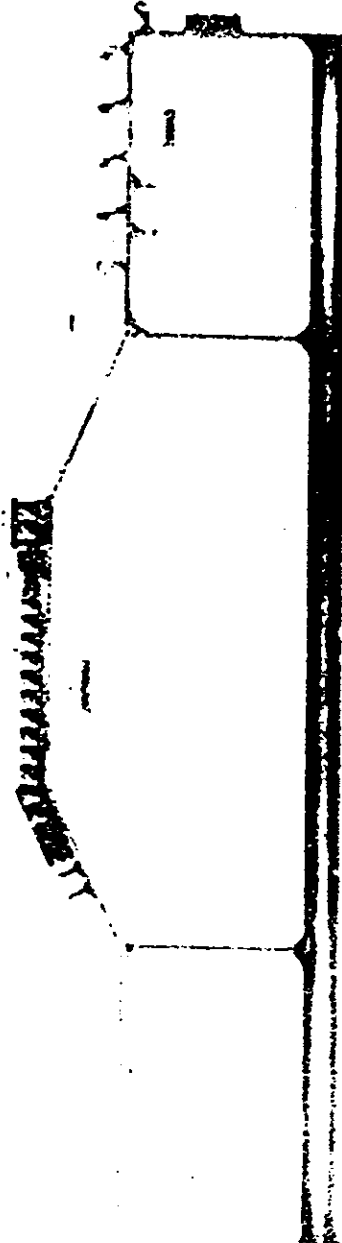
FIGURE 2. GOOD IMAGE QUALITY NEAR THE BEGINNING OF THE MISSION.

The quality of the panoramic photography not degraded by the out-of-focus condition is good throughout the mission.

Camera	153 (AR)
Pass	09D
Frame	116
Date of Photography	15 September 1964
Universal Grid Coordinates	x56.2 y12.7
Enlargement Factor	20X
Geographic Coordinates	47-02'N 32-32'E
Altitude (feet)	593495
Vehicle:	
Pitch	-14-35'
Roll	-00-28'
Yaw	00-19'
Local Sun Time	1441
Solar Elevation	32-05'
Solar Azimuth	291-30'
Exposure	1/338 sec.
Dist	L05
Dist	0.63
Delta	0.52
Gross Fog	0.17
