CORONA J
PERFORMANCE EVALUATION REPORT
MISSION 1008-1 and 1008-2
FTV 1177; J-10

1 April 1965

This document is the final payload test and performance evaluation report for Missions 1008-1 and 1008-2.

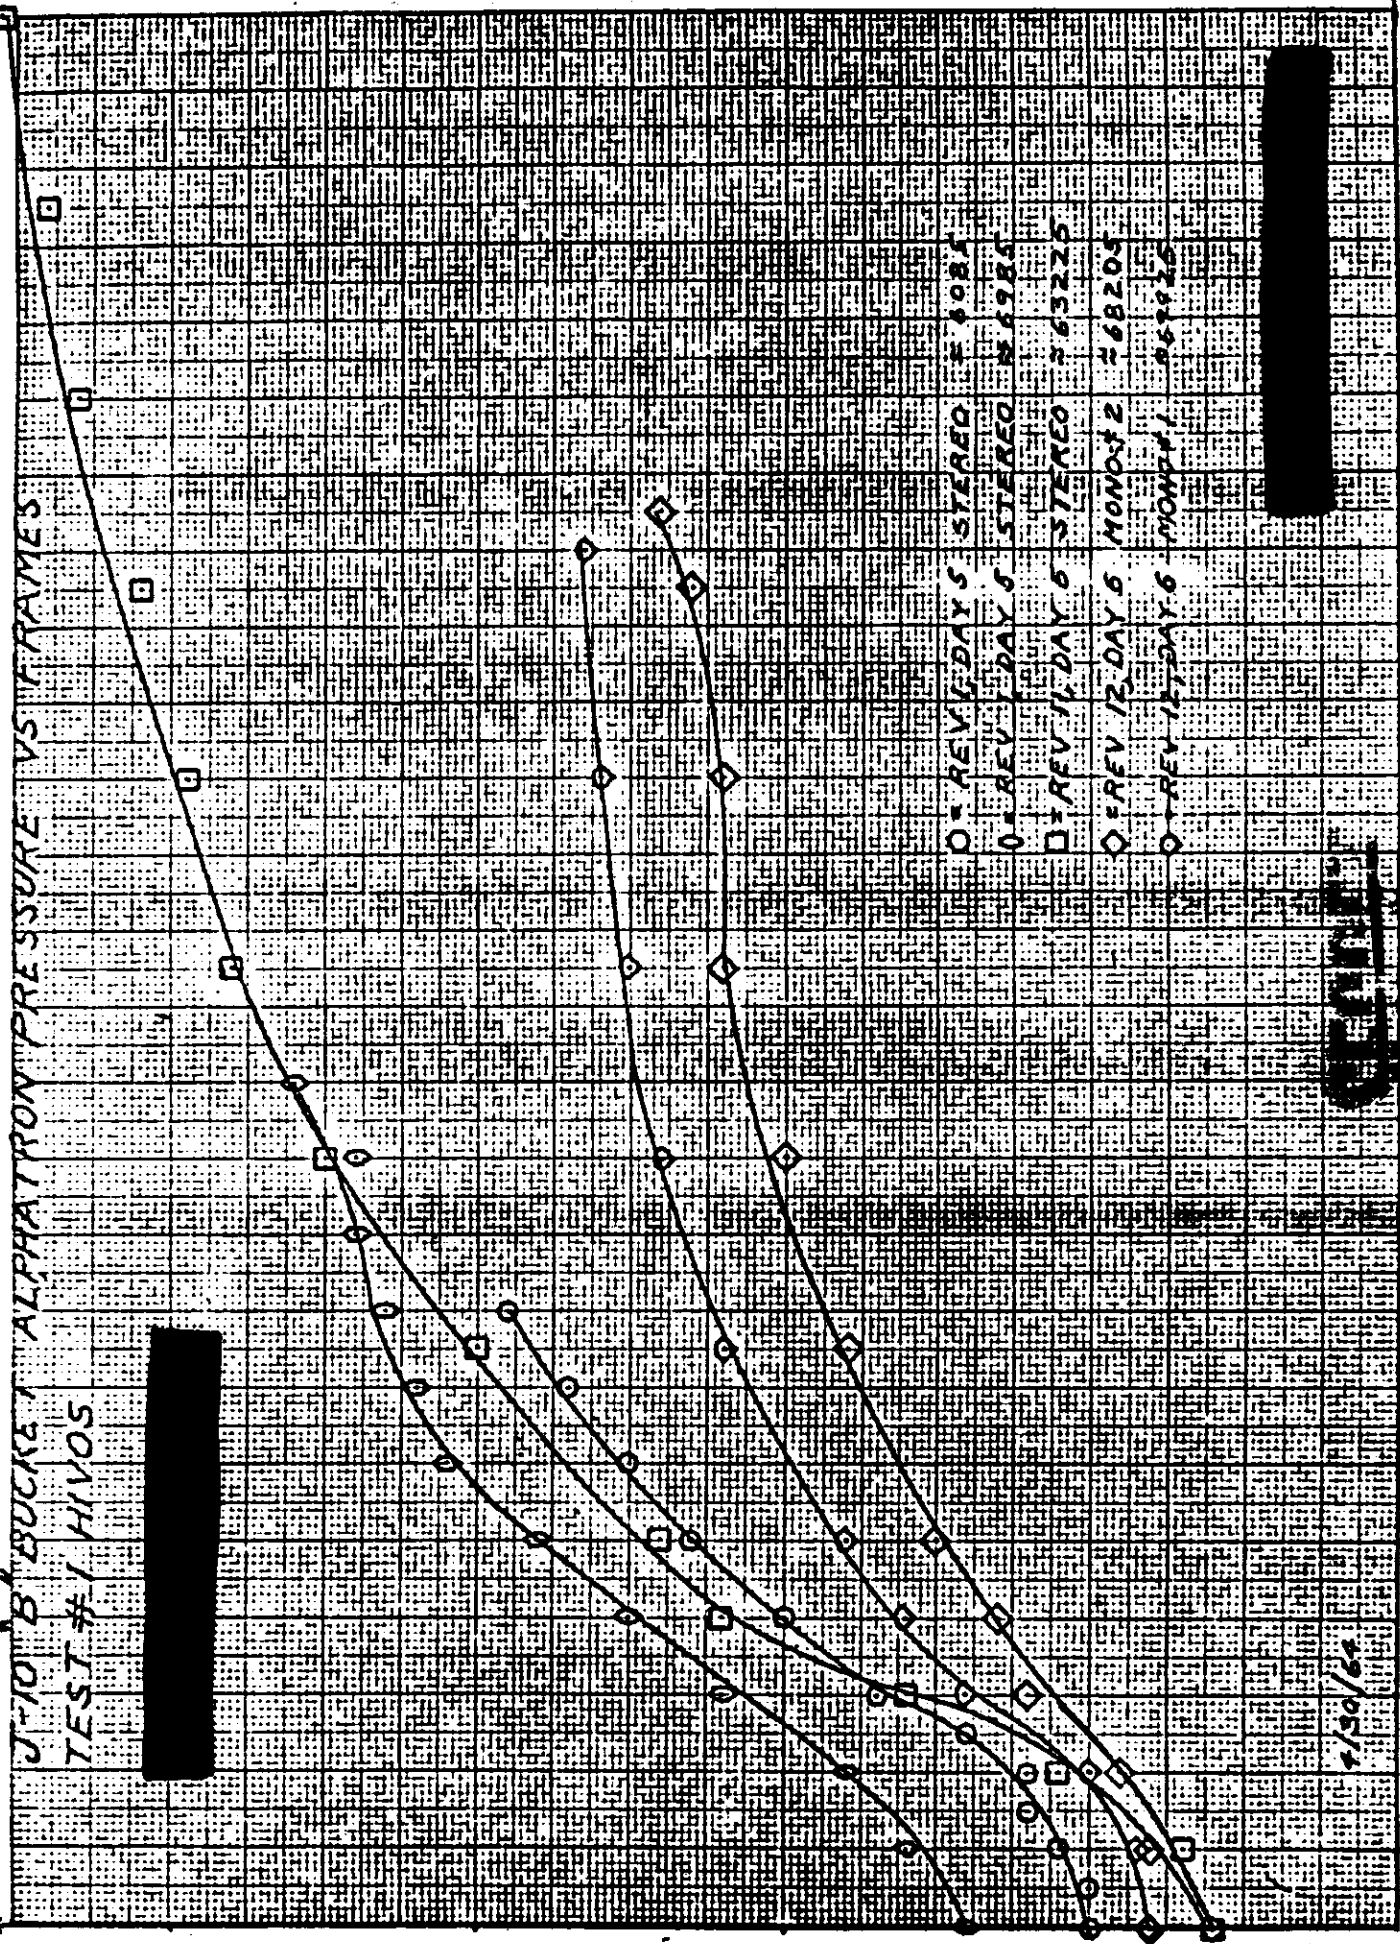
J-10 BUCKER 1 ALPHA IRRON PRESSURE VS. FAMES

The internal camera pressure experienced during the HIVOS test is plotted in Figure 2-2 as a function of frame number. Pressures in the corona discharge sensitive region were present during all operations.

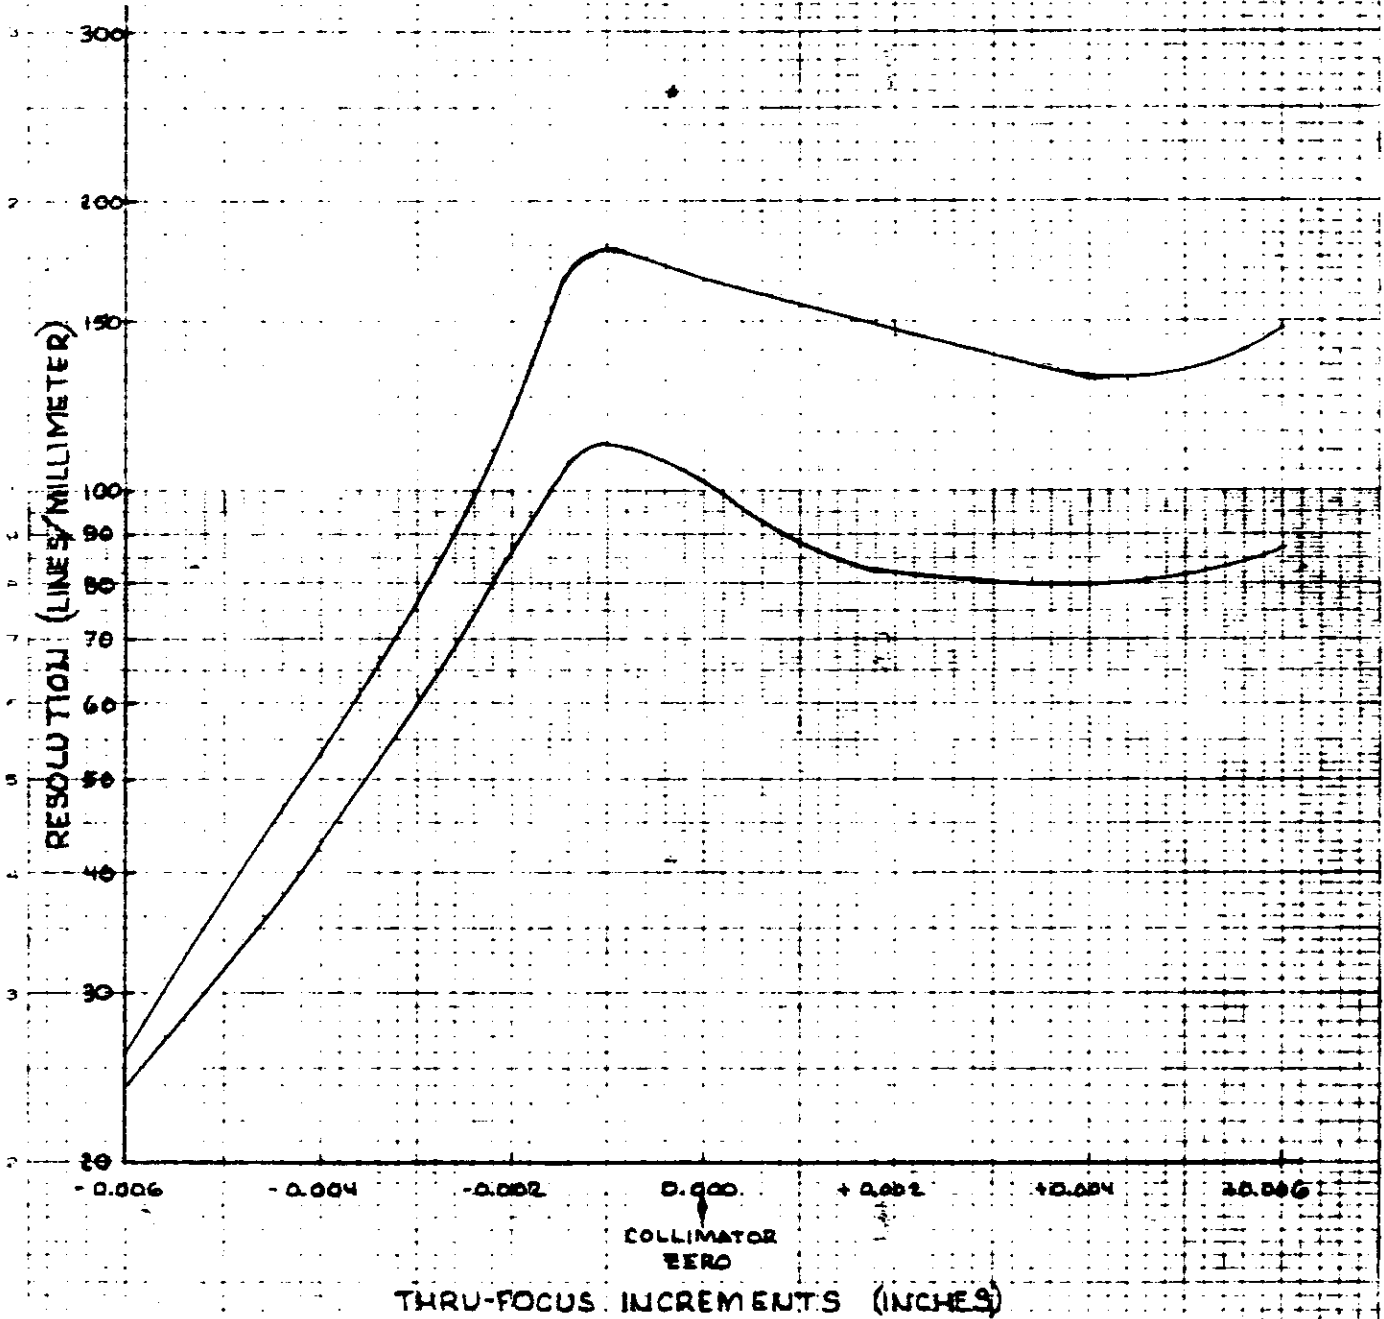
CAMERA NO. 150

The dynamic resolution test of the J-10 payload system was performed at the A/P facility on 7 May 1964. Each panoramic camera photographed high and low contrast resolution targets. The resulting through focus resolution data is shown in Figure 2-3 for the Master camera and in Figure 2-4 for the Slave camera.

HIGH CONTRAST RESOLUTION - 178 L/MM

LOW CONTRAST RESOLUTION - 112 L/MM

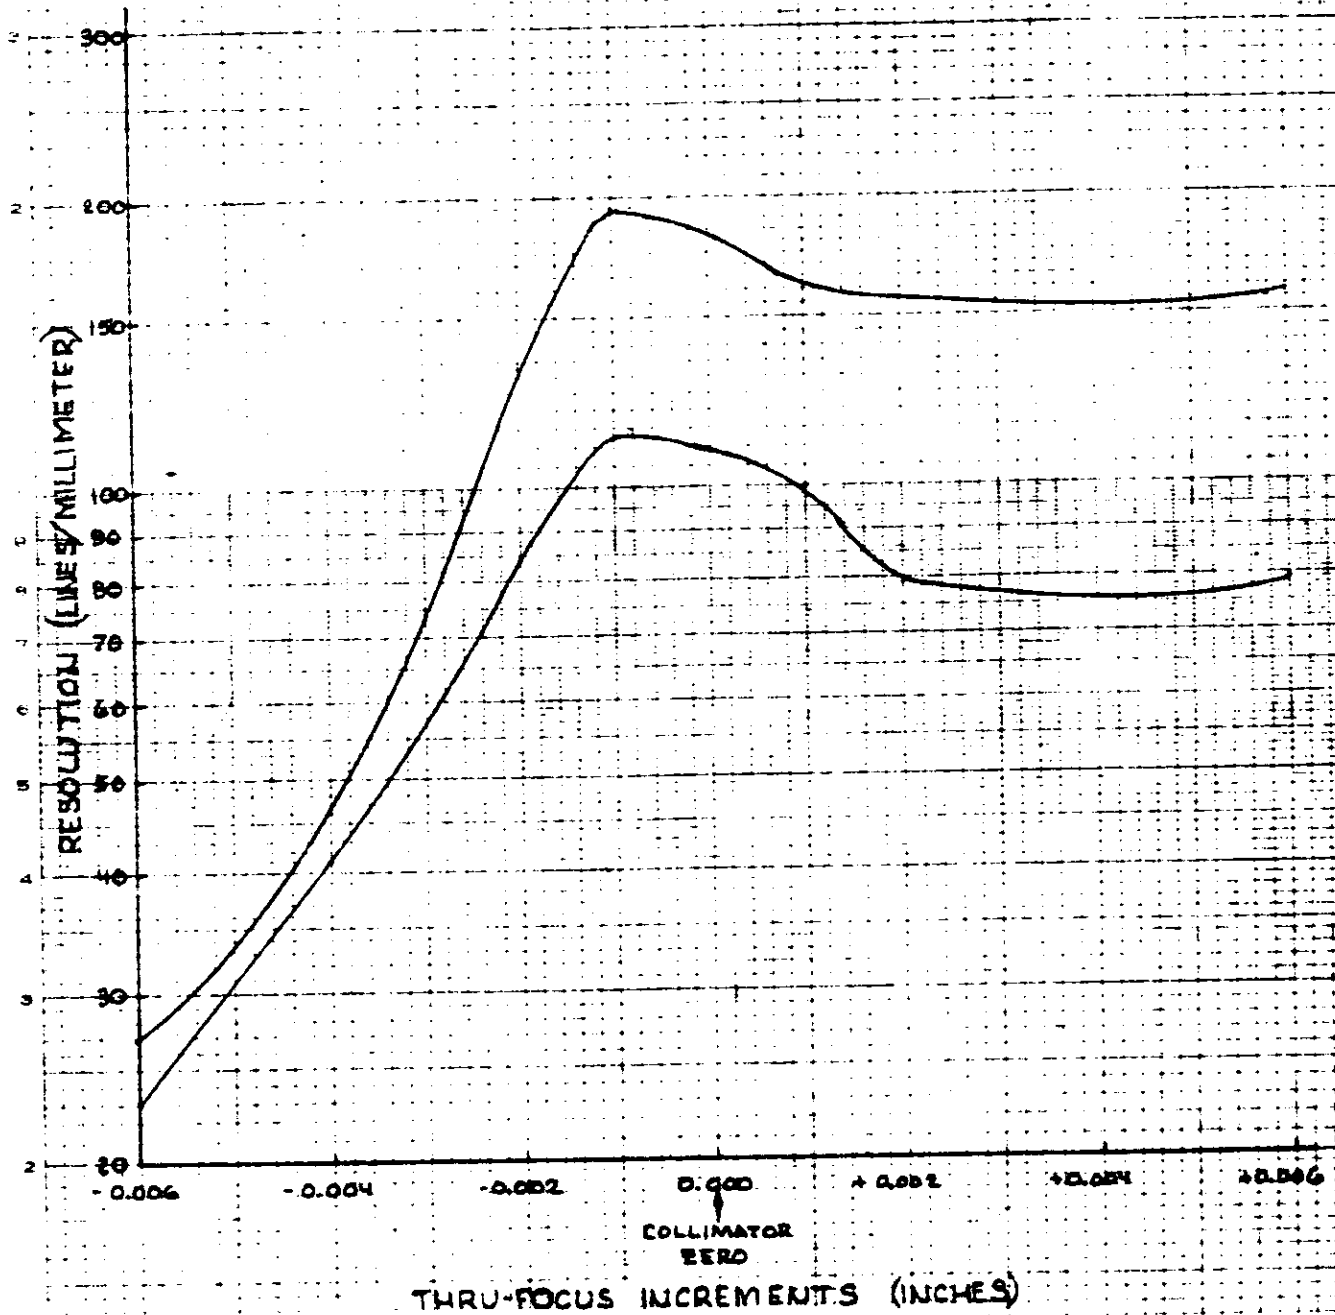
FIGURE 2-4

HIGH CONTRAST RESOLUTION - 194 L/MM

LOW CONTRAST RESOLUTION - 113 L/MM
