J-23

IN-FLIGHT FAILURE ANALYSIS SUMMARY

Manager
Payload Integration

9/9/65
ats

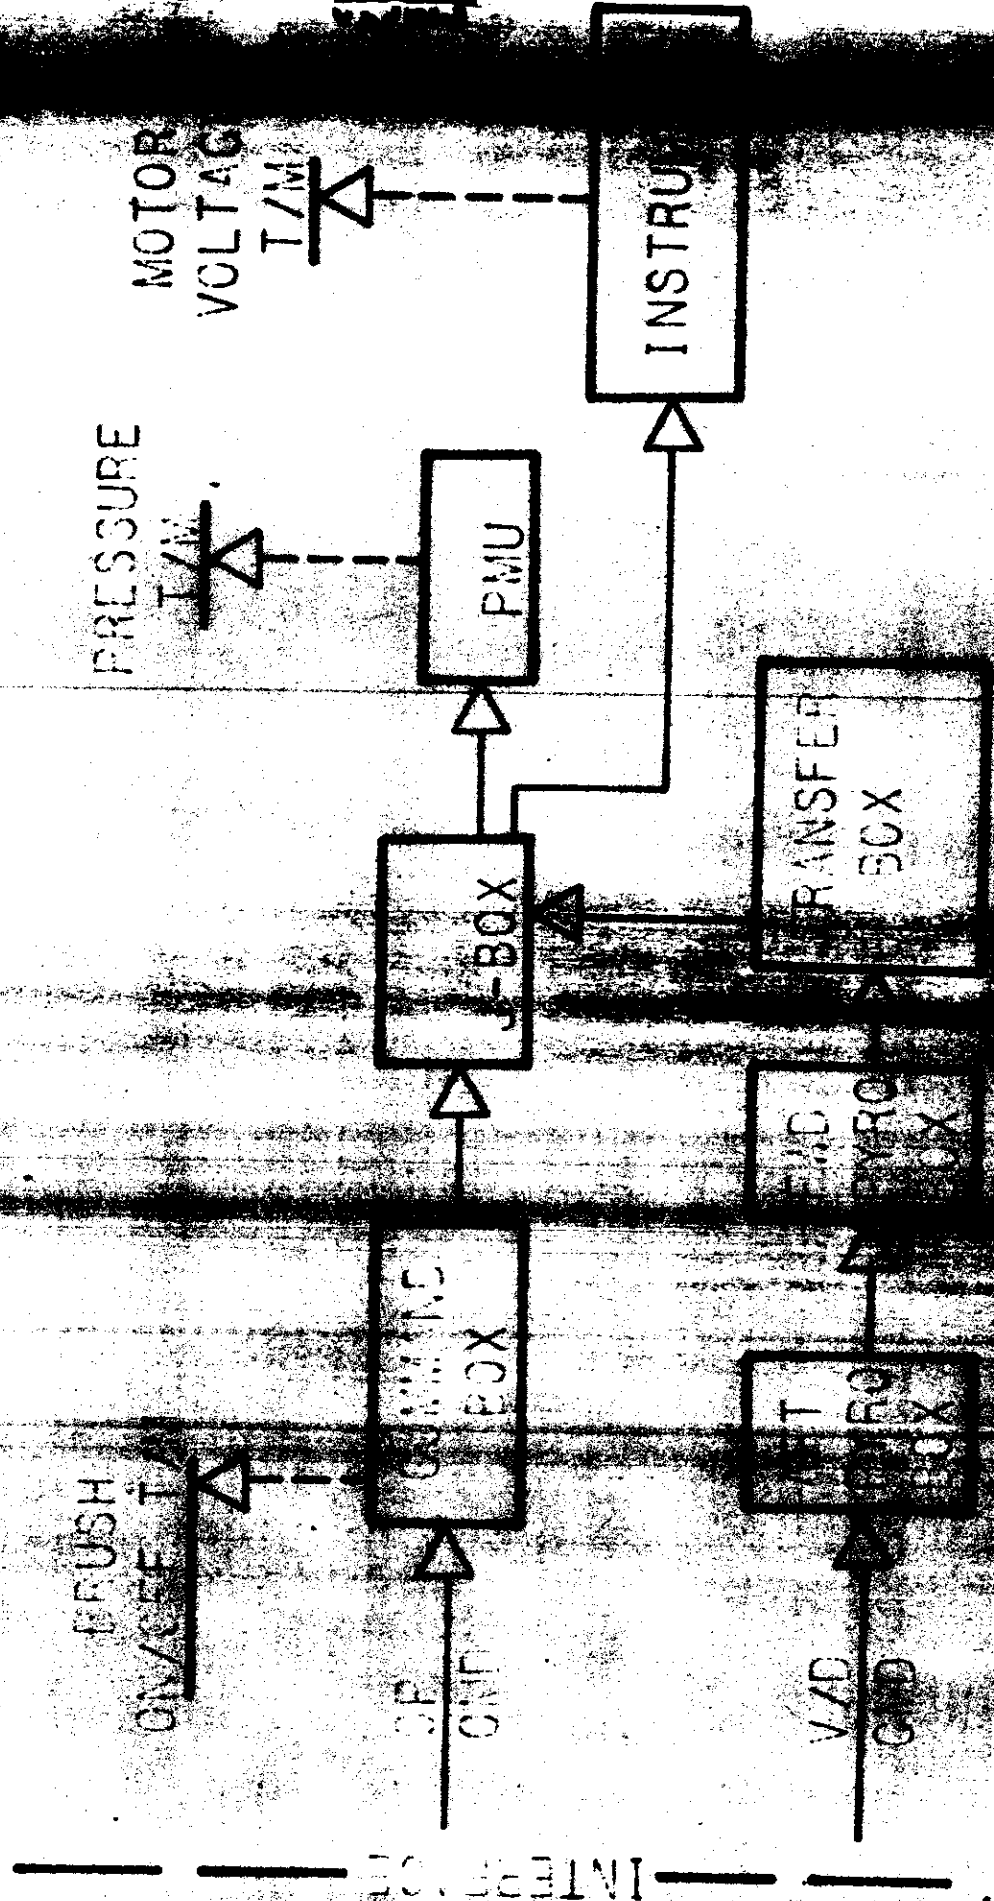
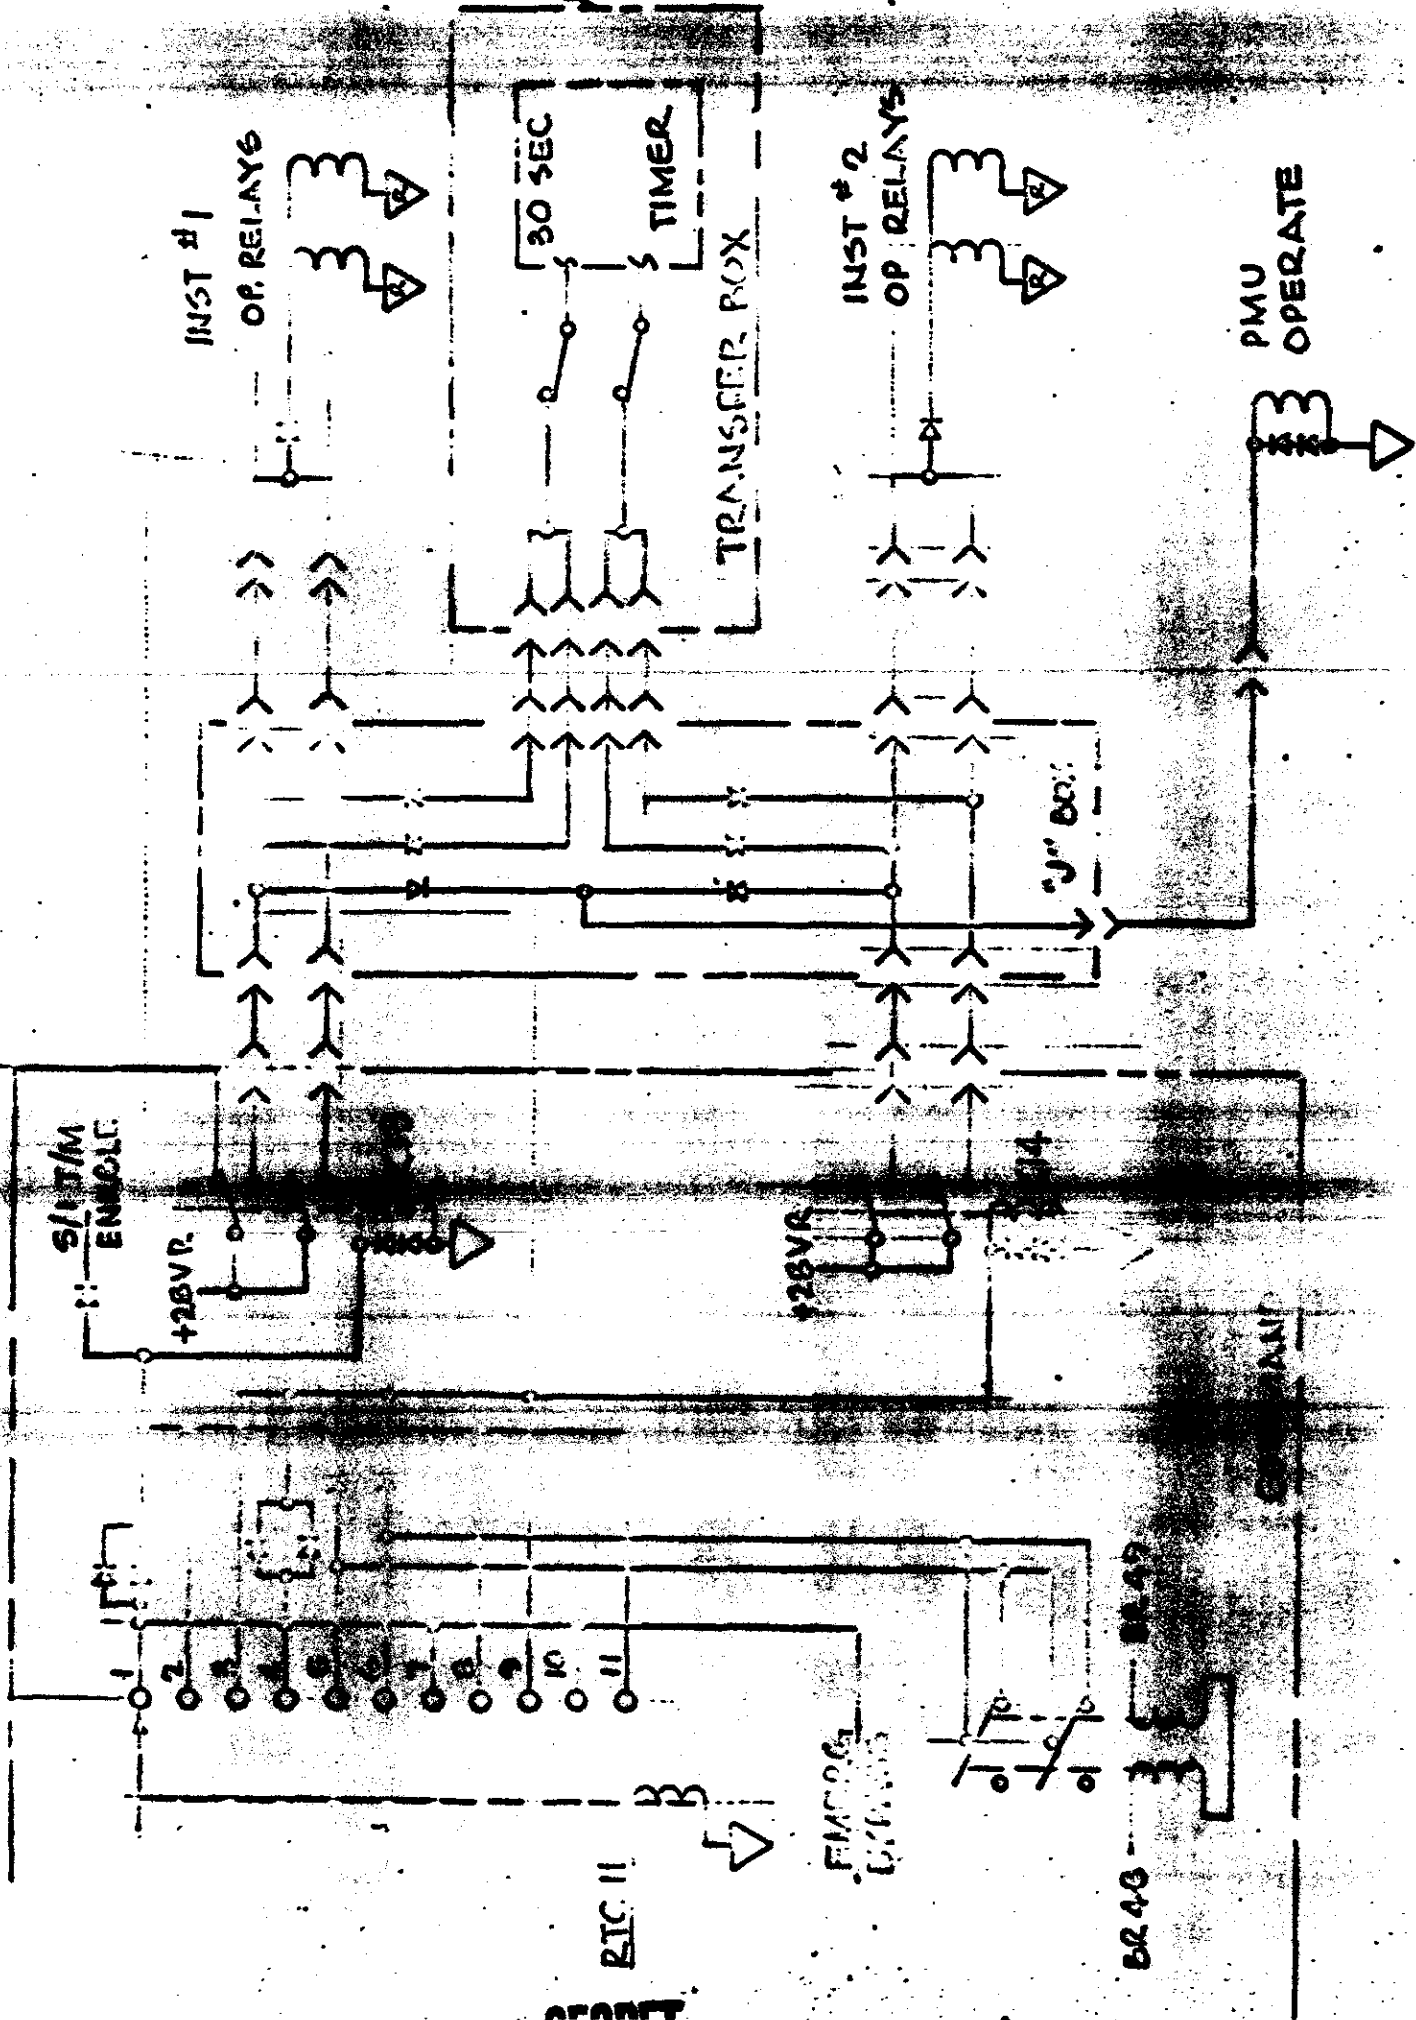
BLOCK DIAGRAM INSTRUMENT OPERATE CUM AND

In reviewing the events, it is concluded that the most probable cause of failure is located in the command box on the circuit associated with the master instrument operate relay, K-13, which feeds the voltage to the FMU and the master instrument (ref. block diagram and schematic attached.)

When both components did not receive the necessary voltage, the suspicion is logically cast on K-13 circuitry. This further substantiated when the by-pass circuit, vehicle deactivate, successfully operated the system.
