CORONA J

PERFORMANCE EVALUATION REPORT

MISSION 1012-1 and 1012-2

FTV 1179; J-13

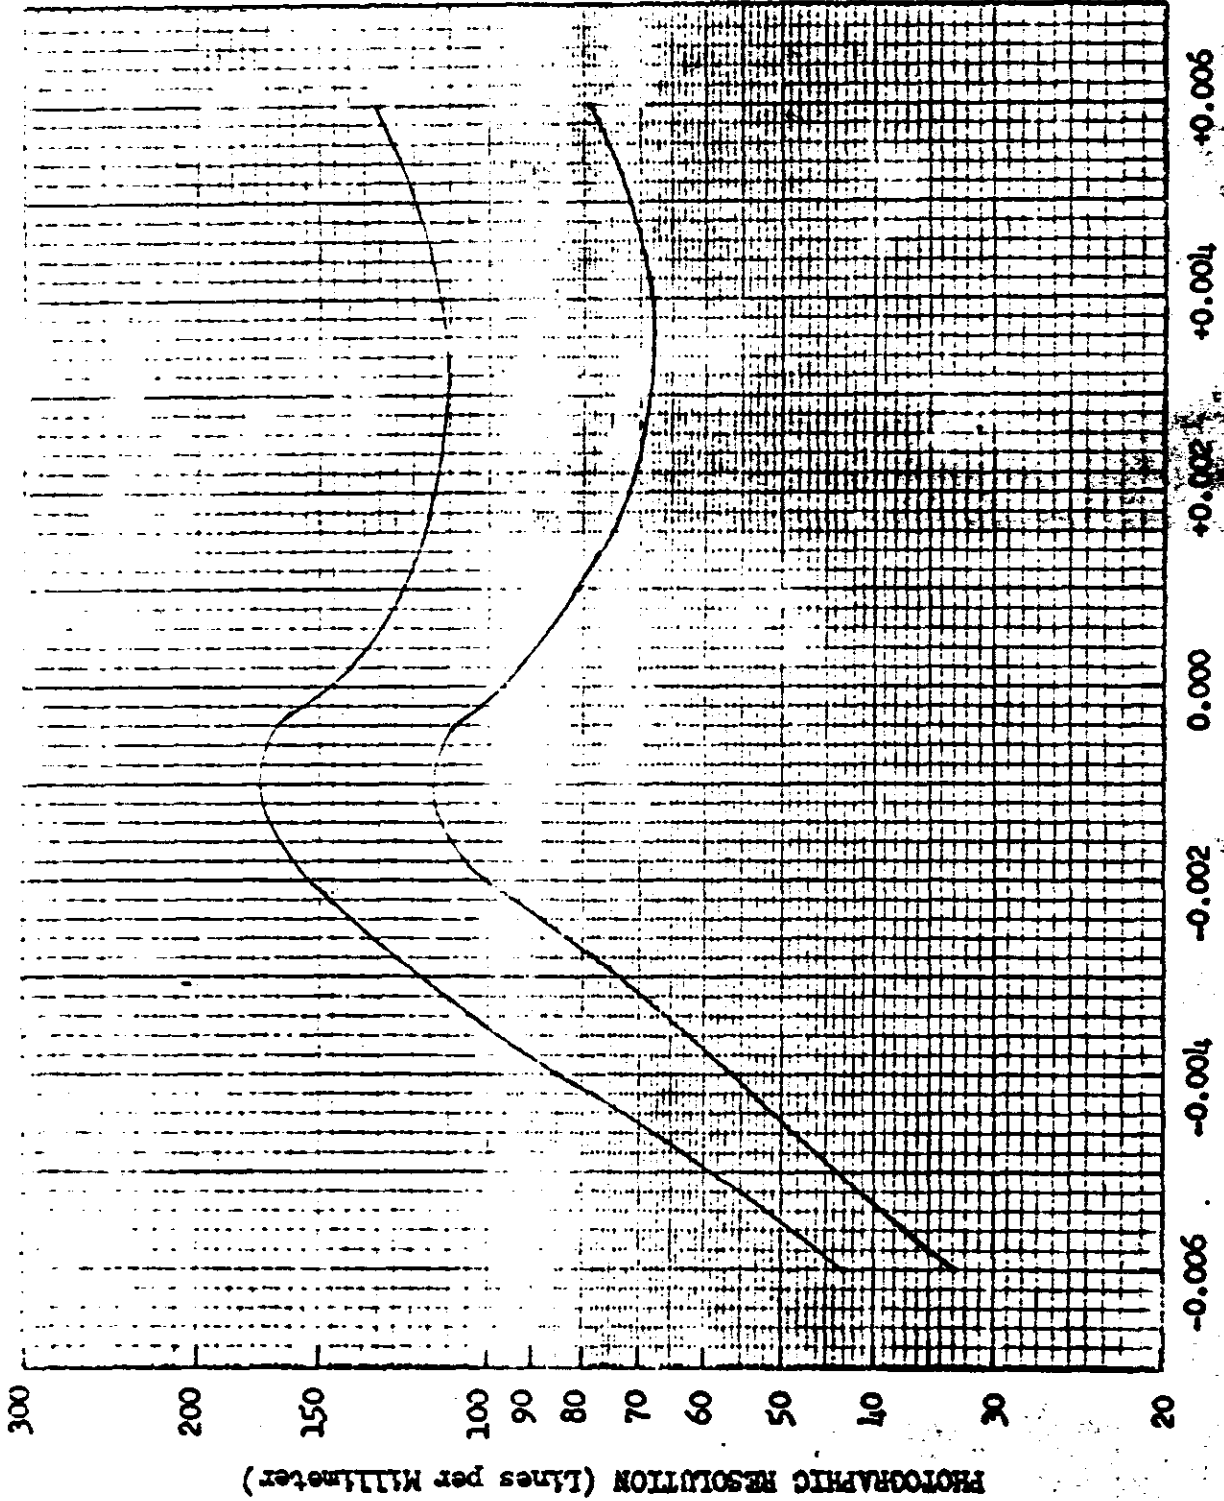
FIGURE 2-1

The dynamic resolution test of the J-13 payload system was performed at the A/P facility on 23 July 1964. Each panoramic camera photographed high and low contrast resolution targets. The resulting through focus resolution data is shown in Figure 2-1 for the Master camera and in Figure 2-2 for the Slave camera.
