CORONA J

PERFORMANCE EVALUATION REPORT

MISSION 1023-1 and 1023-2

FTV 1618; J-23

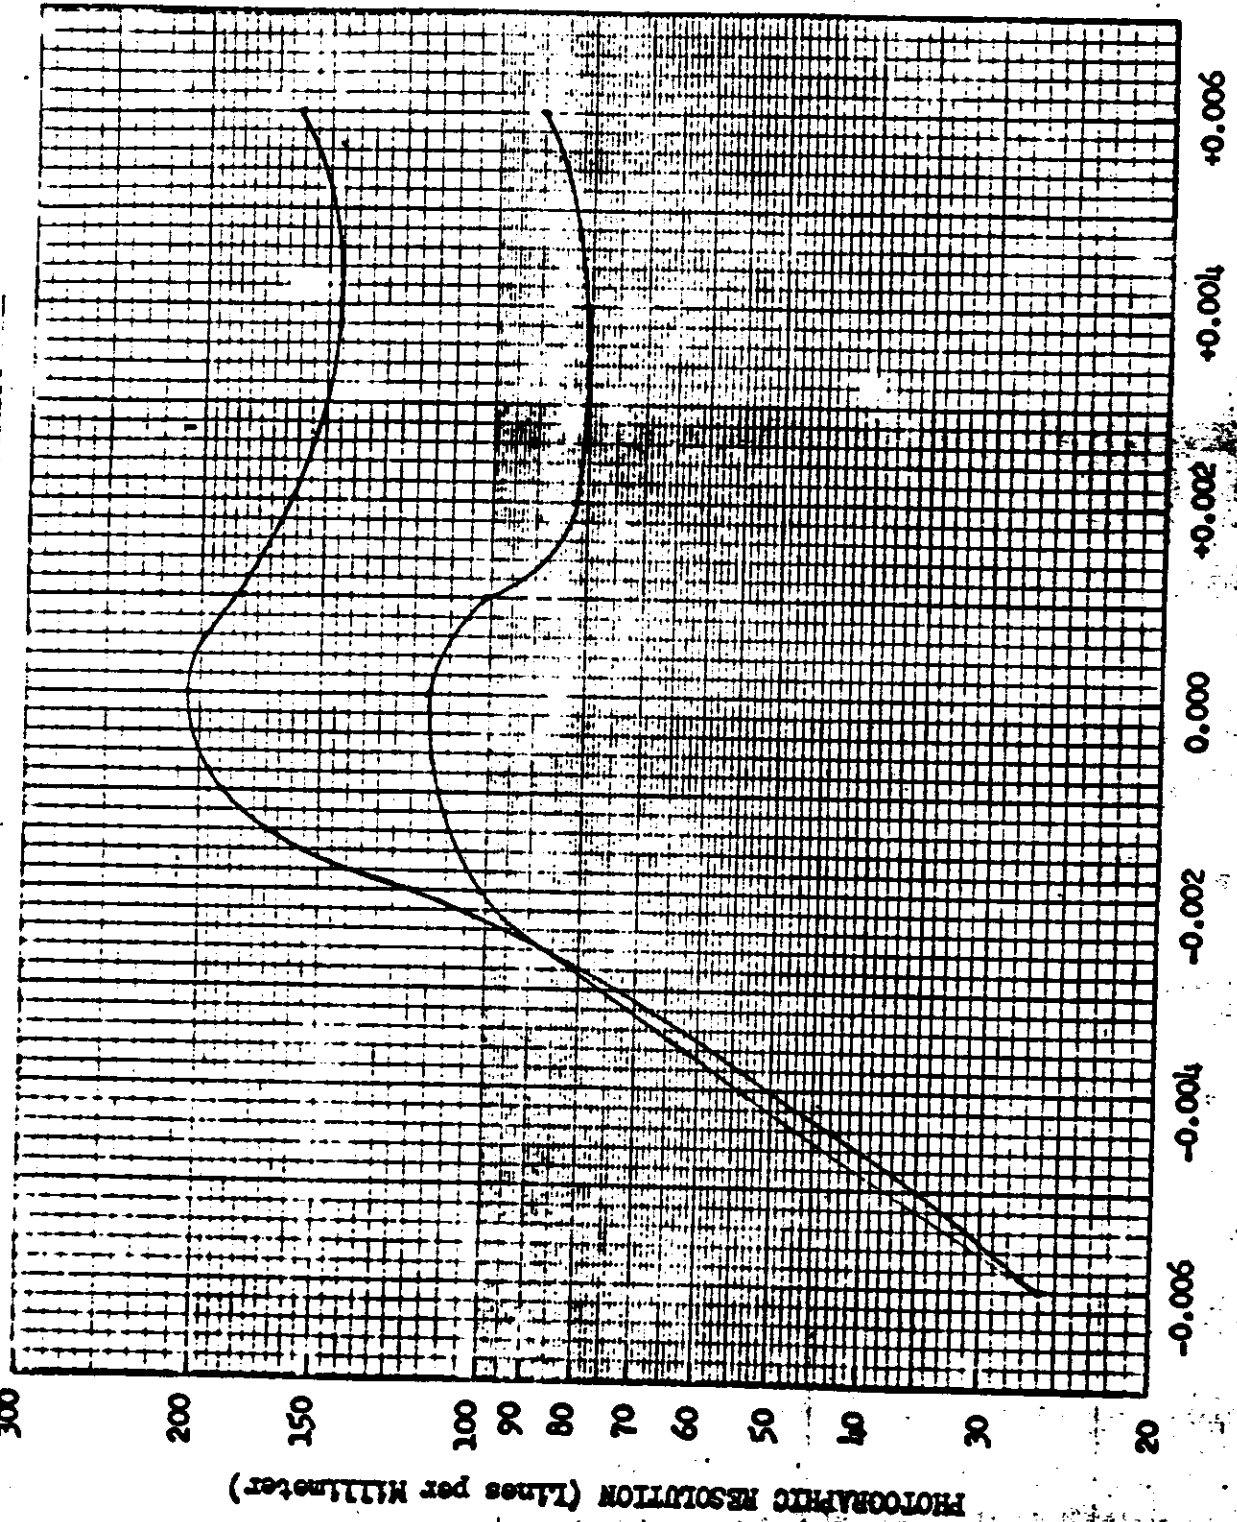
THROUGH FOCUS INCREMENTS (Inches)
FIGURE 2-1

Maximum high contrast resolution 206 lines/mm at .000 focal position.

Maximum low contrast resolution 116 lines/mm at .000 focal position

The resolution test data for both instruments as shown in Figures 2-1 and 2-2, has been reviewed and appears normal in all respects. The demonstrated resolution performance meets the system requirements specification.

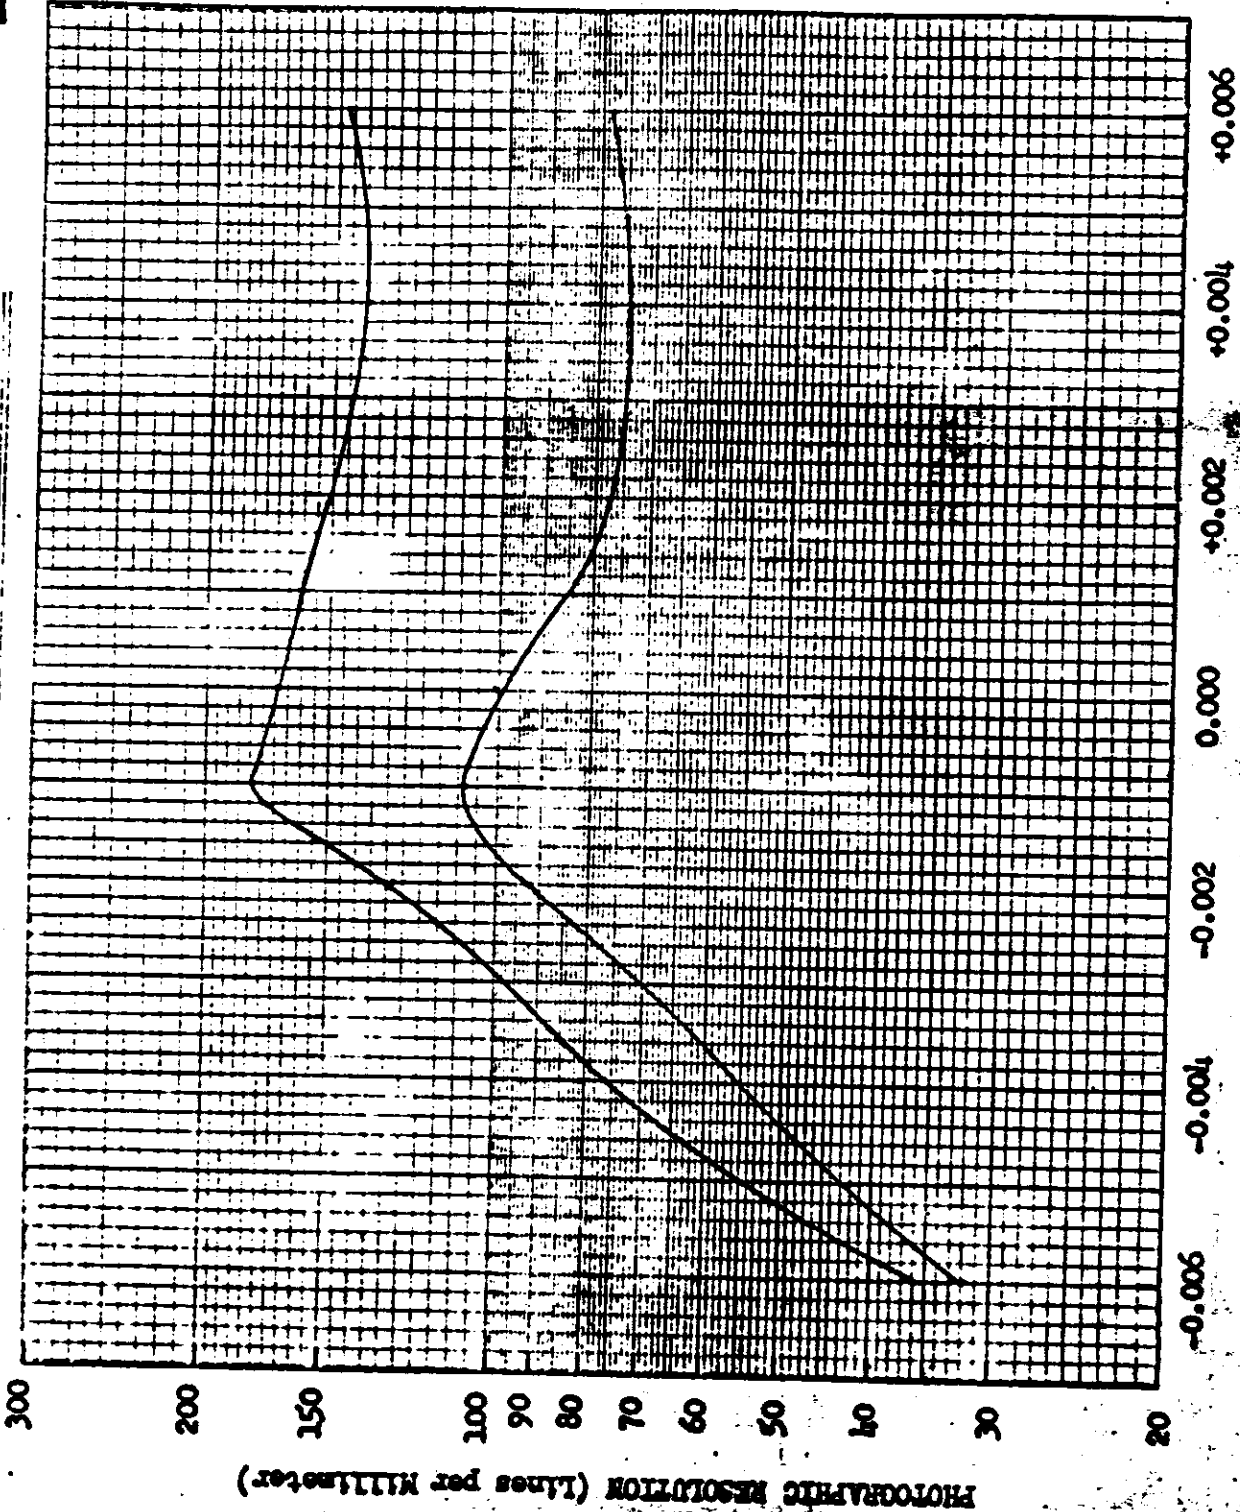
FIGURE 2-2

Maximum high contrast resolution 179 lines/mm at .001 focal position

Maximum low contrast resolution 108 lines/mm at .001 focal position.

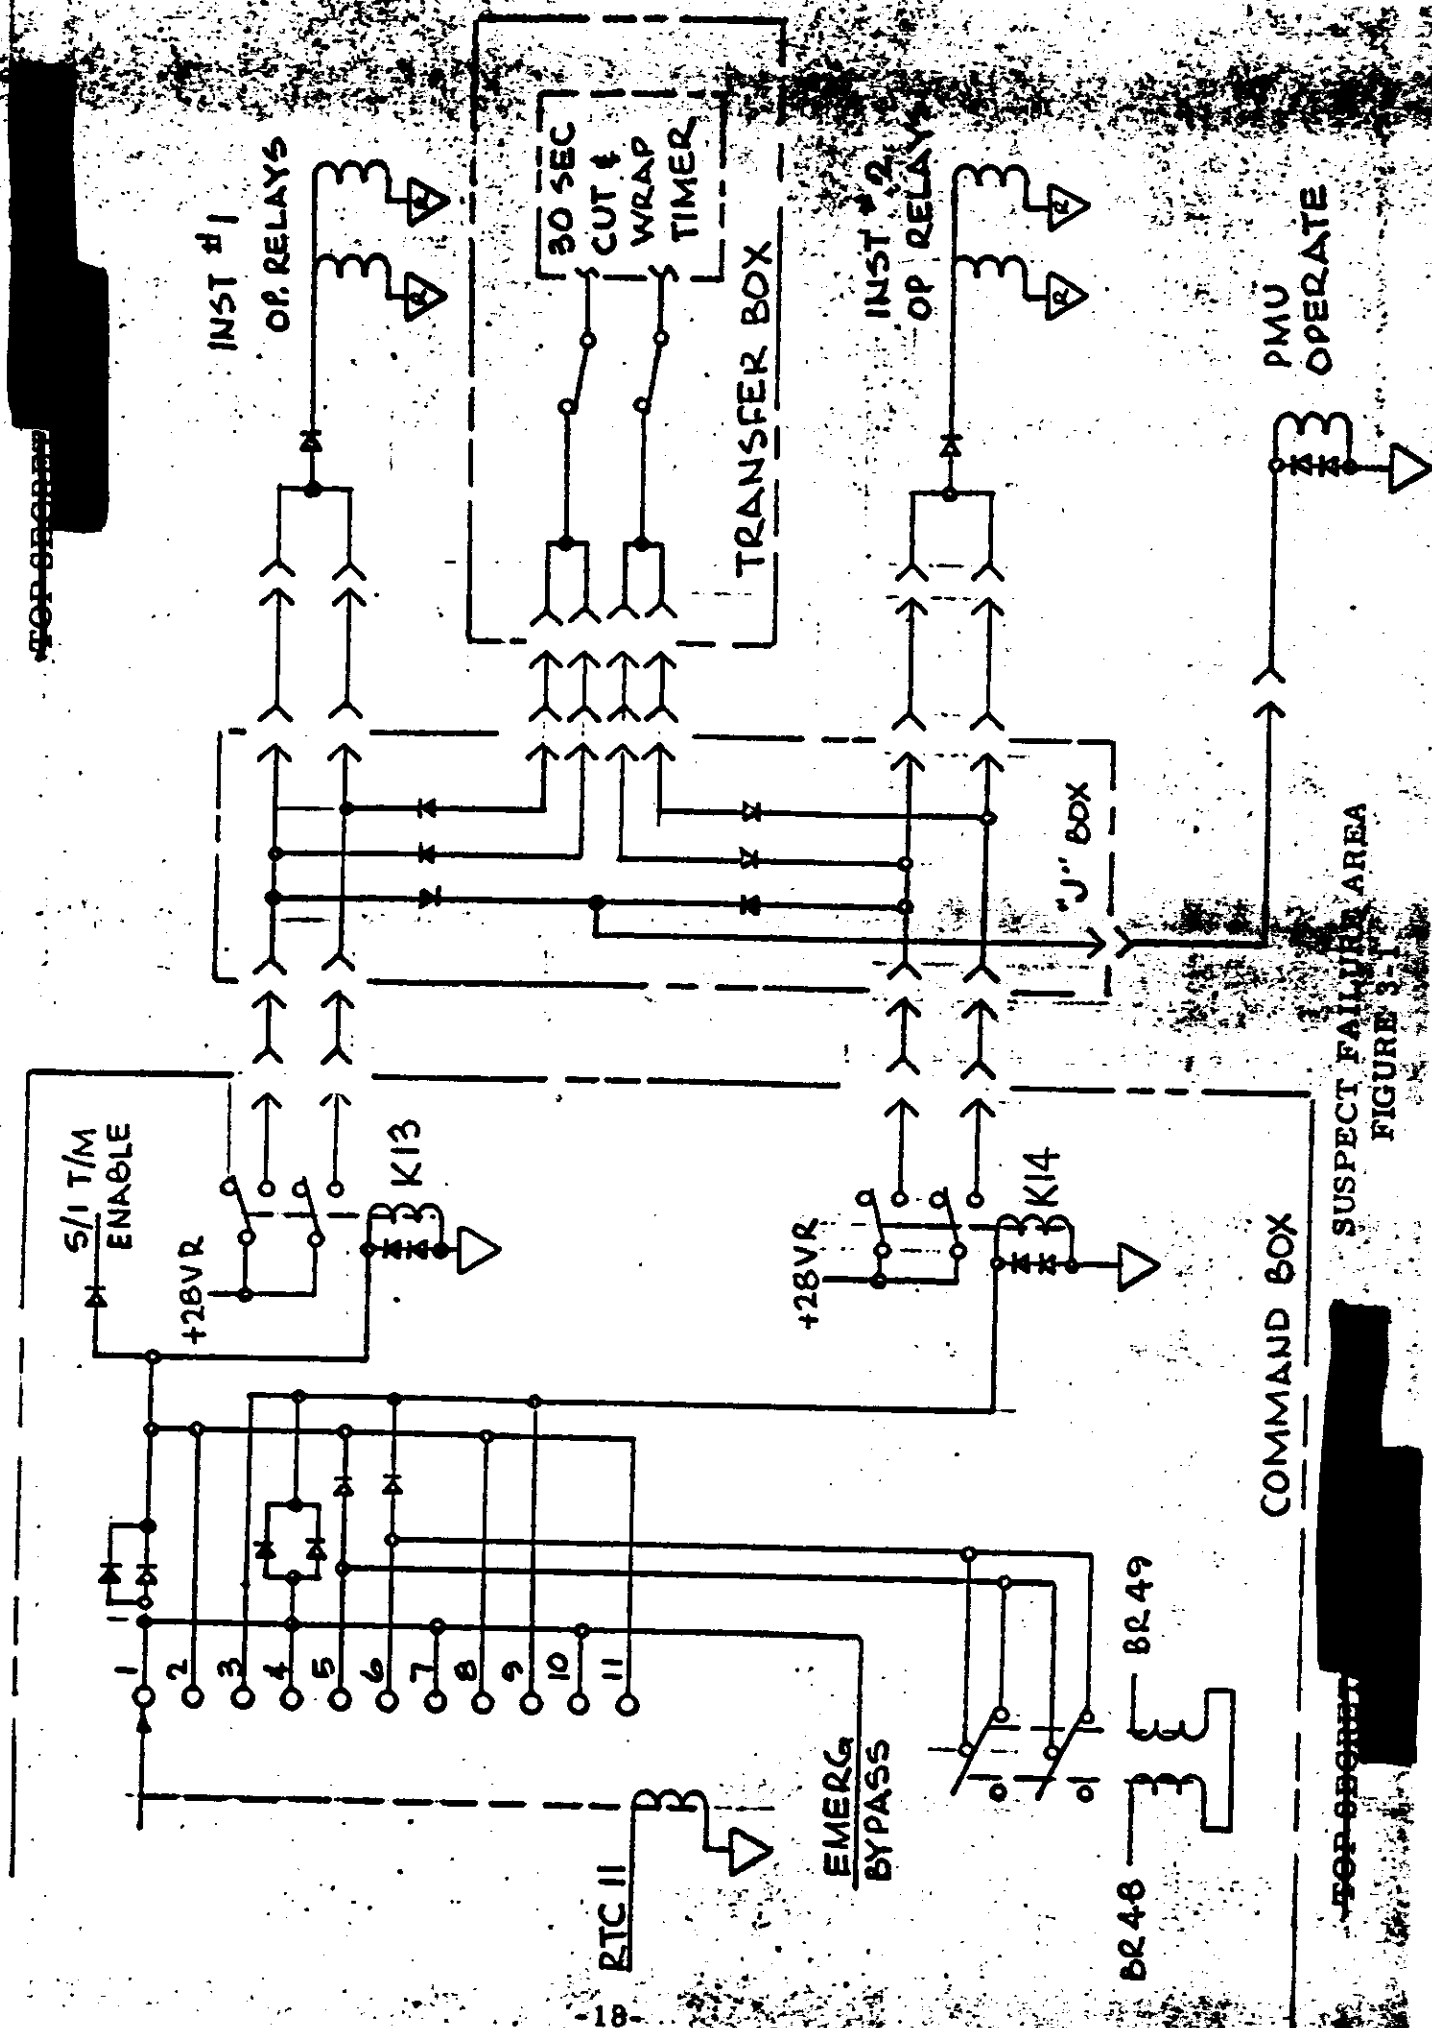
SUSPECT FAILURE AREA
FIGURE 3-1

On pass 102, the system was in a programmed intermix OFF emergency operate mode with a 147 cycle programmed operation. Cycle counter data indicated completion of 34 of the programmed 147 cycles. An engineering pass was taken on pass 104 confirming failure of the Master camera. Neither the transport or scan functions operated. Telemetry data indicated no operate signal was received by the camera operate relays. A series of command combinations were tried, without success, in an attempt to isolate and program around the faulty component or components. A schematic of the primary suspect area is contained in Figure 3-1. Table 3-1 is a tabulation of the command settings from rev 101 through the end of the mission.

In all of the combinations of stereo and mono No. 1 operations tried on engineering passes, a signal was verified to the S/I, T/M enable (ref. Figure 3-1). At these same times no operate signal was observed at the instrument No. 1 operate relays or the PMU operate relays.
