PHOTOGRAPHIC EVALUATION REPORT  
MISSION 1021-1  
18-23 MAY 1965  
MISSION 1021-2  
23-28 MAY 1965

JANUARY 1966

NATIONAL PHOTOGRAPHIC INTERPRETATION CENTER

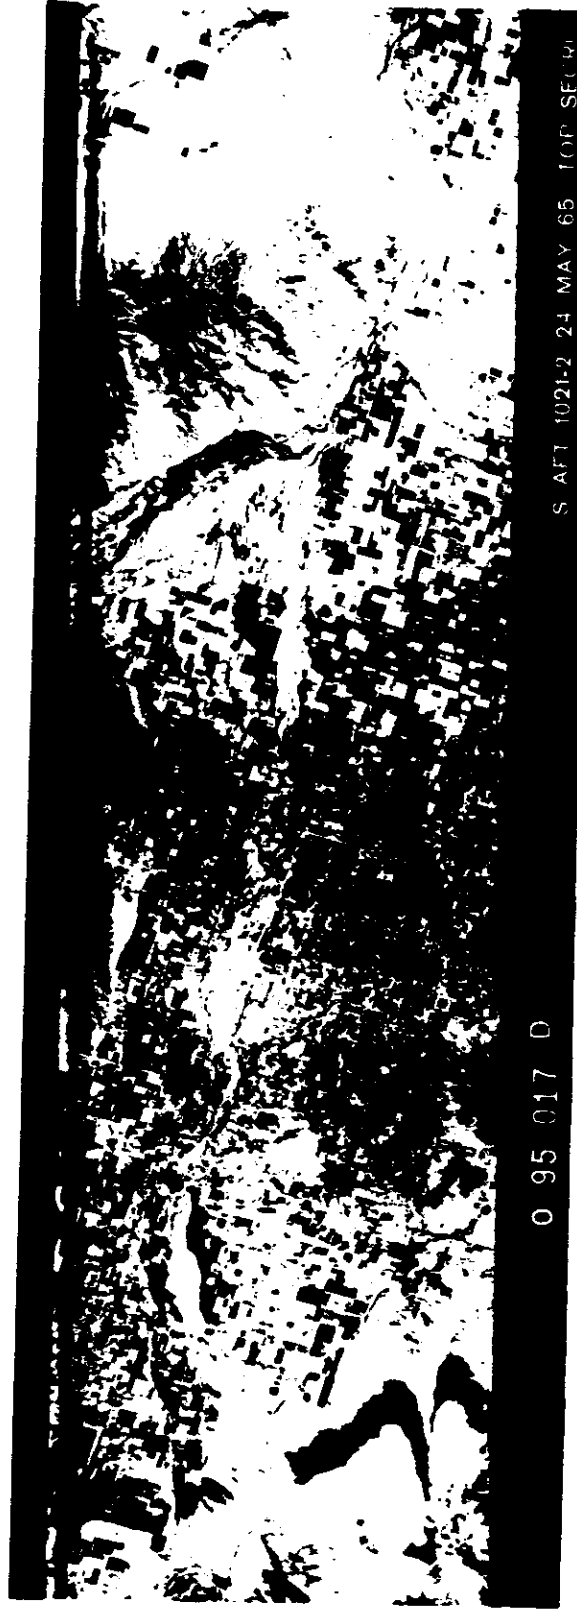
FIGURES 11 AND 12. EXAMPLE OF DEGRADED PHOTOGRAPHY DUE TO THE CUT  
AND SPLICE

These photographs illustrate the abrasions parallel to the film  
edge and the out of focus condition.
