PHOTOGRAPHIC
EVALUATION REPORT
MISSION 1026-1
28 OCTOBER -
2 NOVEMBER 1965
MISSION 1026-2
3-7 NOVEMBER 1965

NATIONAL PHOTOGRAPHIC INTERPRETATION CENTER

SYNOPSIS

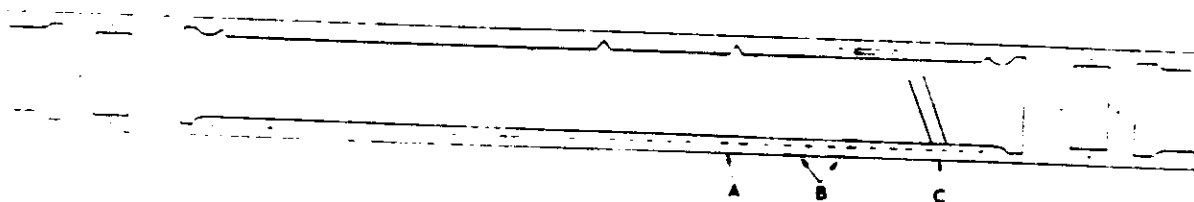
Approximate Location of Fog Patterns

a. The configuration of the fog patterns on the material is illustrated below. Elimination of the light leaks which cause these patterns is in progress. The fogged areas were present throughout the mission, and their density level is commensurate with the duration of the sit time between camera operations.

- 1. 1st frame from start of pass.
- 2. 1st frame from end of pass.
- 3. 1st frame from end of pass.

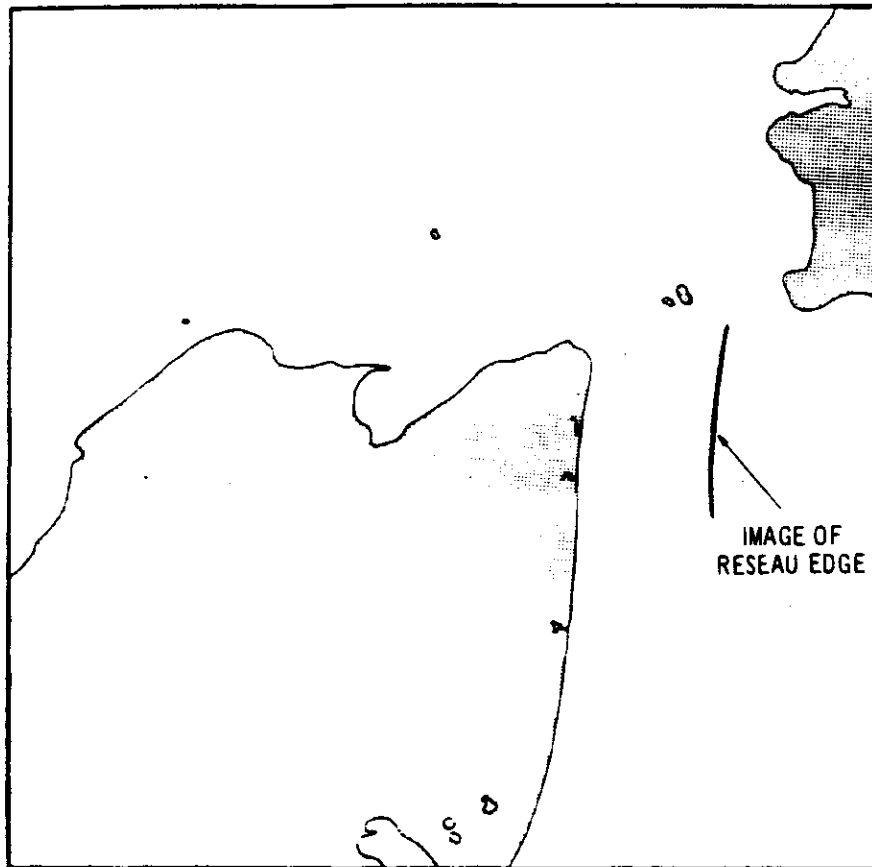
FIGURE 9. QUALITY OF INDEX PHOTOGRAPHY ON MISSION 1026-1

The index camera operated well throughout the mission, and the photographic quality is good. Some frames contain an image of a portion of the edge of the reseau. These images are caused by internal light scatter within the glass being refracted by the edge of the reseau to form an outline of its edge.

The quality of the index photography of Mission 1026-1 is shown here. The location of the image of the reseau edge is indicated in the drawing on page 10 1.
