PHOTOGRAPHIC
EVALUATION REPORT
MISSION 1024-1
22-27 SEPTEMBER 1965
MISSION 1024-2
27 SEPTEMBER -
2 OCTOBER 1965

NATIONAL PHOTOGRAPHIC INTERPRETATION CENTER

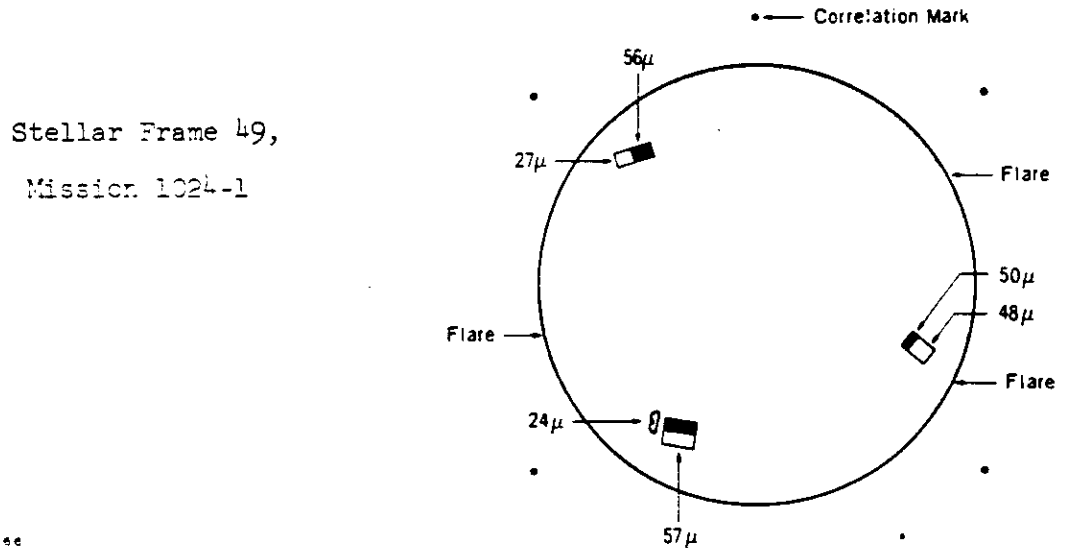
IMAGE DIMENSIONS

a. Elongated Stellar Images. While the stellar images are well defined, they are not circular. At low magnification, the images appear to be smeared, but further study reveals -- an image, a smear, and another

image. A frame, selected at random, was found to have stellar images as large as 24 X 57 microns (See illustration at the end of this section). This elongated imagery causes delays in the stellar reduction process because actual star centers must be determined before the data can be reduced. The probable cause of this anomaly is vehicle perturbation during exposure.
