**PHOTOGRAPHIC
EVALUATION REPORT
MISSION 1027-1
9-10 DECEMBER 1965
MISSION 1027-2
11 DECEMBER 1965**

NATIONAL PHOTOGRAPHIC INTERPRETATION CENTER

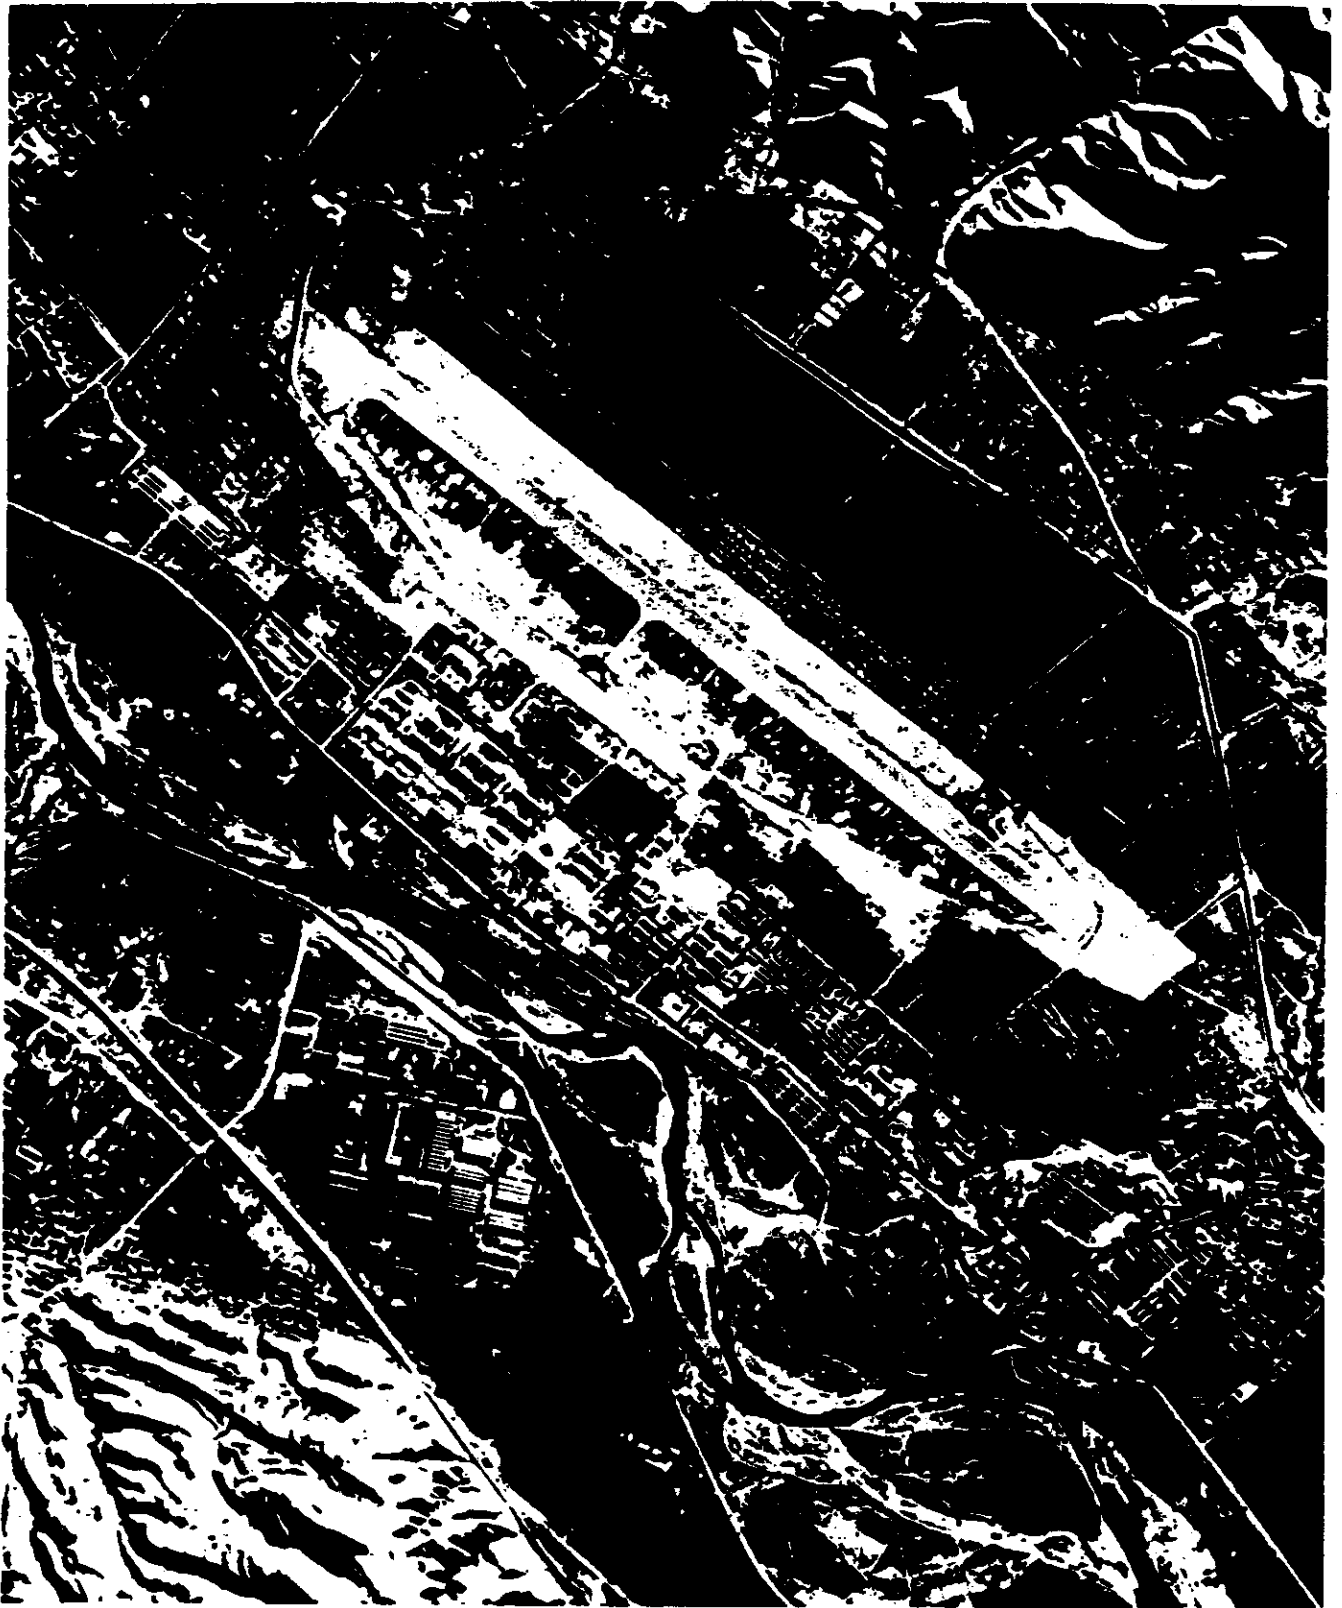
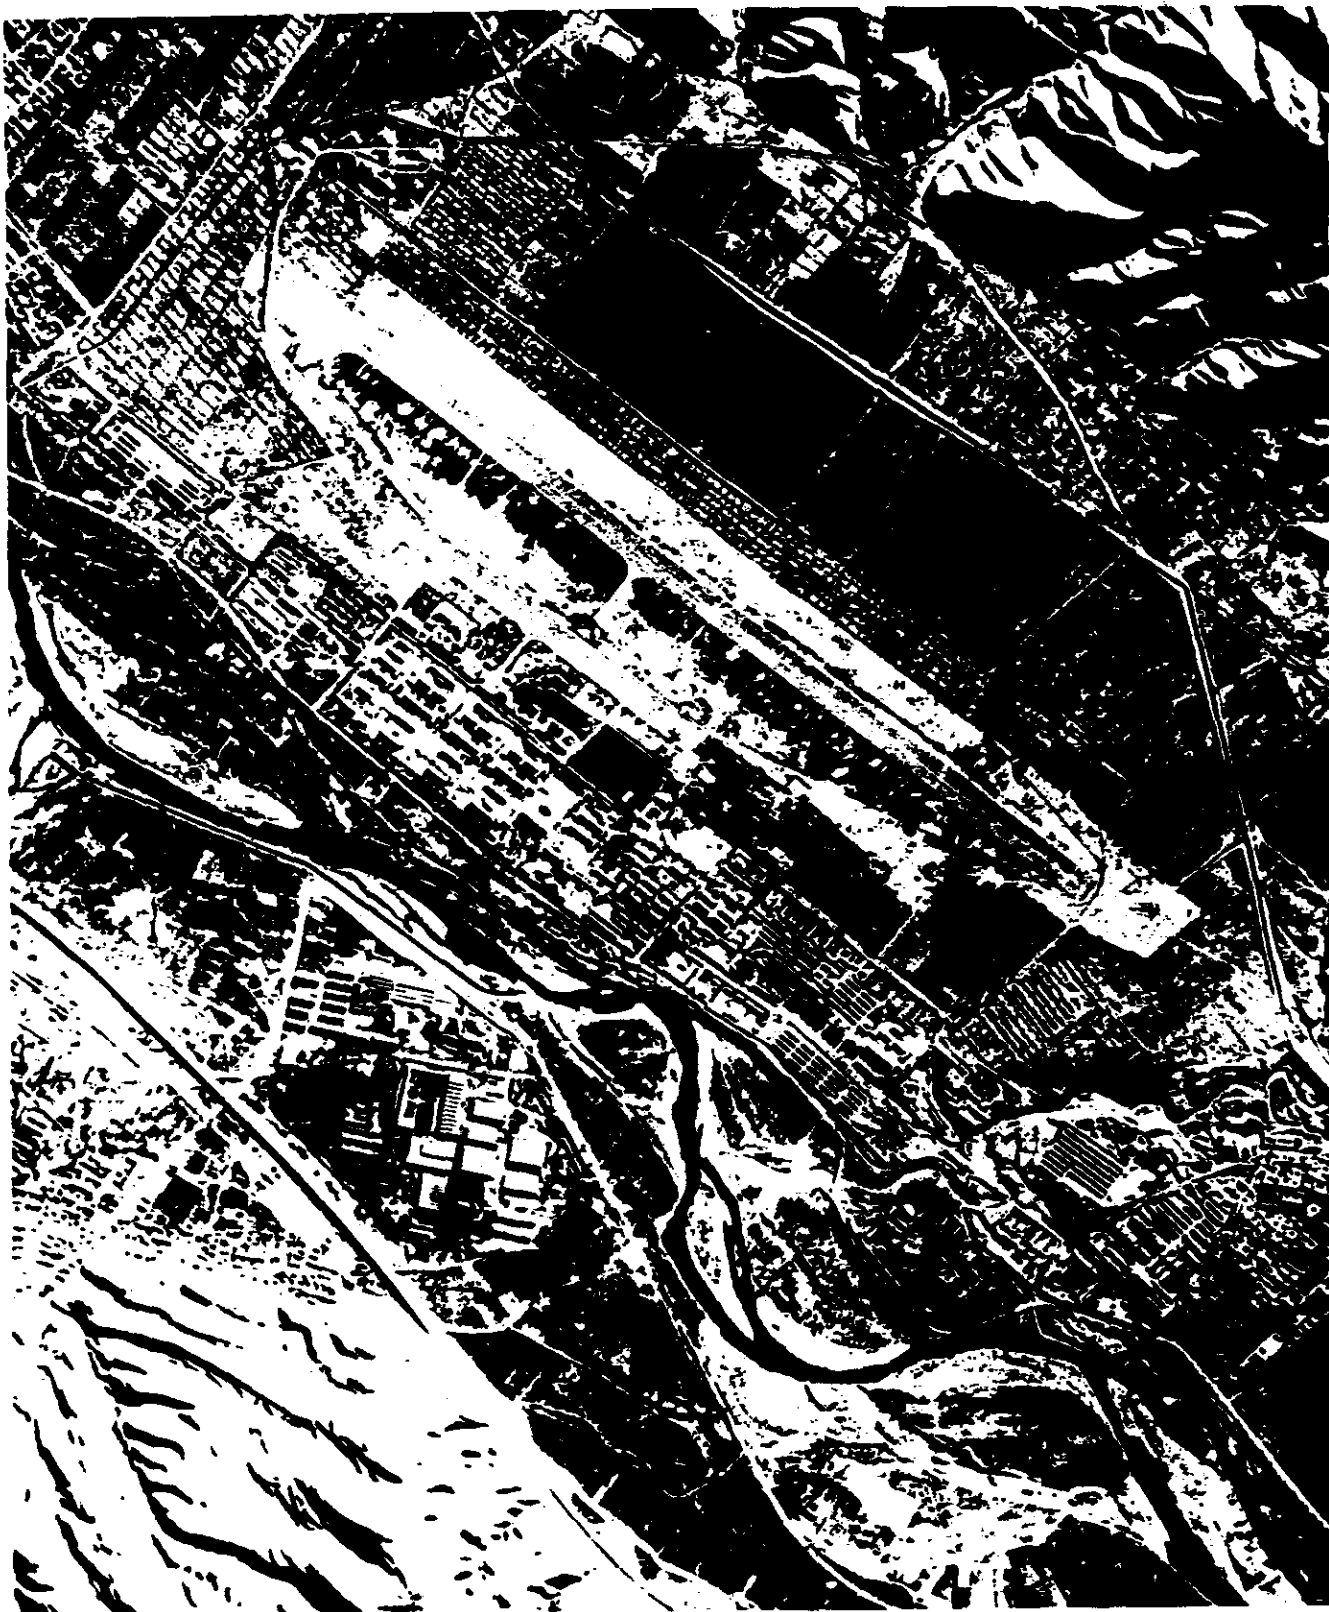
FIGURE 4

Pass 6D, frame 127 fwd has been selected as the MIP frame for Mission 1027-1. It has been assigned an MIP rating of 85. The information potential of the area acquired by the aft camera (frame 131 aft) is almost iden-

tical to this MIP frame.

The following photographs show the subtle difference between the
MIP frame (fwd photography) and the corresponding aft coverage.

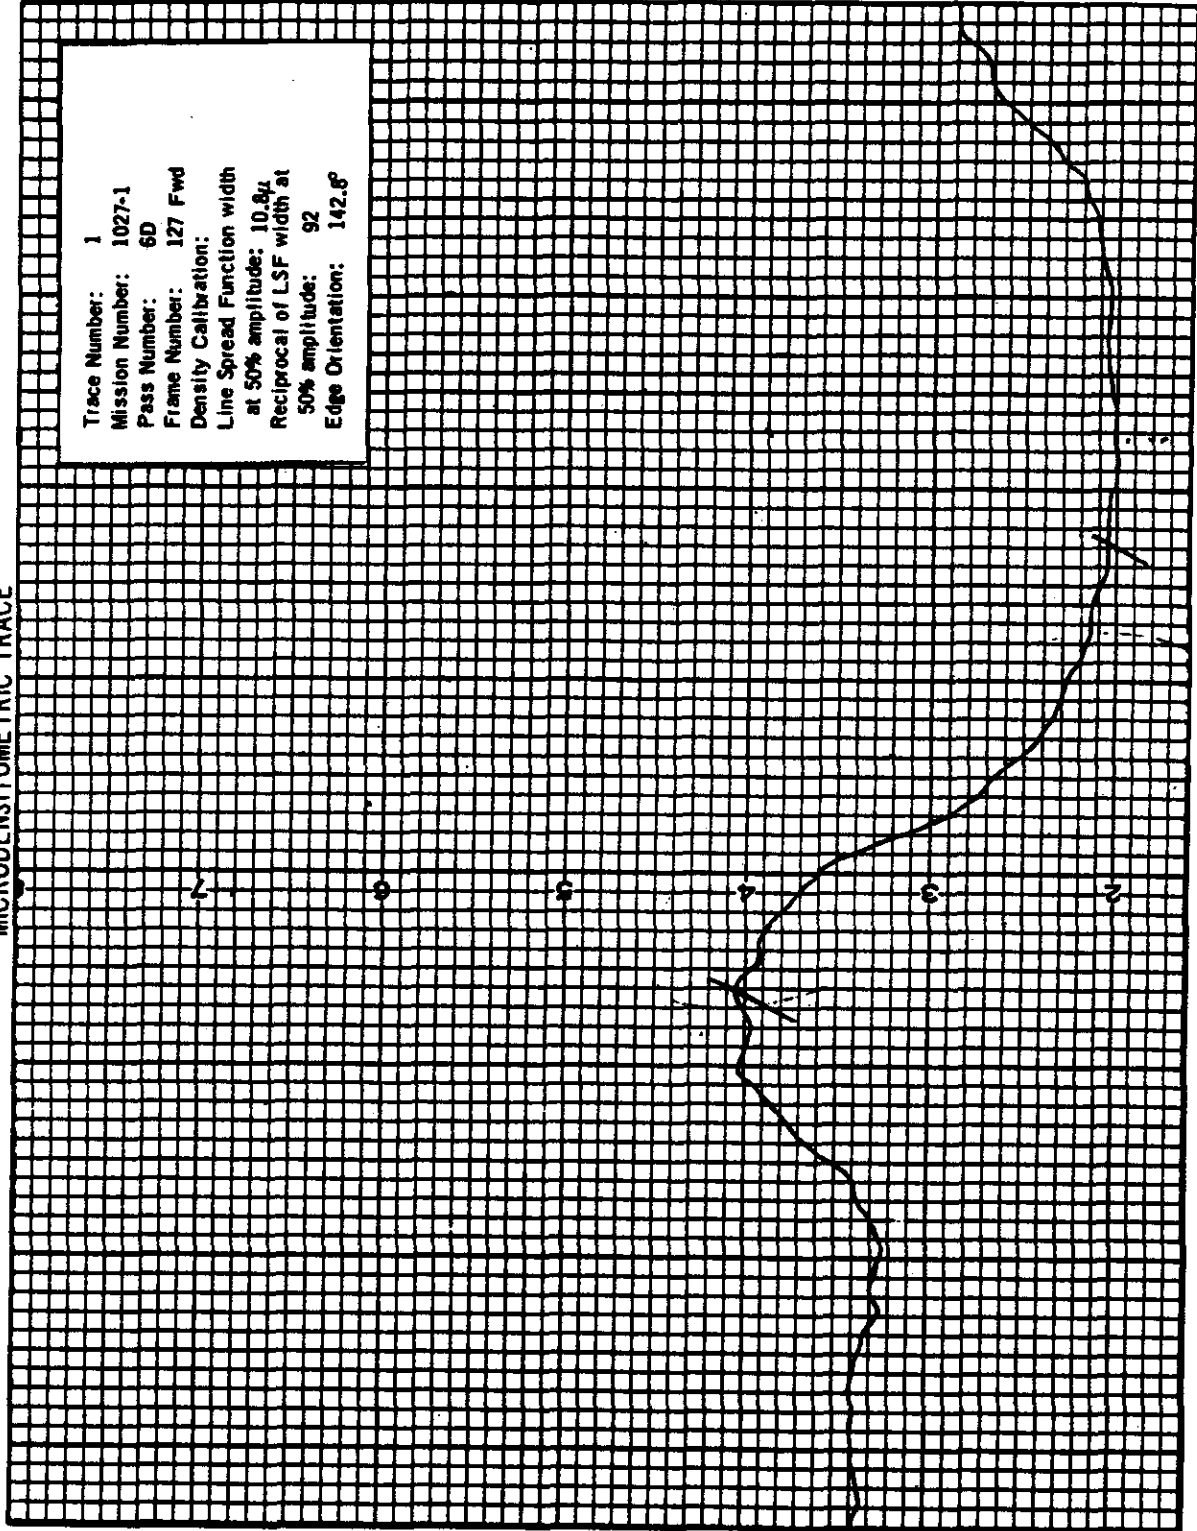
MICRODENSITOMETRIC TRACE

Trace Number: 1
Mission Number: 1027-1
Pass Number: 6D
Frame Number: 127 Fwd
Density Calibration:
Line Spread Function width
at 50% amplitude: 10.8 μ
Reciprocal of LSF width at
50% amplitude: 92
Edge Orientation: 142.8°

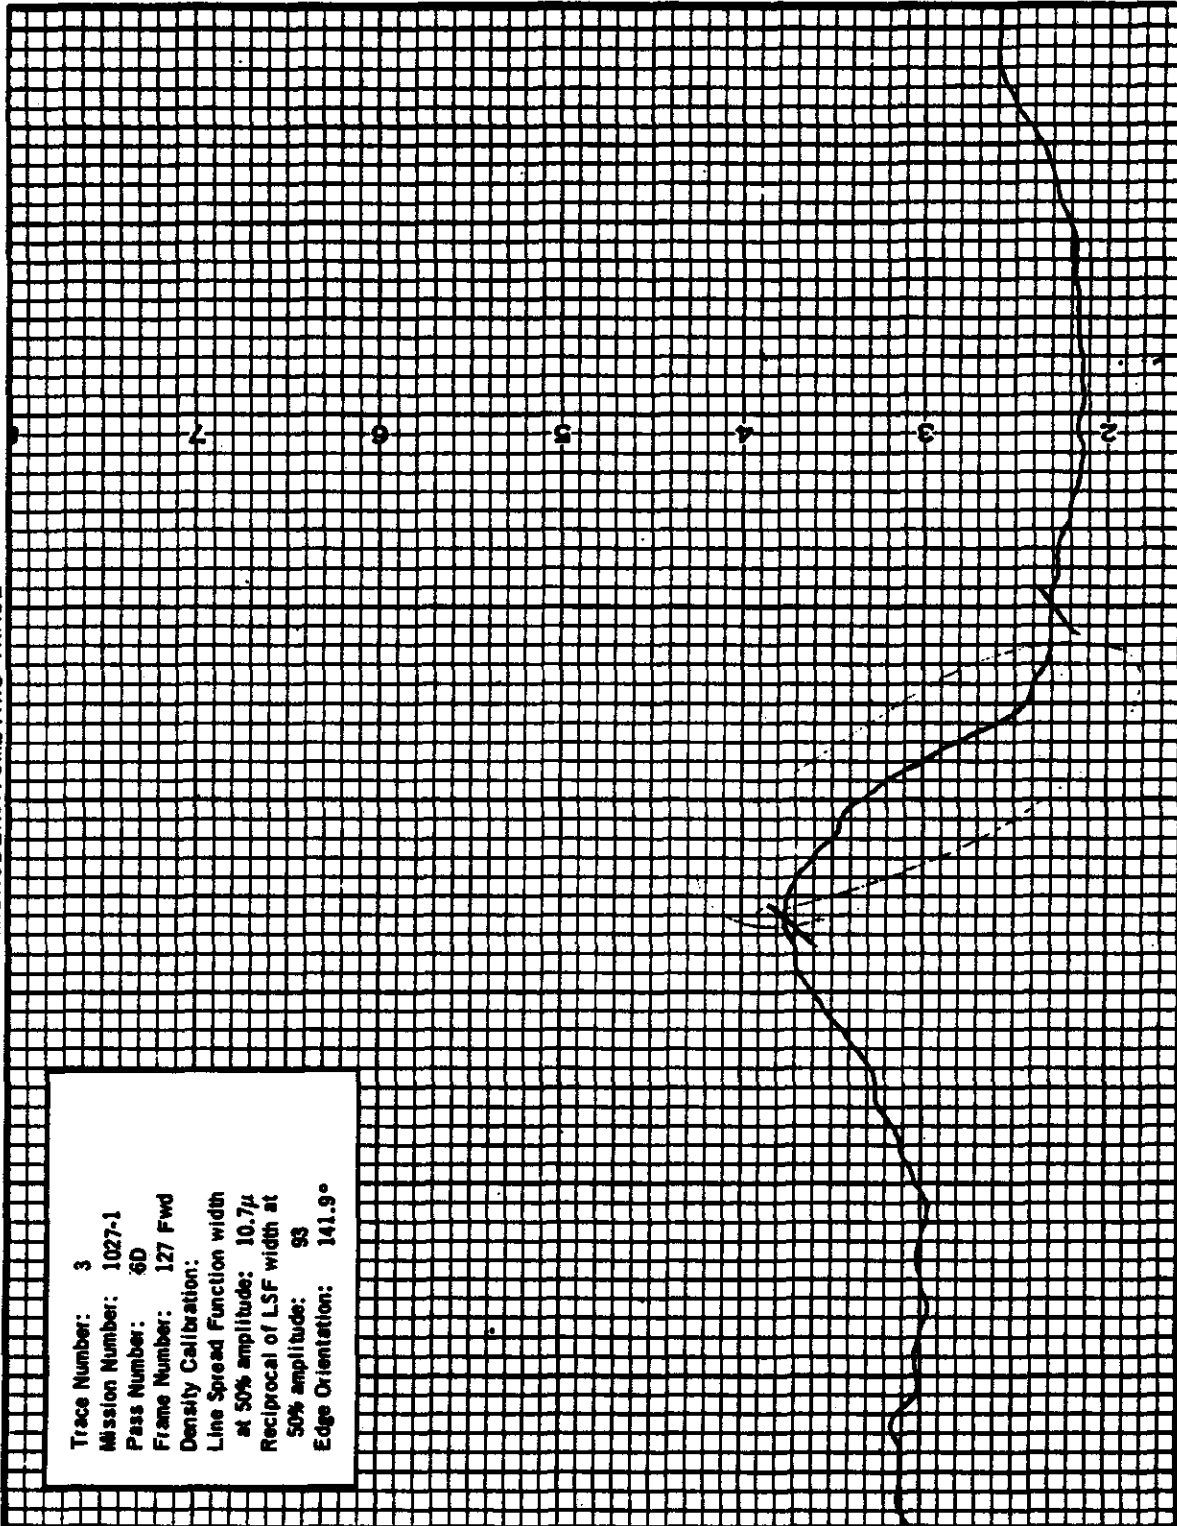
MICRODENSITOMETRIC TRACE

Trace Number: 3
Mission Number: 1027-1
Pass Number: 6D
Frame Number: 127 Fwd
Density Calibration:
Line Spread Function width
at 50% amplitude: 10.7 μ
Reciprocal of LSF width at
50% amplitude: 93
Edge Orientation: 141.9°
