CORONA J  
PERFORMANCE EVALUATION REPORT  
MISSION 1014-1 and 1014-2  
FTV 1180; J-16

8 April 1966

SUBJECT: MISSION 1014-1 AND 1014-2 FINAL REPORT

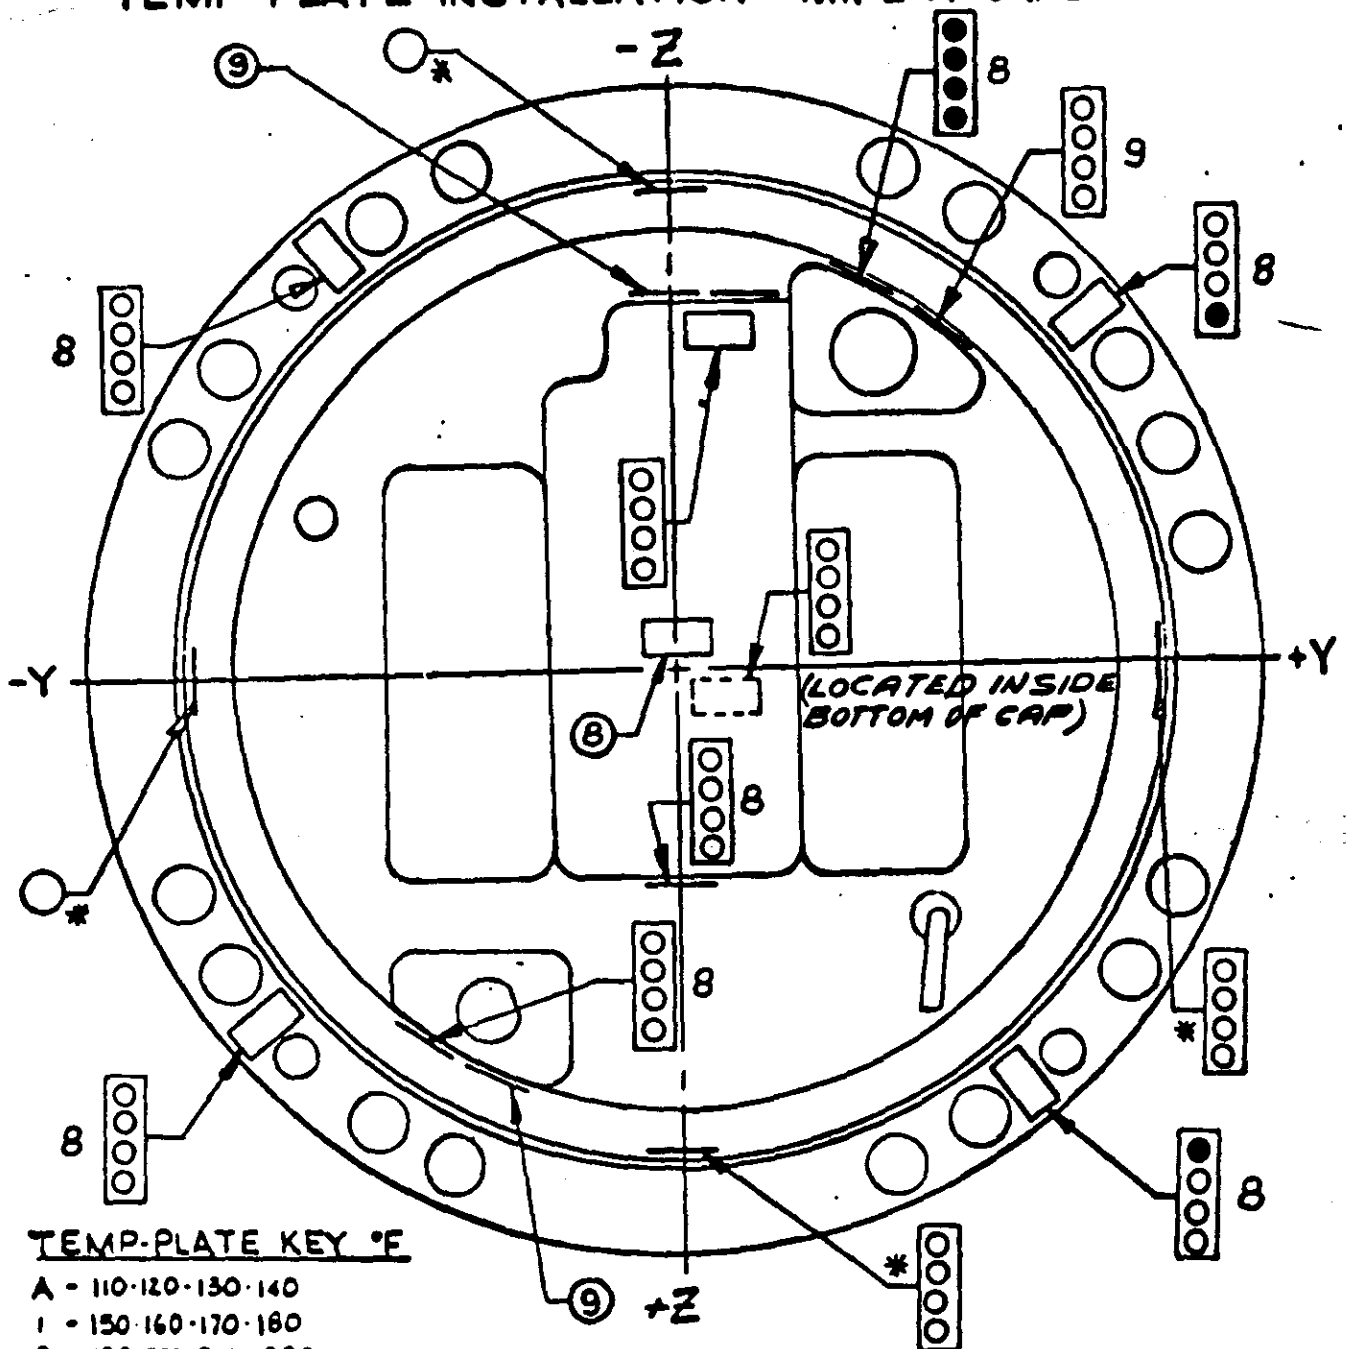
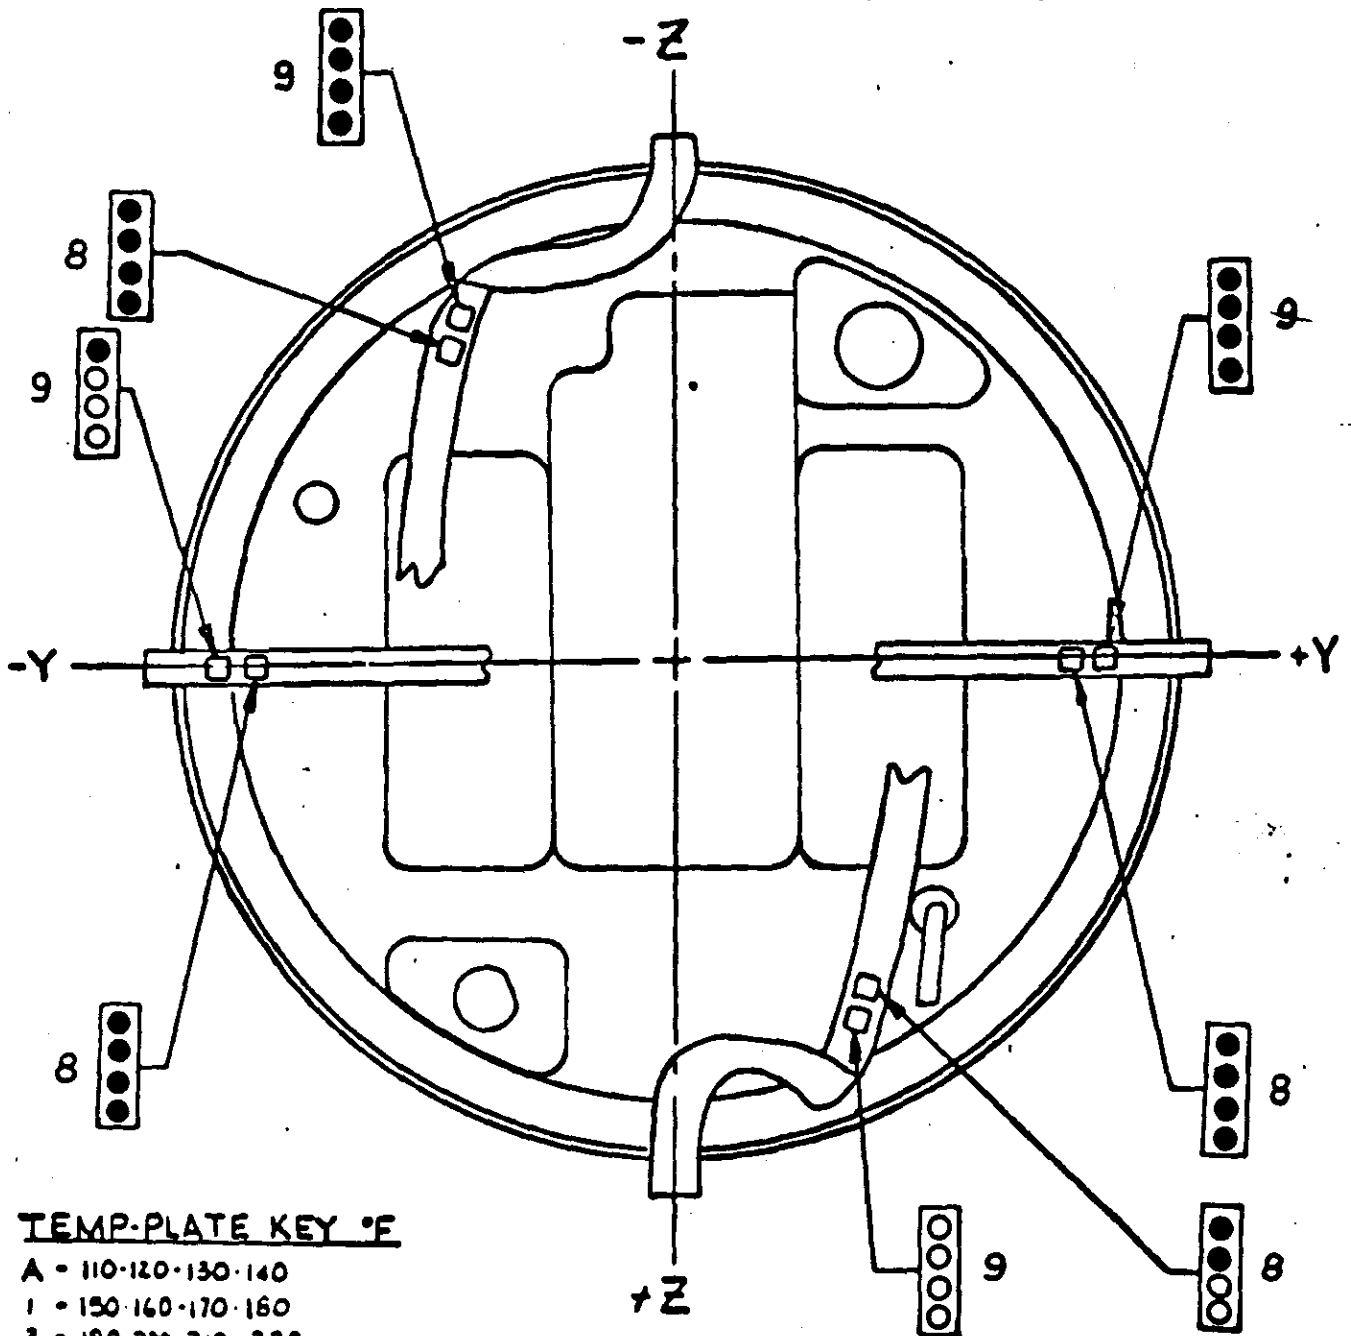
FIGURE 4-1

Post flight inspection indicated that normal paint blistering was the only damage of the recovered capsule. Refer to Figures Nos. 4-1 and 4-2 for the temperature environment encountered during re-entry.

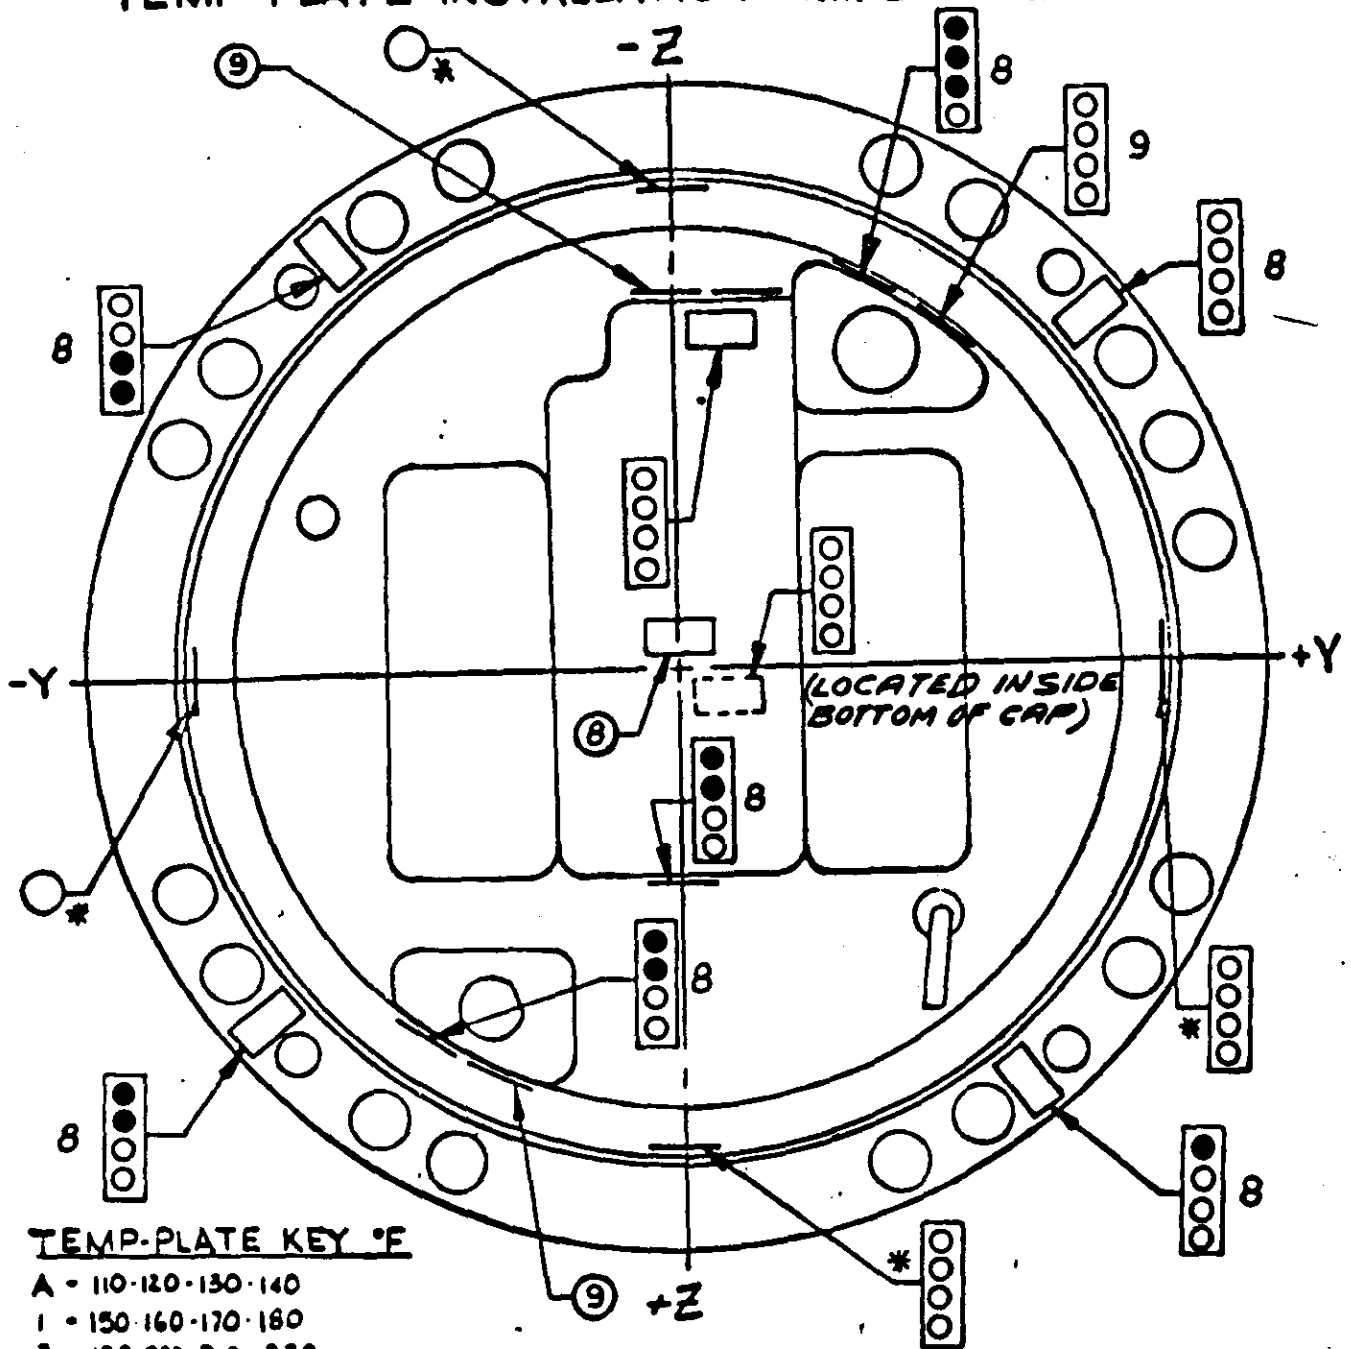
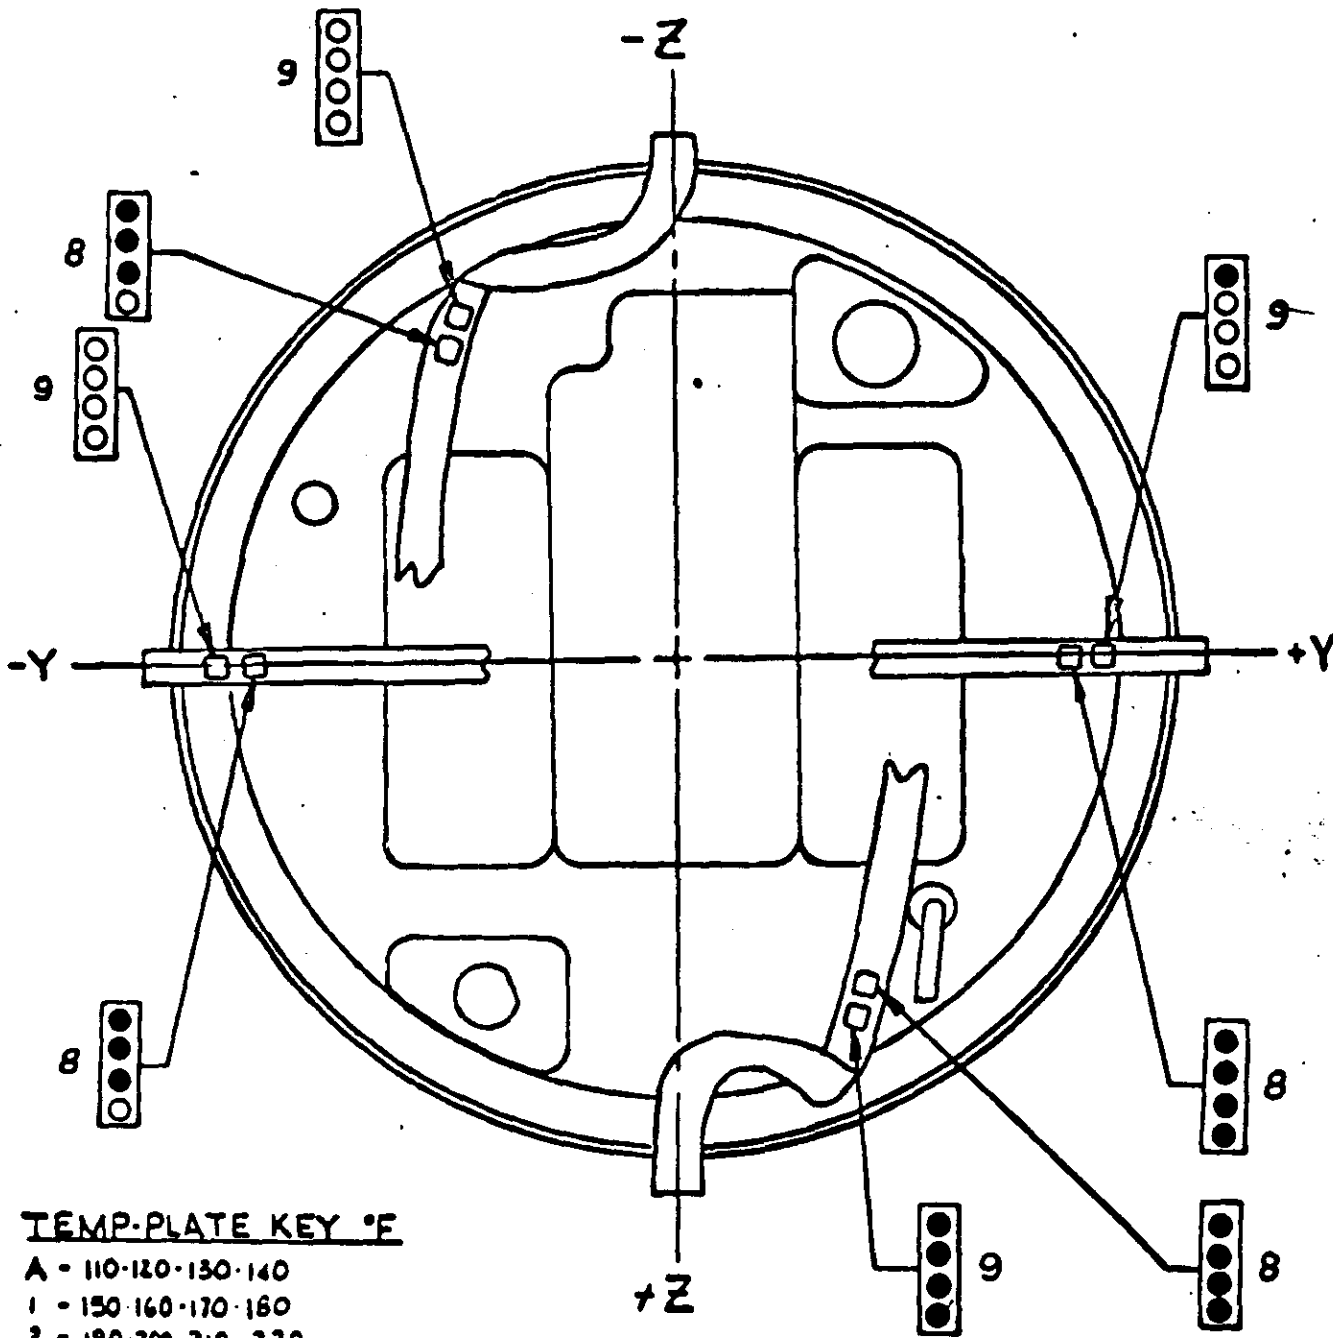
FIGURE 5-1

Post flight inspection indicated that normal paint blistering was the only damage of the recovered capsule. Refer to Figure Nos. 5-1 and 5-2 for the temperature environment encountered during re-entry.
