PHOTOGRAPHIC
EVALUATION REPORT
MISSION 1031-1

7-14 APRIL 1966

MISSION 1031-2

NATIONAL PHOTOGRAPHIC INTERPRETATION CENTER

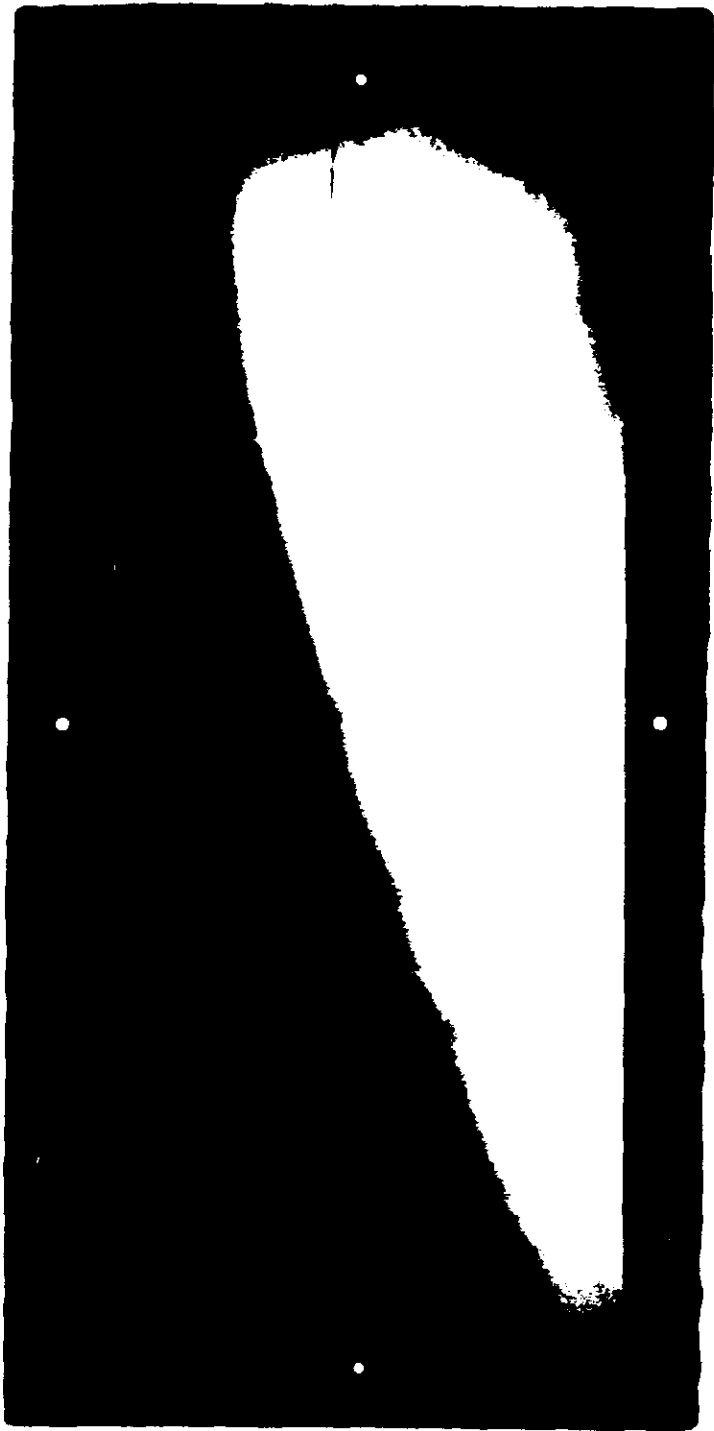
FIGURE 2. VEILED STARBOARD HORIZON IMAGERY, MASTER CAMERA

The cause of the veiling has not been determined. However, studies of the anomaly are still being conducted by the camera manufacturer and by NPIC. It is hoped that the correlary data from the Gemini missions will help explain the situation.

The starboard horizon imagery of the master camera is veiled on passes 1D through 31D. The horizon arcs, which are affected by the veiling, are very indistinct. This anomaly is illustrated by the following photograph. After pass 31D, the imagery becomes sharp and well-defined.

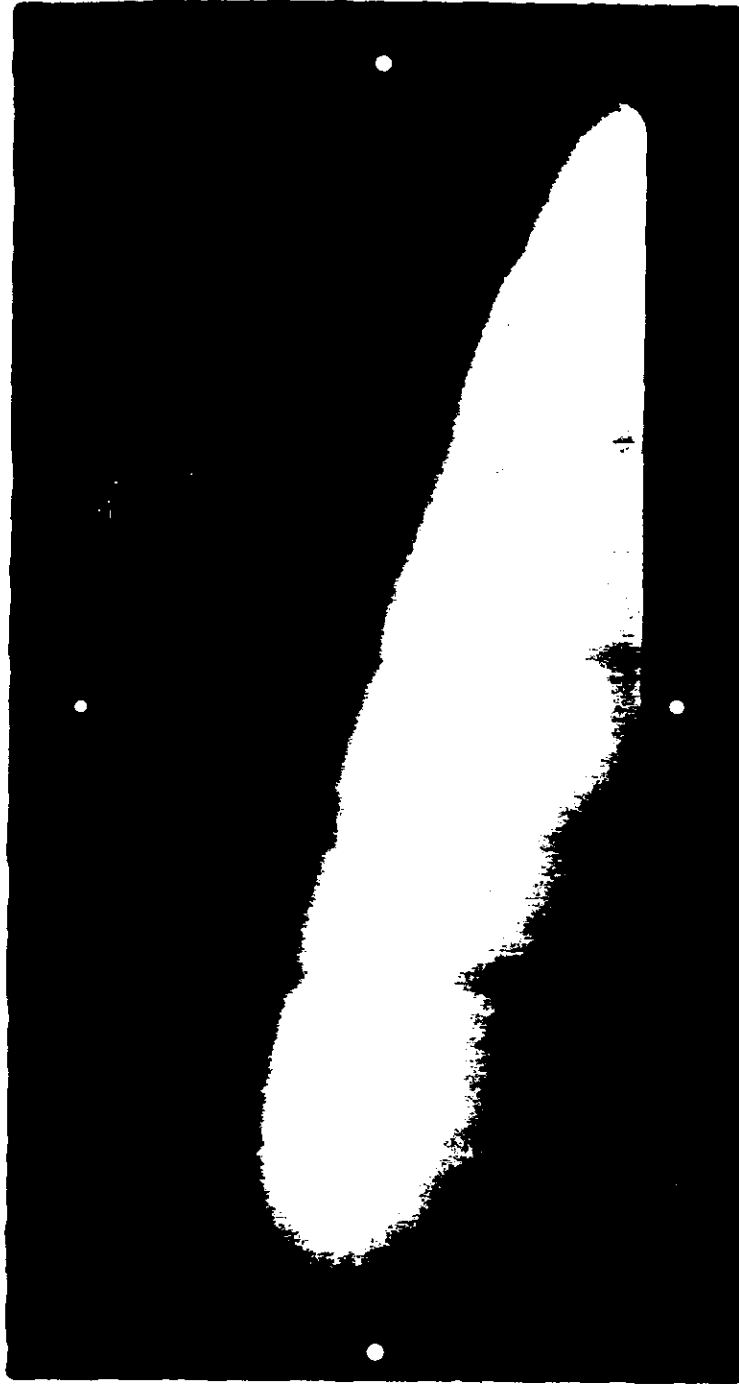
FIGURE 3. VEILED STARBOARD HORIZON IMAGERY, SLAVE CAMERA

After pass 10, the remaining horizon images from the slave starboard horizon camera appear out-of-focus. The following photograph indicates the severity of the phenomenon.

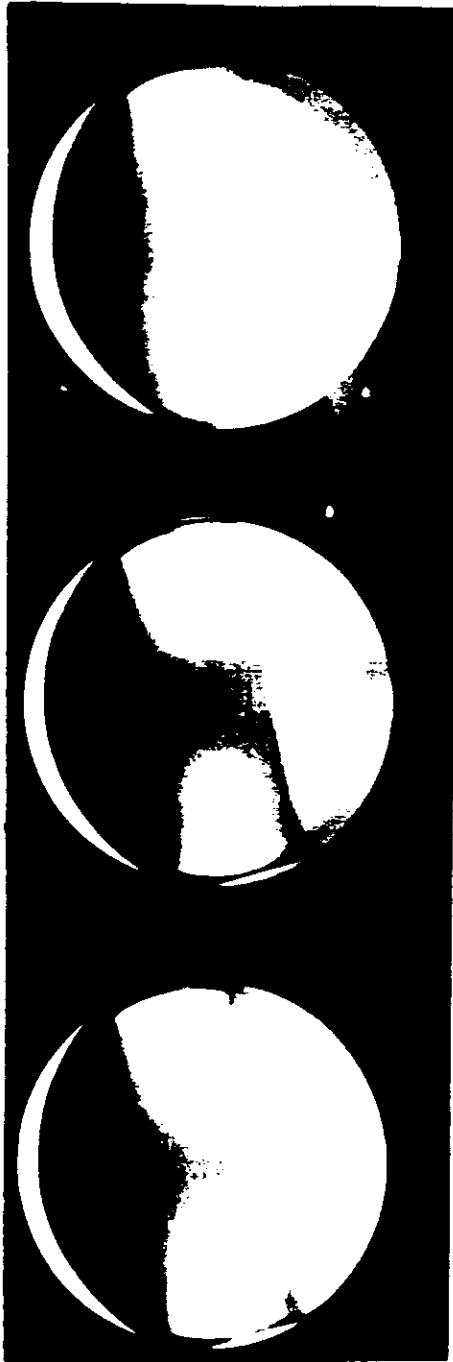
FIGURE 4. STELLAR PHOTOGRAPH, SHUTTER MALFUNCTION

The cause of the malfunction has been attributed to excessive friction in the stellar camera shutter. A possible remedy, which is under investigation by the camera manufacturer, is the use of a stronger shutter closing spring.

The stellar camera shutter remained open during all or part of the film transport procedure between the normal exposed frames on the last 50 percent of Mission 1031-2. This resulted in a higher flare level and an associated loss of some previously detectable star images. Approximately 20 stellar images are detected in most frames prior to the malfunction and only 12 thereafter. The malfunction has been attributed to excessive friction in the stellar camera shutter. The photograph is typical of the imagery produced during the malfunction.
