**PHOTOGRAPHIC
EVALUATION REPORT
MISSION 1028-1
24-29 DECEMBER 1965
MISSION 1028-2
29 DECEMBER 1965 -
2 JANUARY 1966**

**SEPTEMBER 1966
COPY
185 PAGES**

NATIONAL PHOTOGRAPHIC INTERPRETATION CENTER

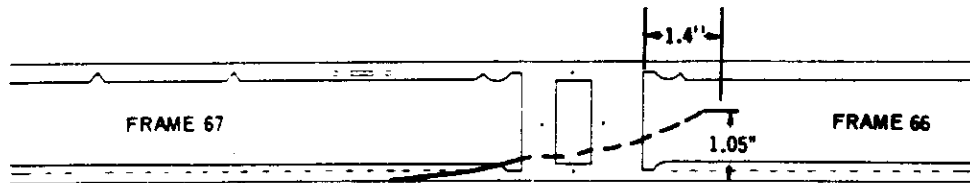
e. A series of crimps, indented from the base side, begin in frame 66 of pass 22D. These crimps join to form a continuous crease which runs off of the frequency mark edge of the film in frame 67. Associated with these crimps are emulsion cracks and abrasions. A manufacturer's splice located in frame 64 is suspected to be the cause of the crimps, crease, and abrasions. Pitch measurements

indicate no extreme bias in the platten area during exposure. It is quite probable that the material was creased during the splicing or spooling process. An illustration of the orientation of the crease follows.
