CORONA J

PERFORMANCE EVALUATION REPORT

MISSION 1027-1

FTV 1621 JX-27

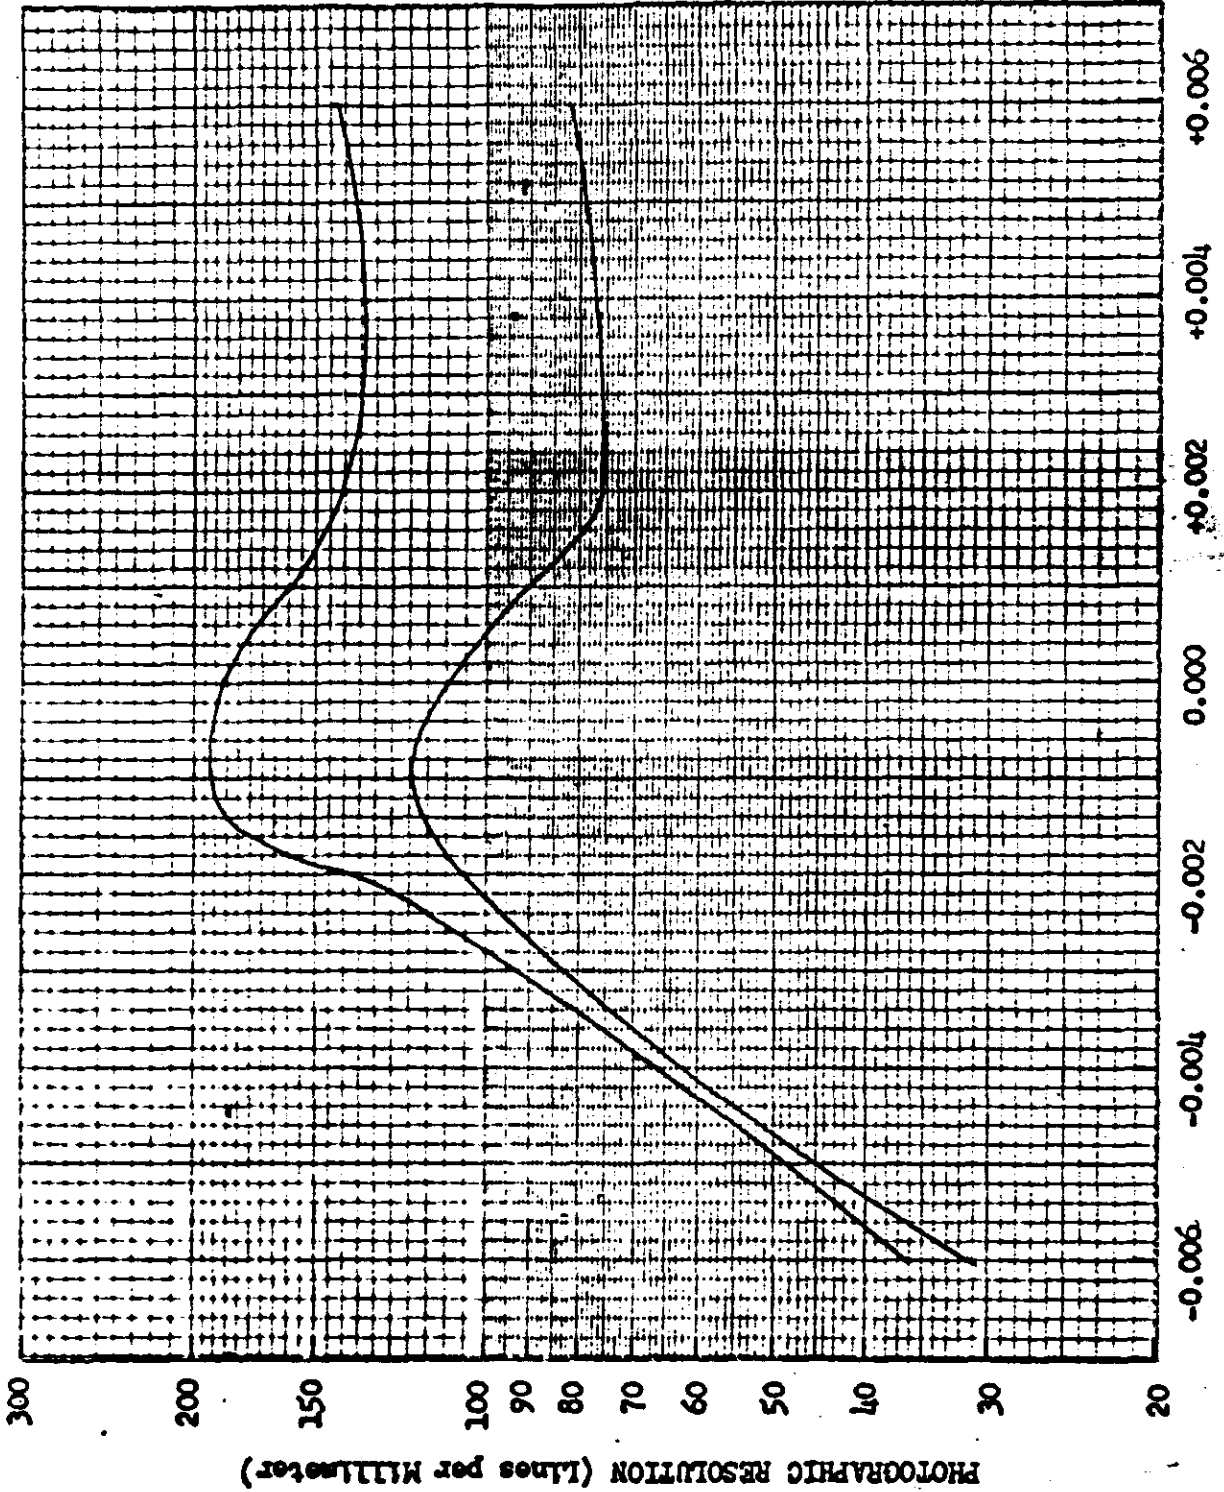
FIGURE 2-1

The dynamic resolution test of the JX-27 payload system was performed at the A/P facility on 16 June 1965. Each panoramic camera photographed high and low contrast resolution targets. The resulting through focus resolution data is shown in Figure 2-1 for the Master camera and in Figure 2-2 for the Slave camera.
