CORONA J

PERFORMANCE EVALUATION REPORT

MISSION 1033-1 and 1033-2

FTV 1630, J-33

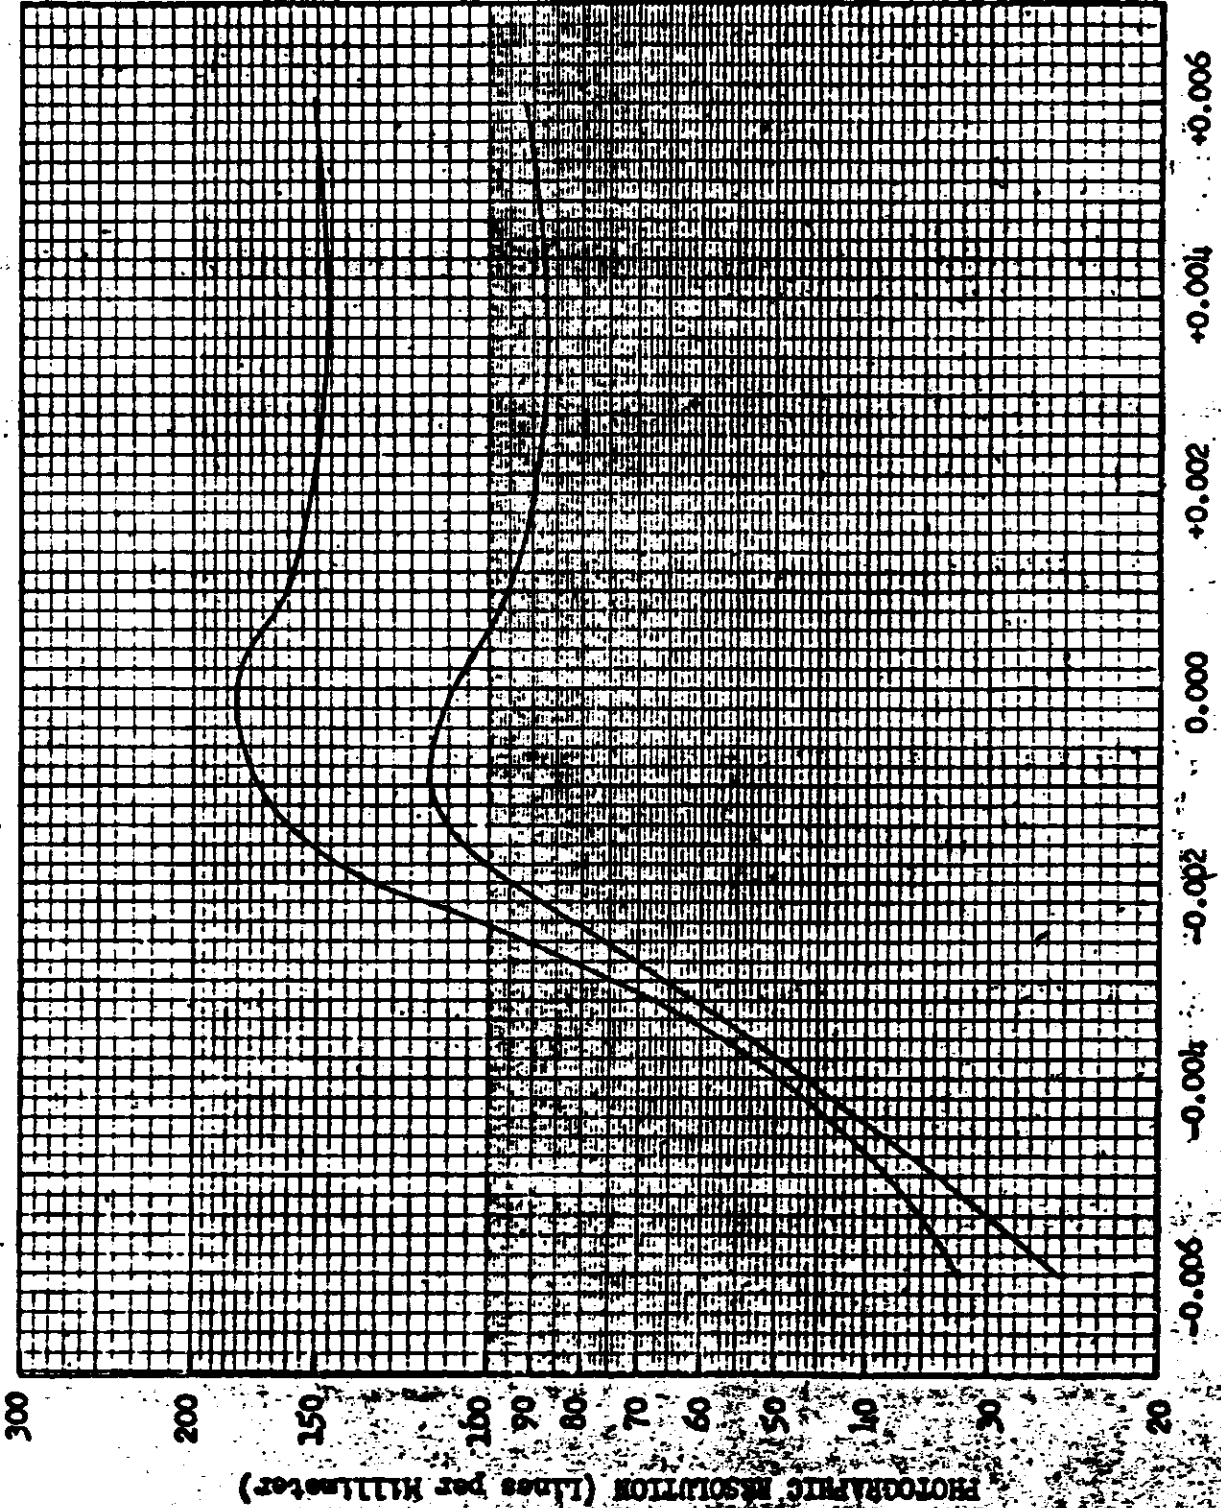
FIGURE 2-1

Master Pan Instrument No. 194.

Maximum high contrast resolution 182 lines/mm at 0.000 focal position.

Maximum low contrast resolution 116 lines/mm at - .001 focal position.

The test data for both instruments is plotted in Figures 2-1 and 2-2. Both instruments met the system requirements specification.
