# PHOTOGRAPHIC EVALUATION REPORT MISSION 1044

SPECIAL STUDY ON  
DUAL GAMMA/VICOSE VS  
CONVENTIONAL/SPRAY  
PROCESSING ANALYSIS

FEBRUARY 1968

NATIONAL PHOTOGRAPHIC INTERPRETATION CENTER

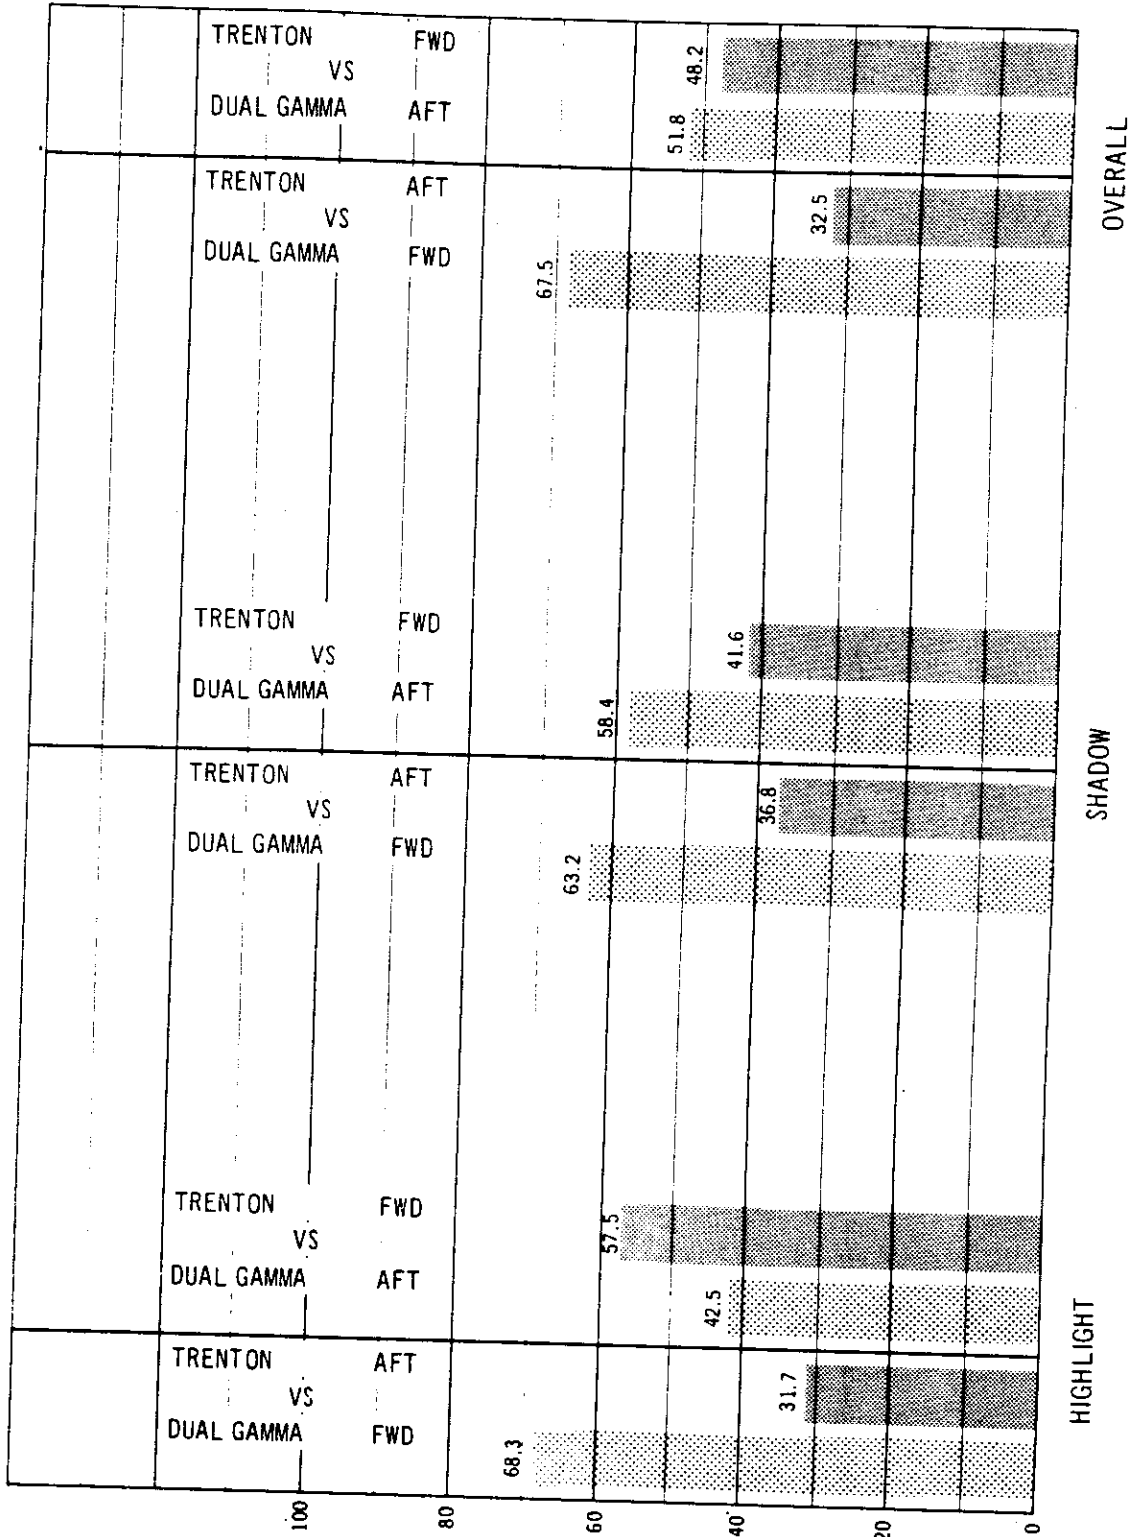
Figure 4. Target Analysis

The differences in intelligence content is subtle in all areas considered. However, 2 developments did emerge from this analysis. They are: (1) The material from the fwd camera is preferred in the majority of instances. (2) The dual gamma product is preferred in the majority of instances when only processing is considered. Contrary to what may have been expected, the most significant degree of preference for the dual gamma product exists in the shadow areas and less noticeable improvement is detected in the highlight areas. In general, the selections, based on overall intelligence content, indicate that the dual gamma product is preferred over the product from the interrupted/Trenton process.
