CORONA J
PERFORMANCE EVALUATION REPORT

MISSION 1049
15 APRIL 1969

This document constitutes the final payload test and performance evaluation report for Mission 1049 which was launched on 12 December 1968.

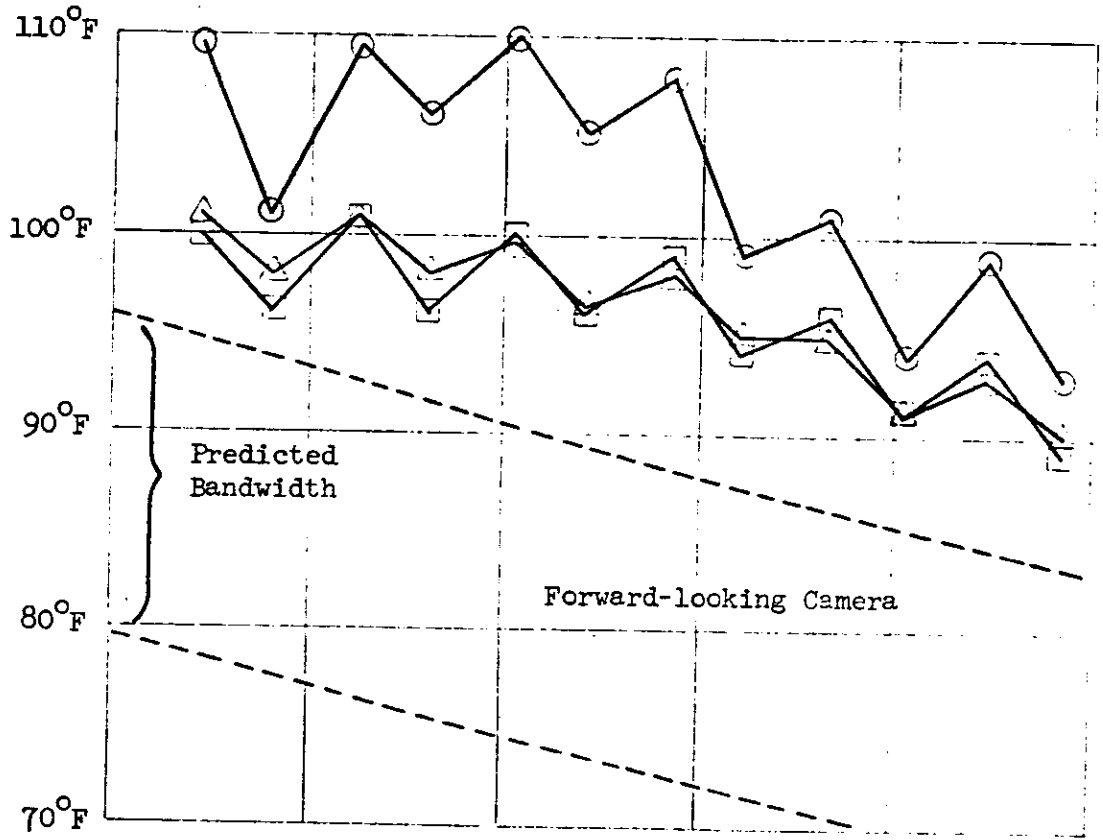
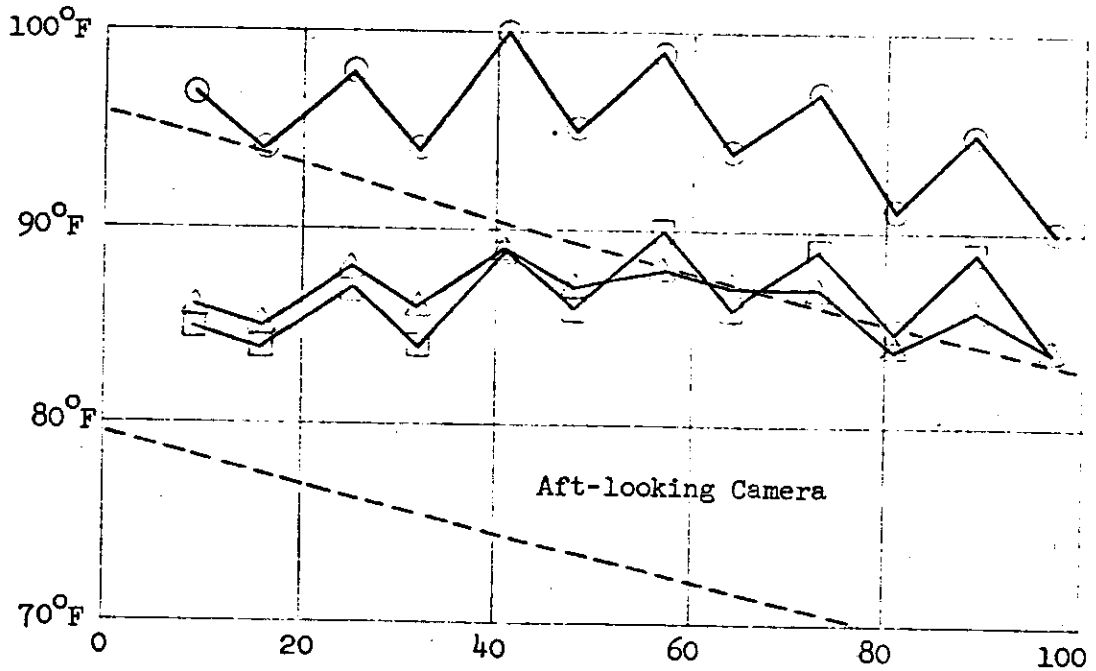
1049-1 TEMPERATURES

Pre-flight emissivity testing of the thermal control surfaces indicated a warm tendency. Reflective striping had been added to the basic paint pattern in order to reduce calculated temperature to within

the upper limits of the nominal range. Such factors as the high winter solar flux, the higher ascent thermal environment, and thermal control surface degradation may have contributed to the temperature disparity.

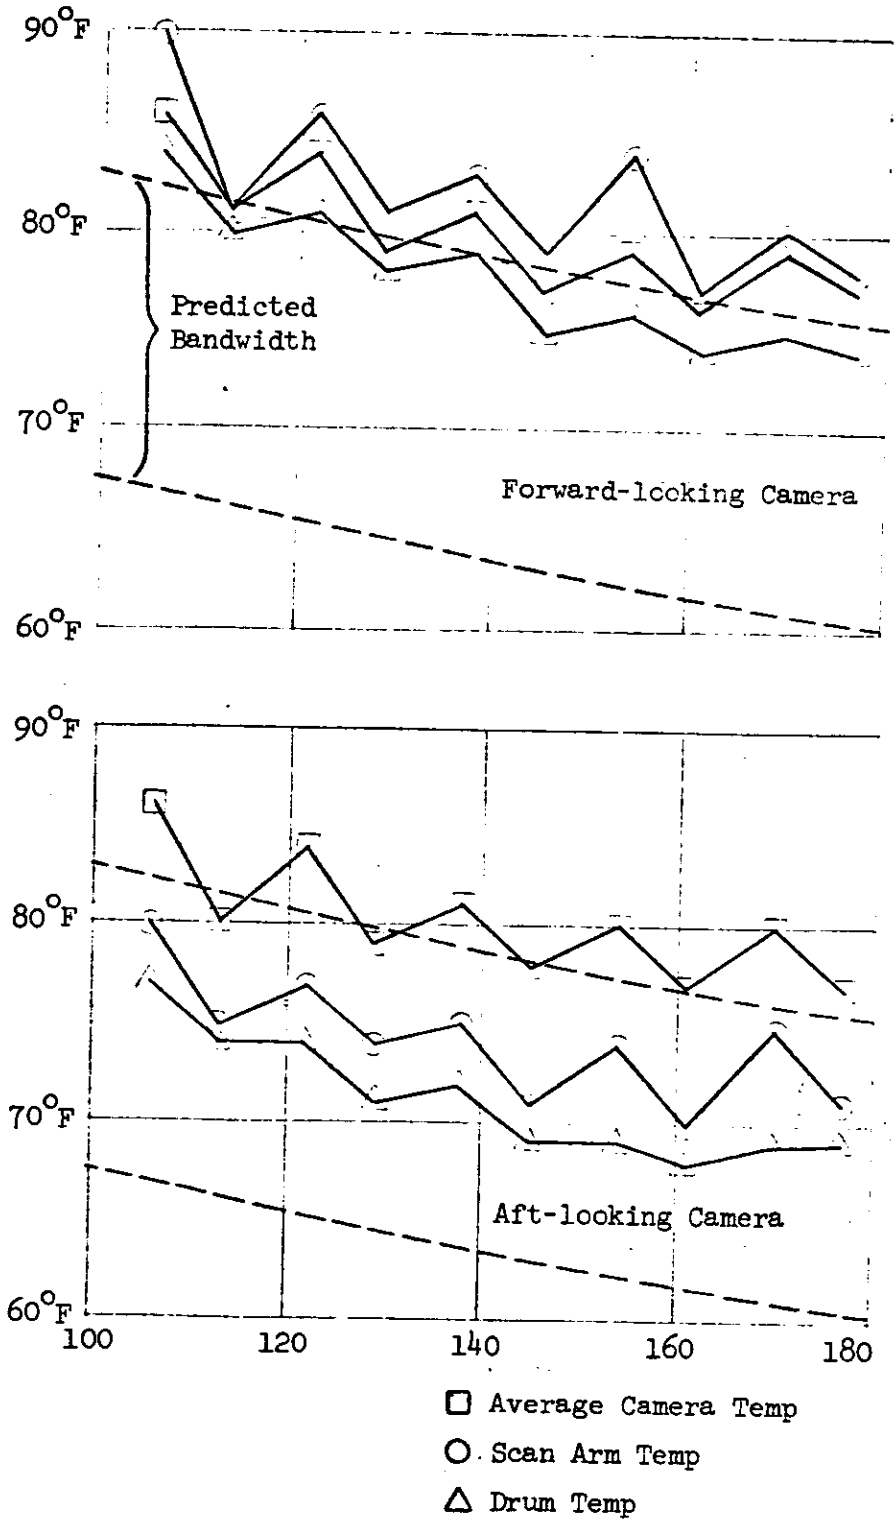
1049-2 TEMPERATURES

degree cooling had been forecast. The chart on the following page illustrates thermal conditions during the second mission.
