CORONA J  
PERFORMANCE EVALUATION REPORT  
MISSION 1104-1 and 1104-2  
FTV 1644, CR-4

SUBJECT: MISSION 1104 FINAL REPORT (CR-4)

This document is the final payload test and performance evaluation report for Missions 1104-1 and 1104-2 which were launched on 7 August 1968.

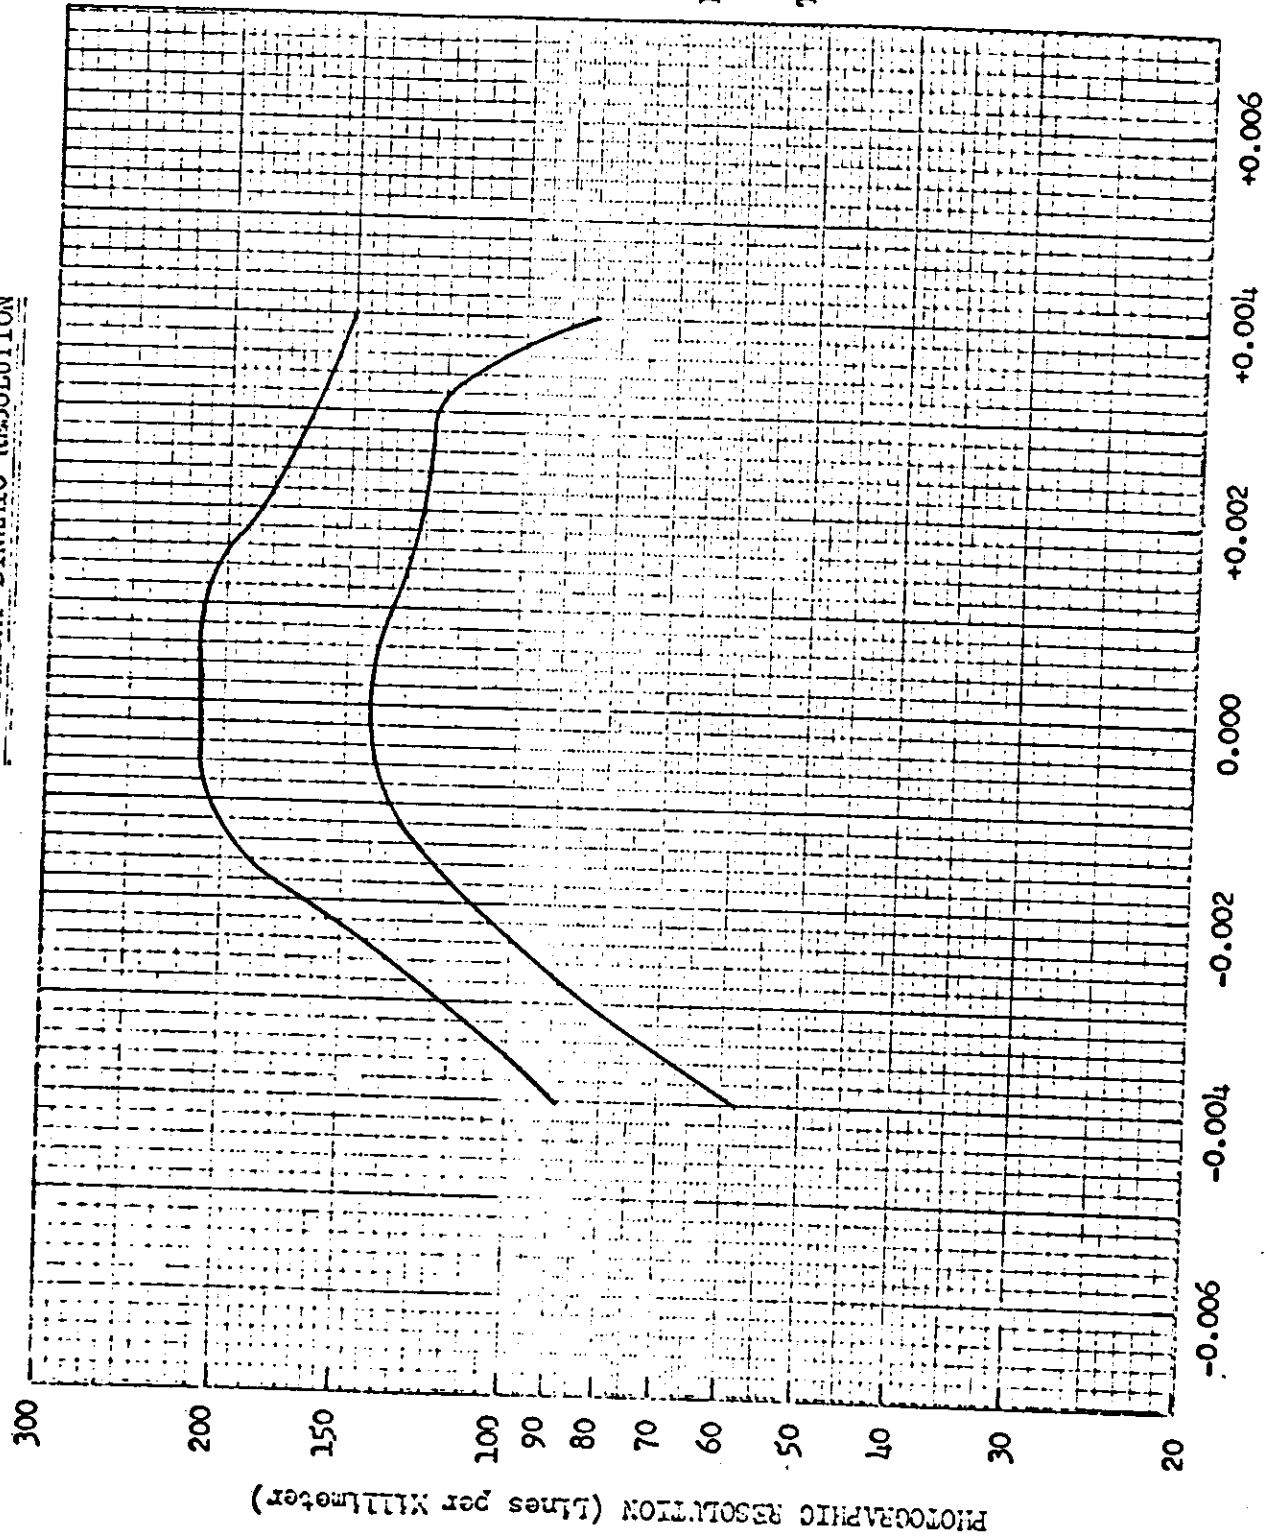
The final test data for both instruments is shown in Figures 2-1 and 2-2. Both instruments met the system requirements specification.

Camera No: 308  
Payload No: CR-4  
Resolution (1/mm)             
High Contrast: 212  
Low Contrast: 141  
Film Type: 3404  
Test Date: 6 June 1968

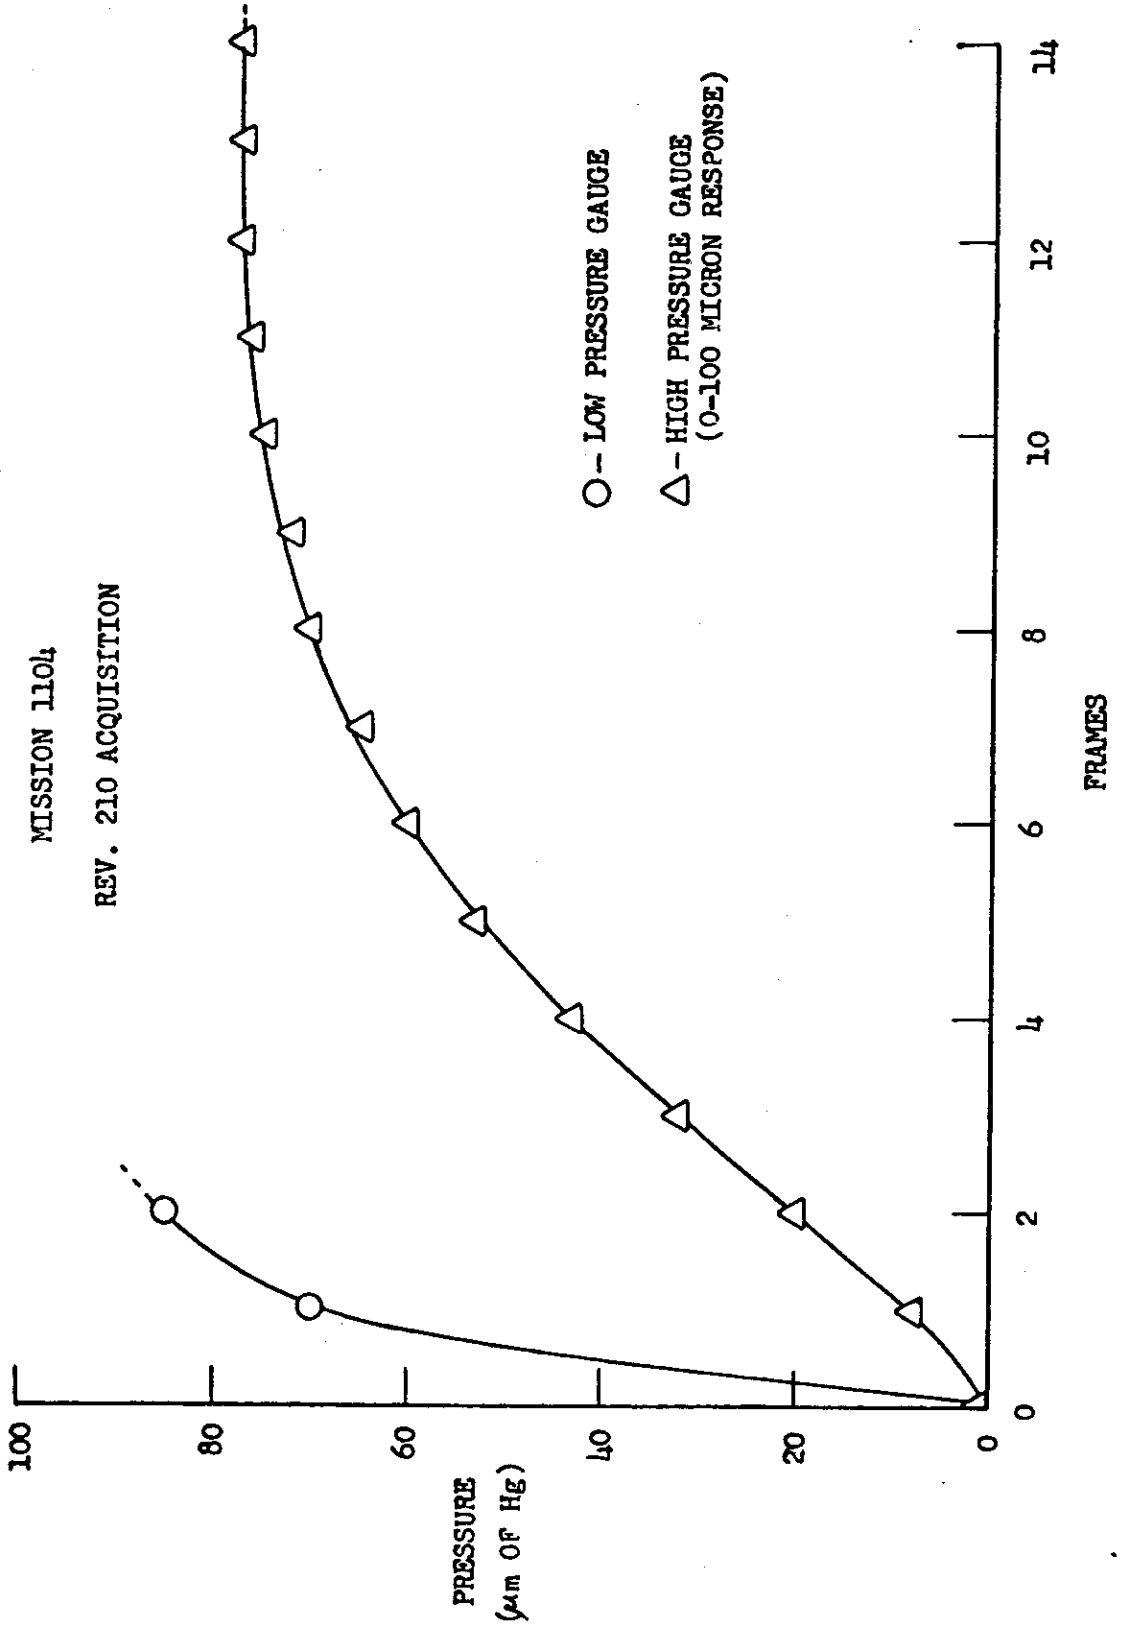
FIGURE 3-7

1. Stabilized pressures of 56 microns, 69 microns, and greater than 100 microns were observed during some operates, even when the lower range (16 micron) control was supposed to be in effect. Refer to Figure 3-7.
2. Supply pressure dropped 160 psi and 575 psi on two (2) operates and 100 to 150 psi per operate on several other instrument operates. Refer to Figure 3-9.
3. Pressure buildup, on occasion, exceeded 100 microns (gage limit) within 2 seconds. Refer to Figure 3-8.
4. Internal pressure fluctuated during instrument operation. During one such operate the pressure went to 66 microns, decreased to 62 microns, then increased to 70 microns at the "OFF" command.

The problem was attributed to a faulty high pressure regulator. The PMU was disabled during Rev. 124, after 130 minutes of operate time, with a pressure of 350 psi remaining. The system was re-enabled during Rev. 200 and remained on for the balance of the flight, with the exception of Rev. 211. The supply pressure remaining at the end of the mission was 200 psi. Refer to Figure 3-9. The system apparently did not perform as desired for the SO-180 film employed in Instrument 309 at the end of Mission 1104-2. This condition was evidenced by the predominance of corona discharge marking recorded on this special material.
