CORONA J
PERFORMANCE EVALUATION REPORT

MISSION 1049
15 APRIL 1969

This document constitutes the final payload test and performance evaluation report for Mission 1049 which was launched on 12 December 1968.

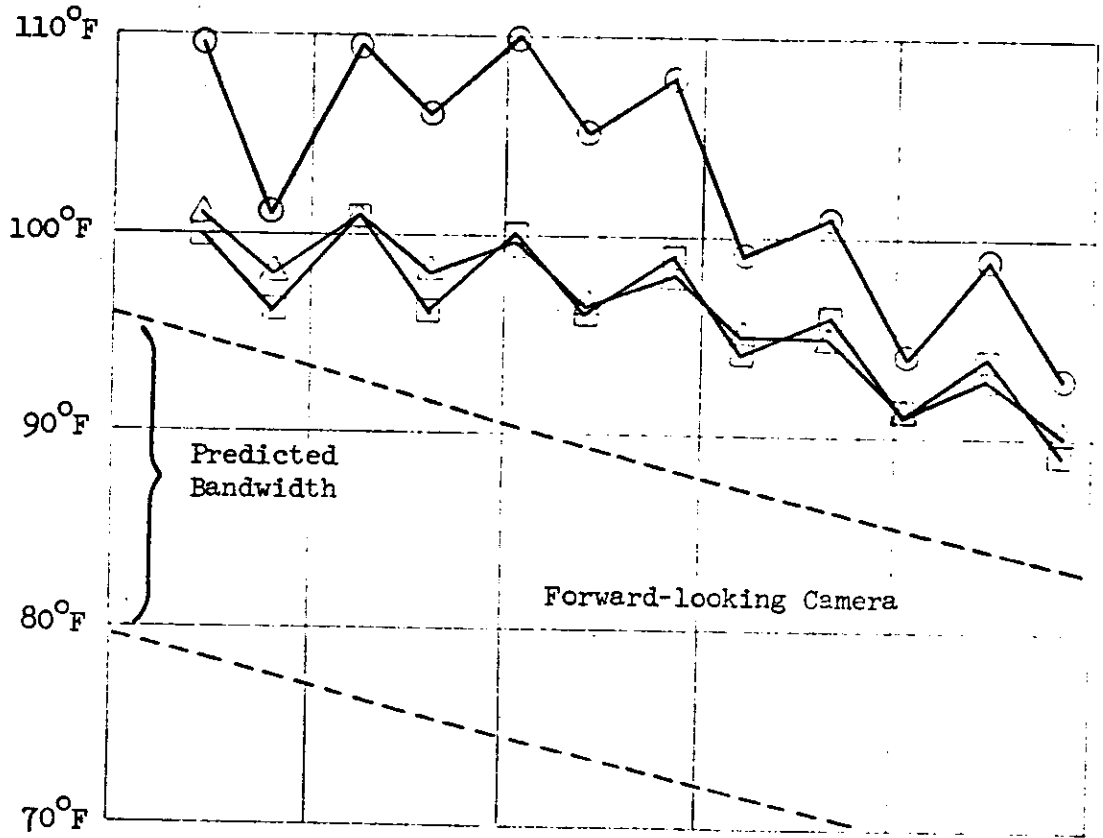
1049-1 TEMPERATURES

Pre-flight emissivity testing of the thermal control surfaces indicated a warm tendency. Reflective striping had been added to the basic paint pattern in order to reduce calculated temperature to within

the upper limits of the nominal range. Such factors as the high winter solar flux, the higher ascent thermal environment, and thermal control surface degradation may have contributed to the temperature disparity.
