CORONA J
PERFORMANCE EVALUATION REPORT
MISSION 1048-1 and 1048-2
FTV 1647, J-49

This report details the performance of the payload system (J-49) during the operational phase of Mission 1048.

This document is the final payload test and performance evaluation report for Missions 1048-1 and 1048-2 which was launched on 18 September 1968.

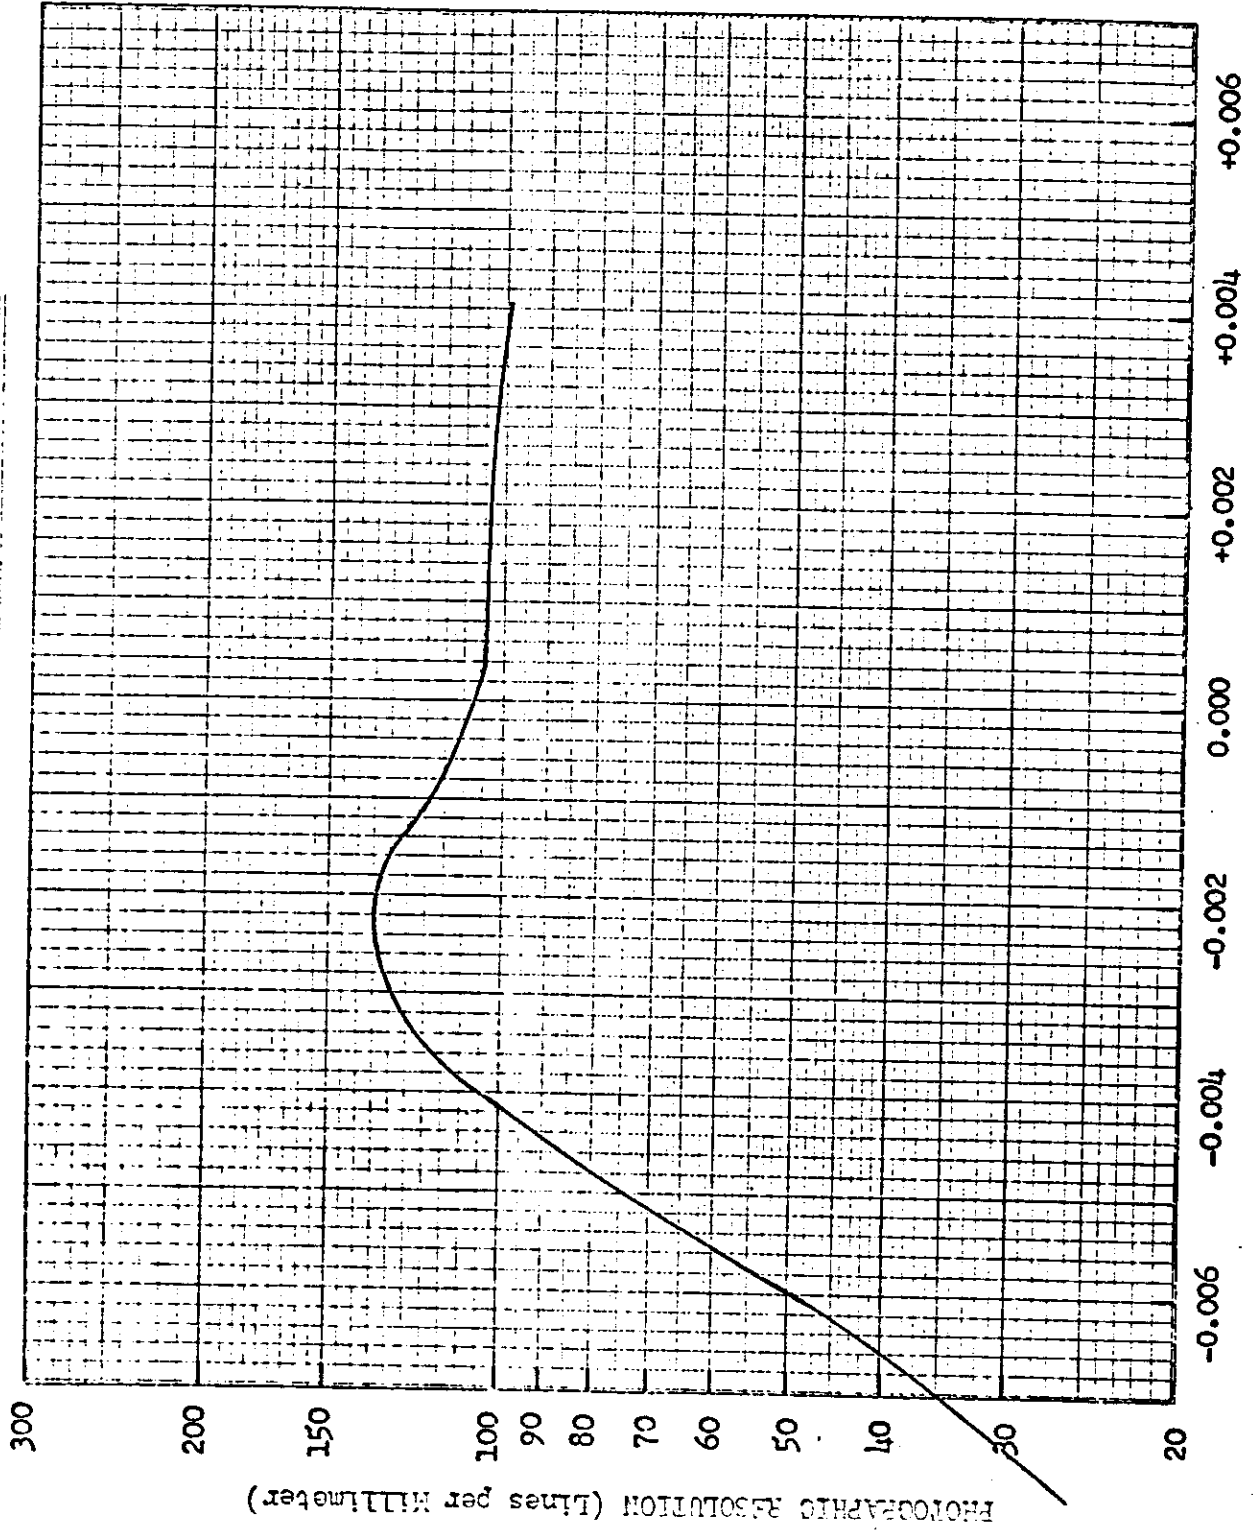
FIGURE 2-1

Master Pan Instrument No. 222

Maximum high contrast resolution 174 lines/mm at -0.002 focal position.

Maximum low contrast resolution 123 lines/mm at -0.002 focal position.

The final low contrast test data for both instruments is shown in Figures 2-1 and 2-2. Both instruments met the system requirements specification.

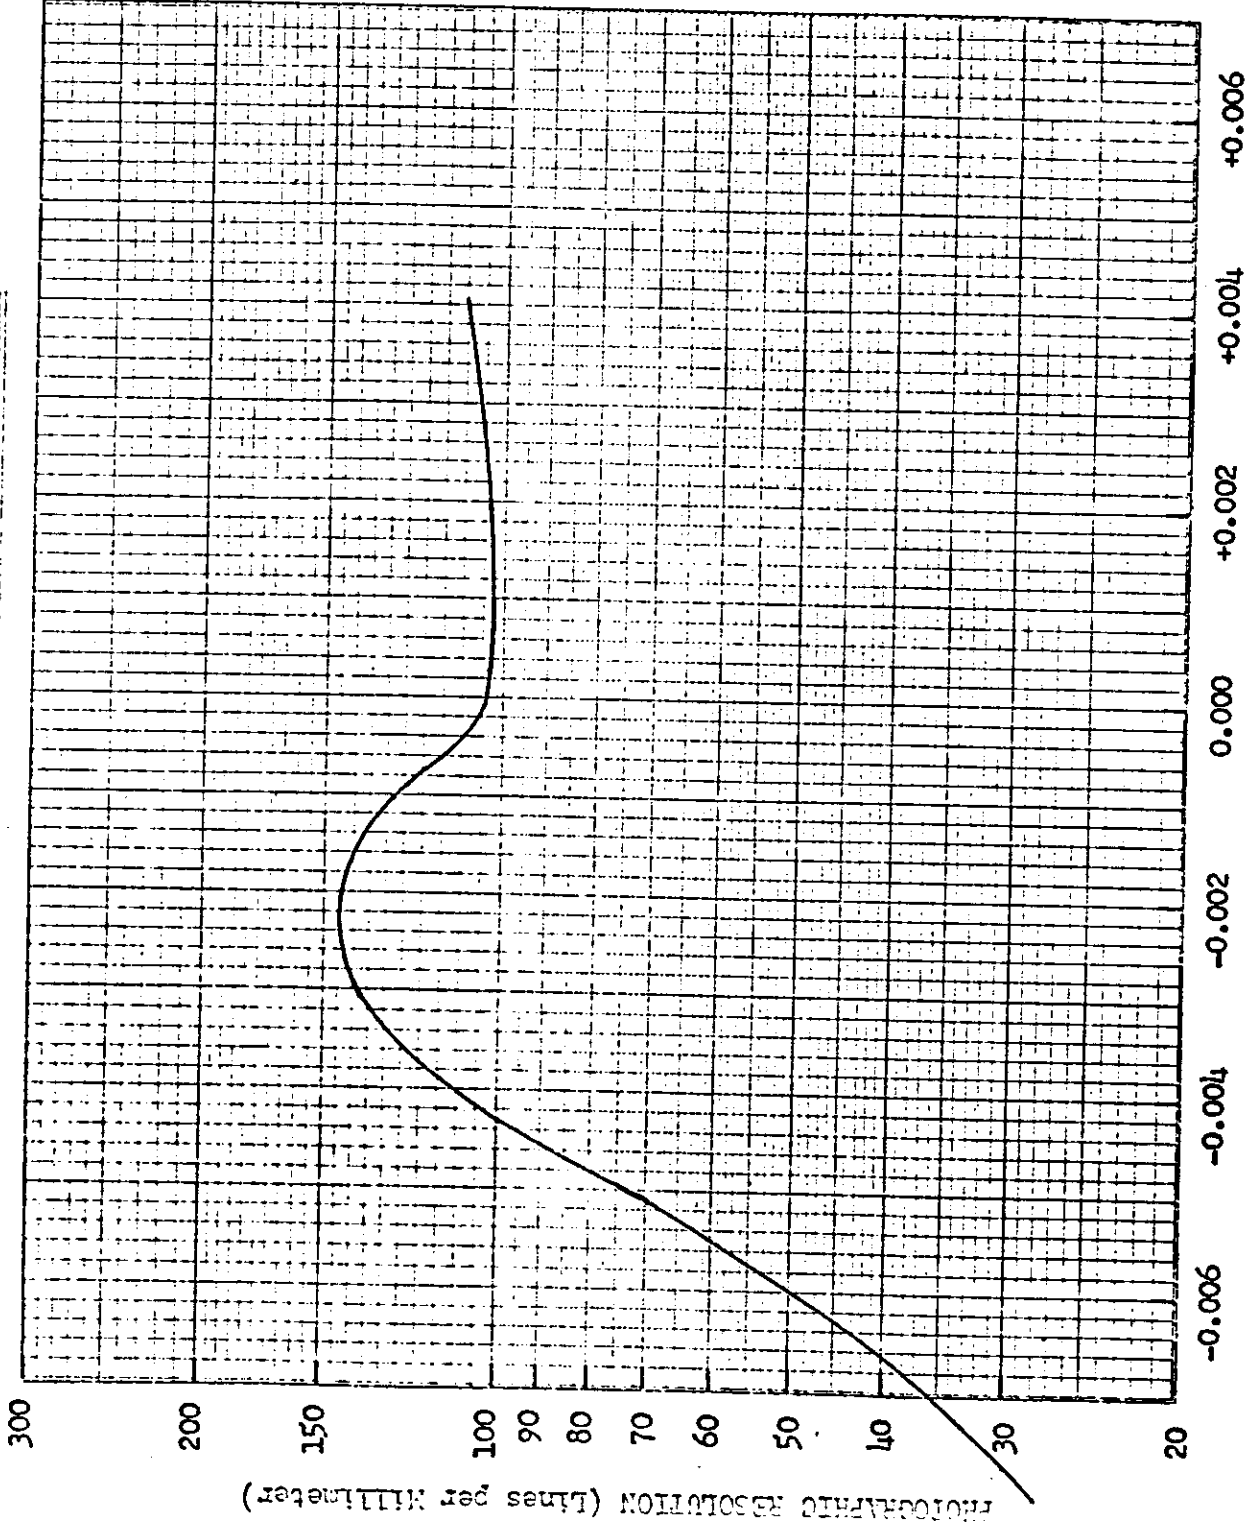
FIGURE 2-2

Slave Instrument No. 223

Maximum high contrast resolution 187 lines/mm at -0.003 focal position.

Maximum low contrast resolution 131 lines/mm at -0.002 focal position.
