CORONA J

PERFORMANCE EVALUATION REPORT

MISSION 1048-1 and 1048-2

FTV 1647, J-49

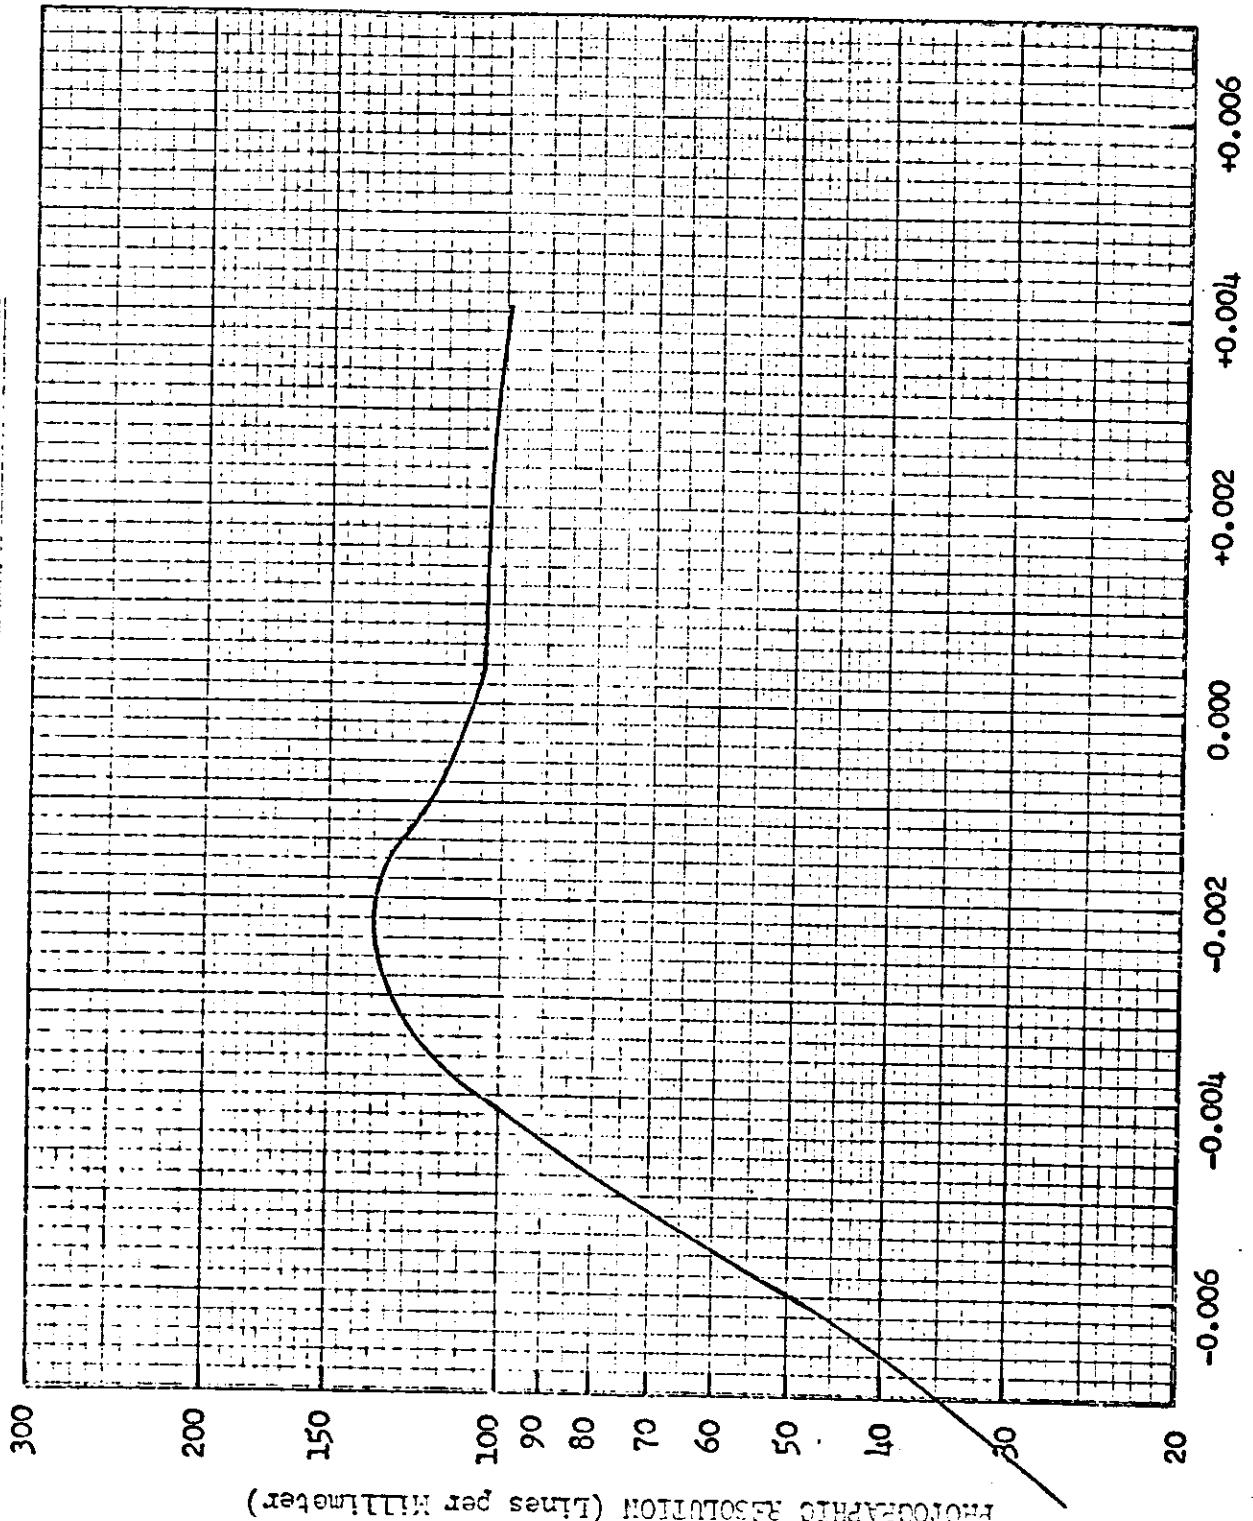
FIGURE 2-1

PRE-FLIGHT DYNAMIC RESOLUTION

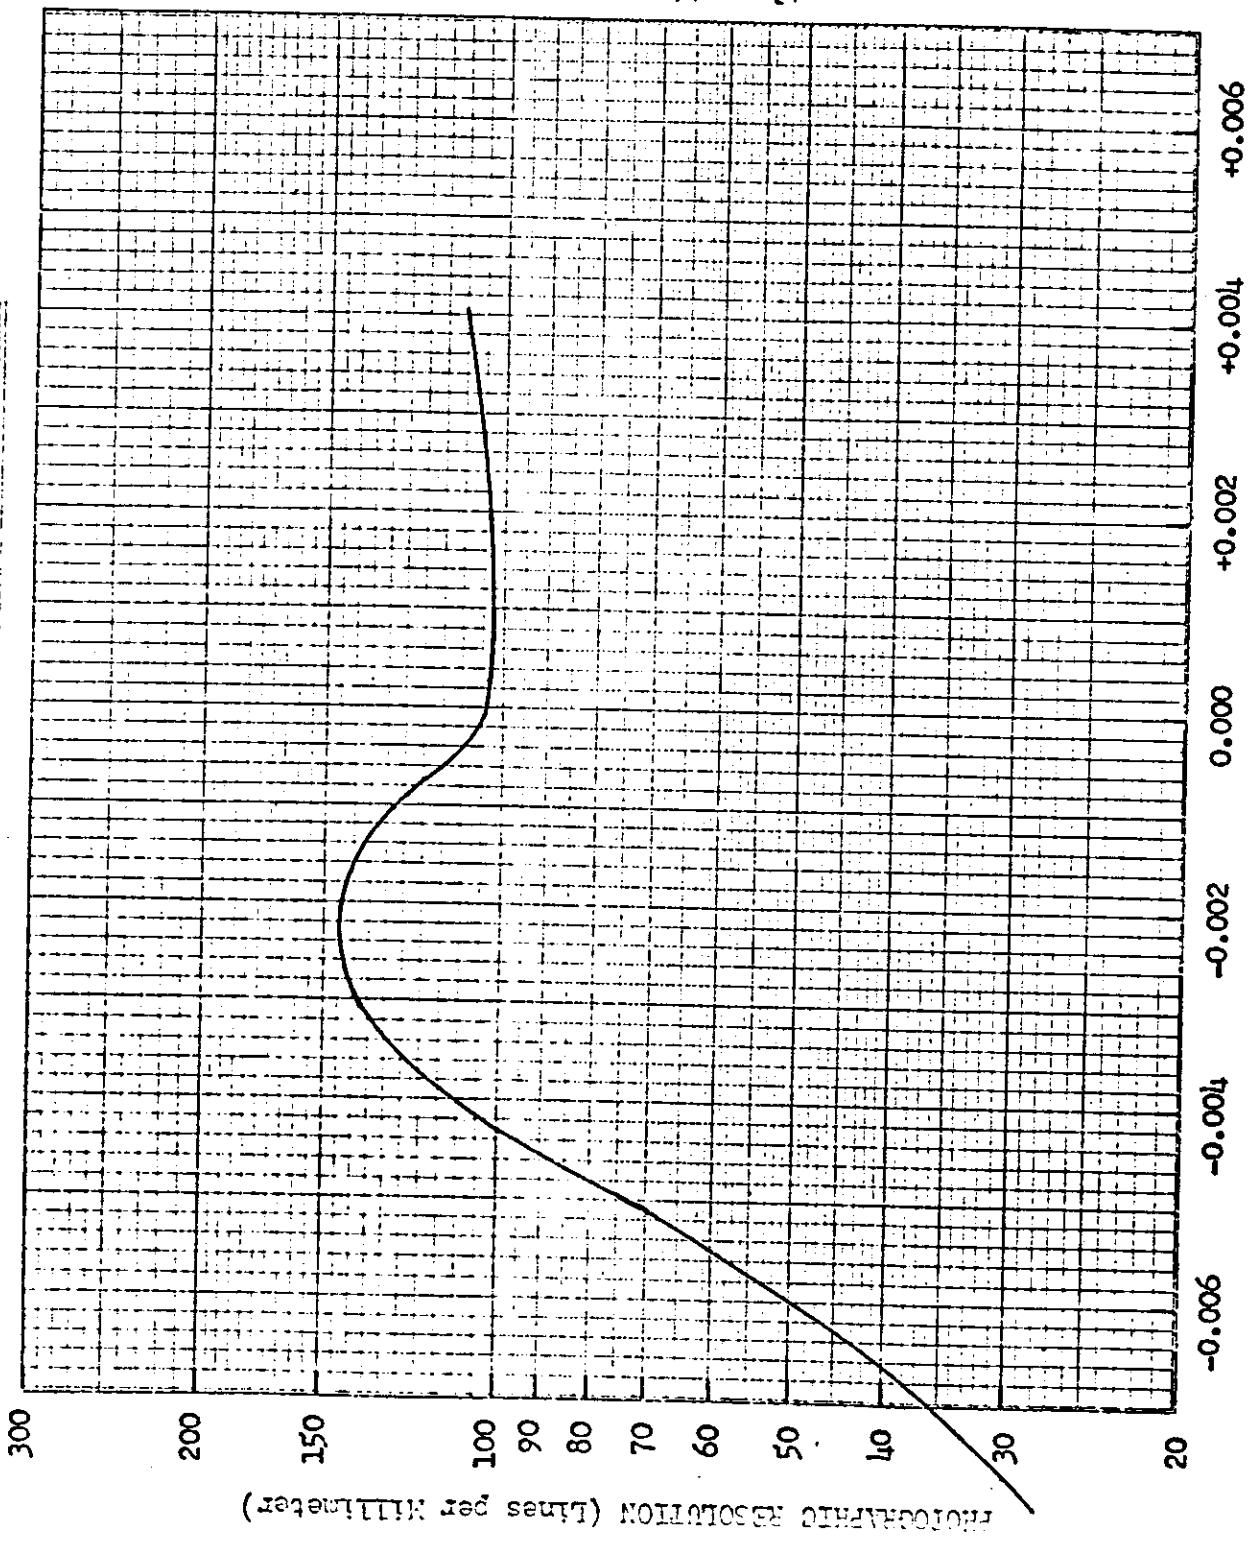
FIGURE 2-2

PRE-FLIGHT DYNAMIC RESOLUTION

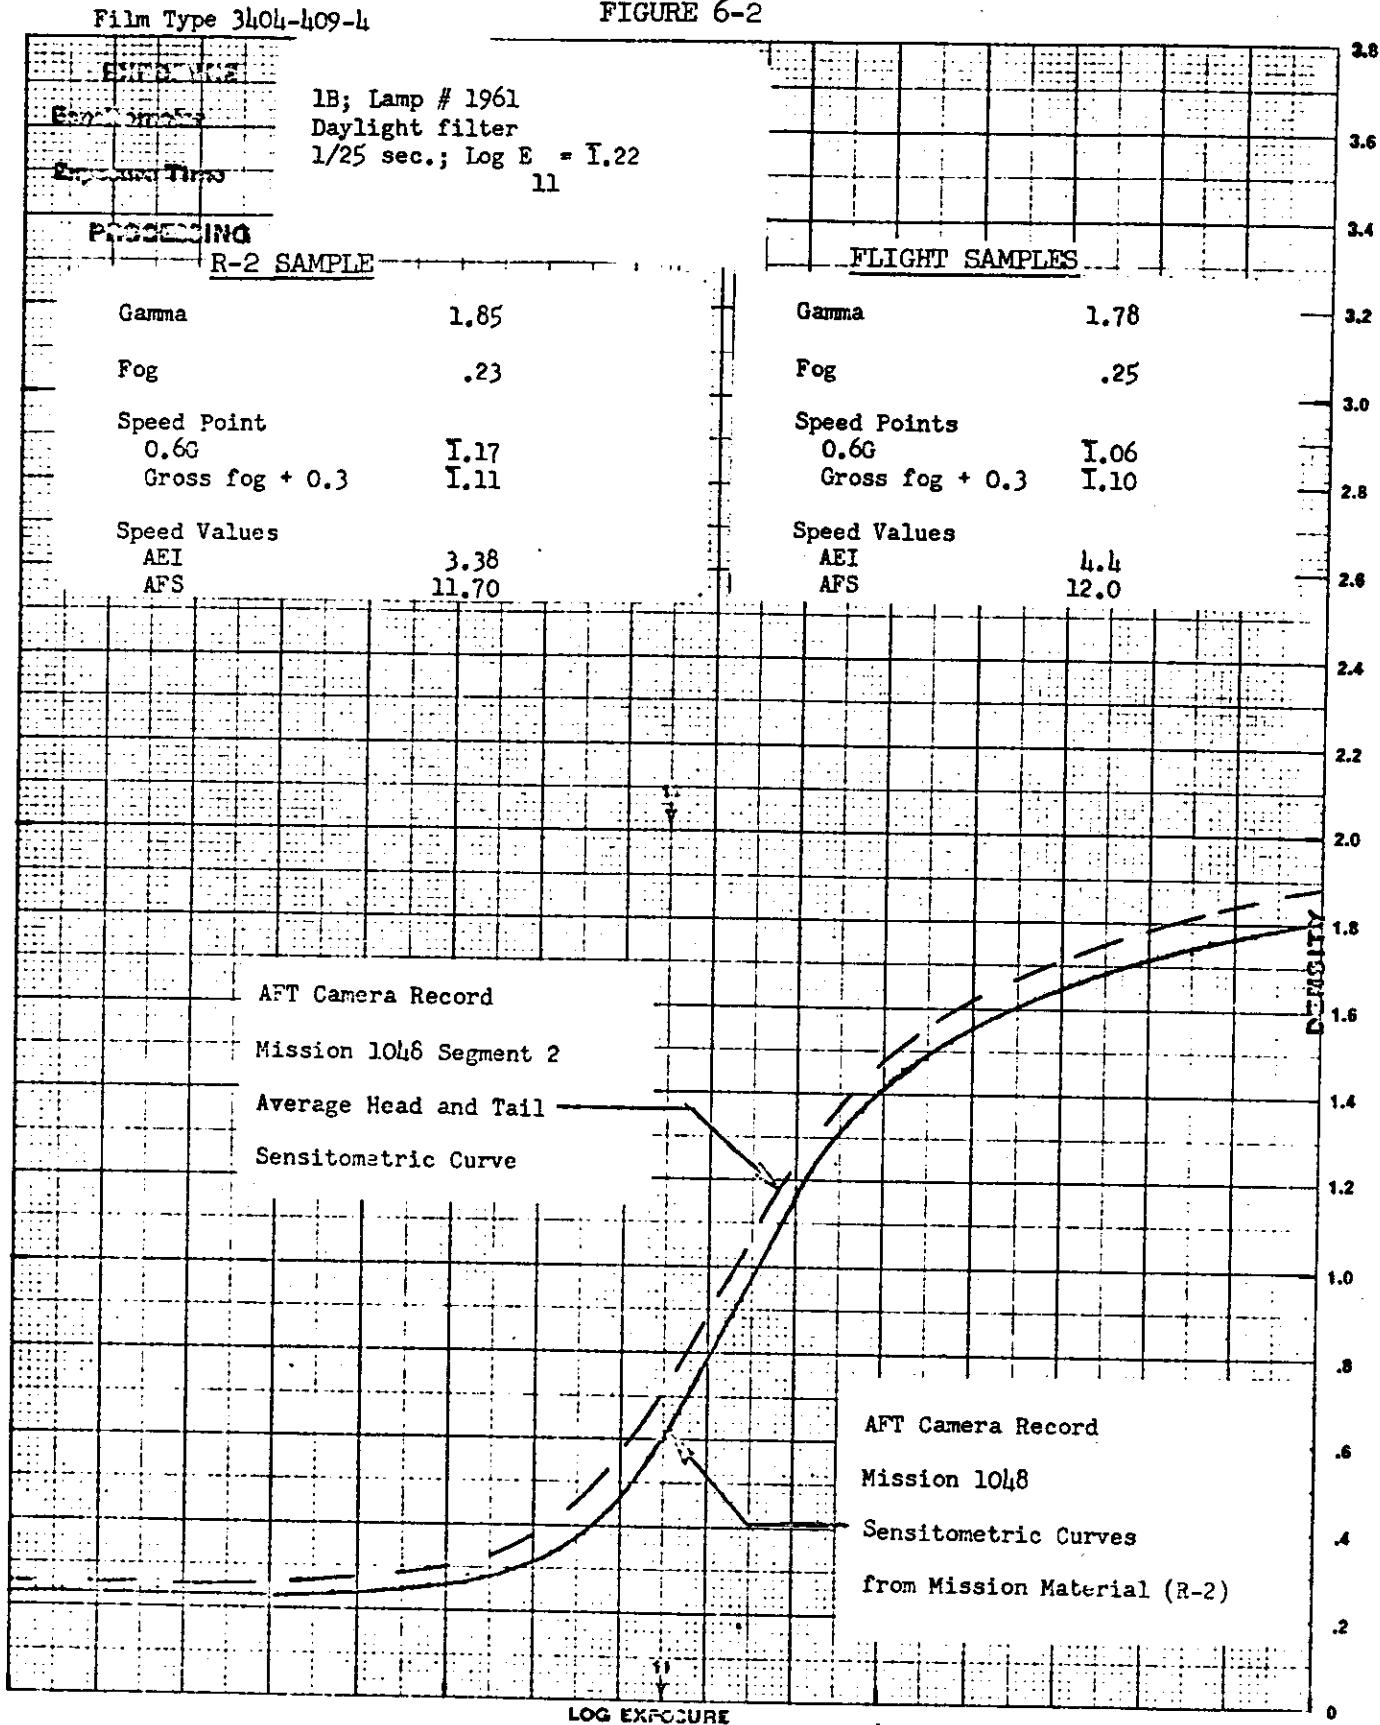
FIGURE 6-2

The curves illustrated in Figure 6-2 describe an apparent disparity in the dual-gamma process first noted on Mission 1104. Comparison of these curves
