CORONA J
PERFORMANCE EVALUATION REPORT
MISSION 1107-1 and 1107-2
FTV 1652, CR-7

This document constitutes the final payload test and performance evaluation report for Mission 1107 which was launched on 24 July 1969.

This report presents the final performance evaluation of Corona Mission 1107. The purpose of the report is to define the performance characteristics of the CR-7 payload system and to evaluate the technical aspects of the Mission, including analysis of in-flight anomalies.

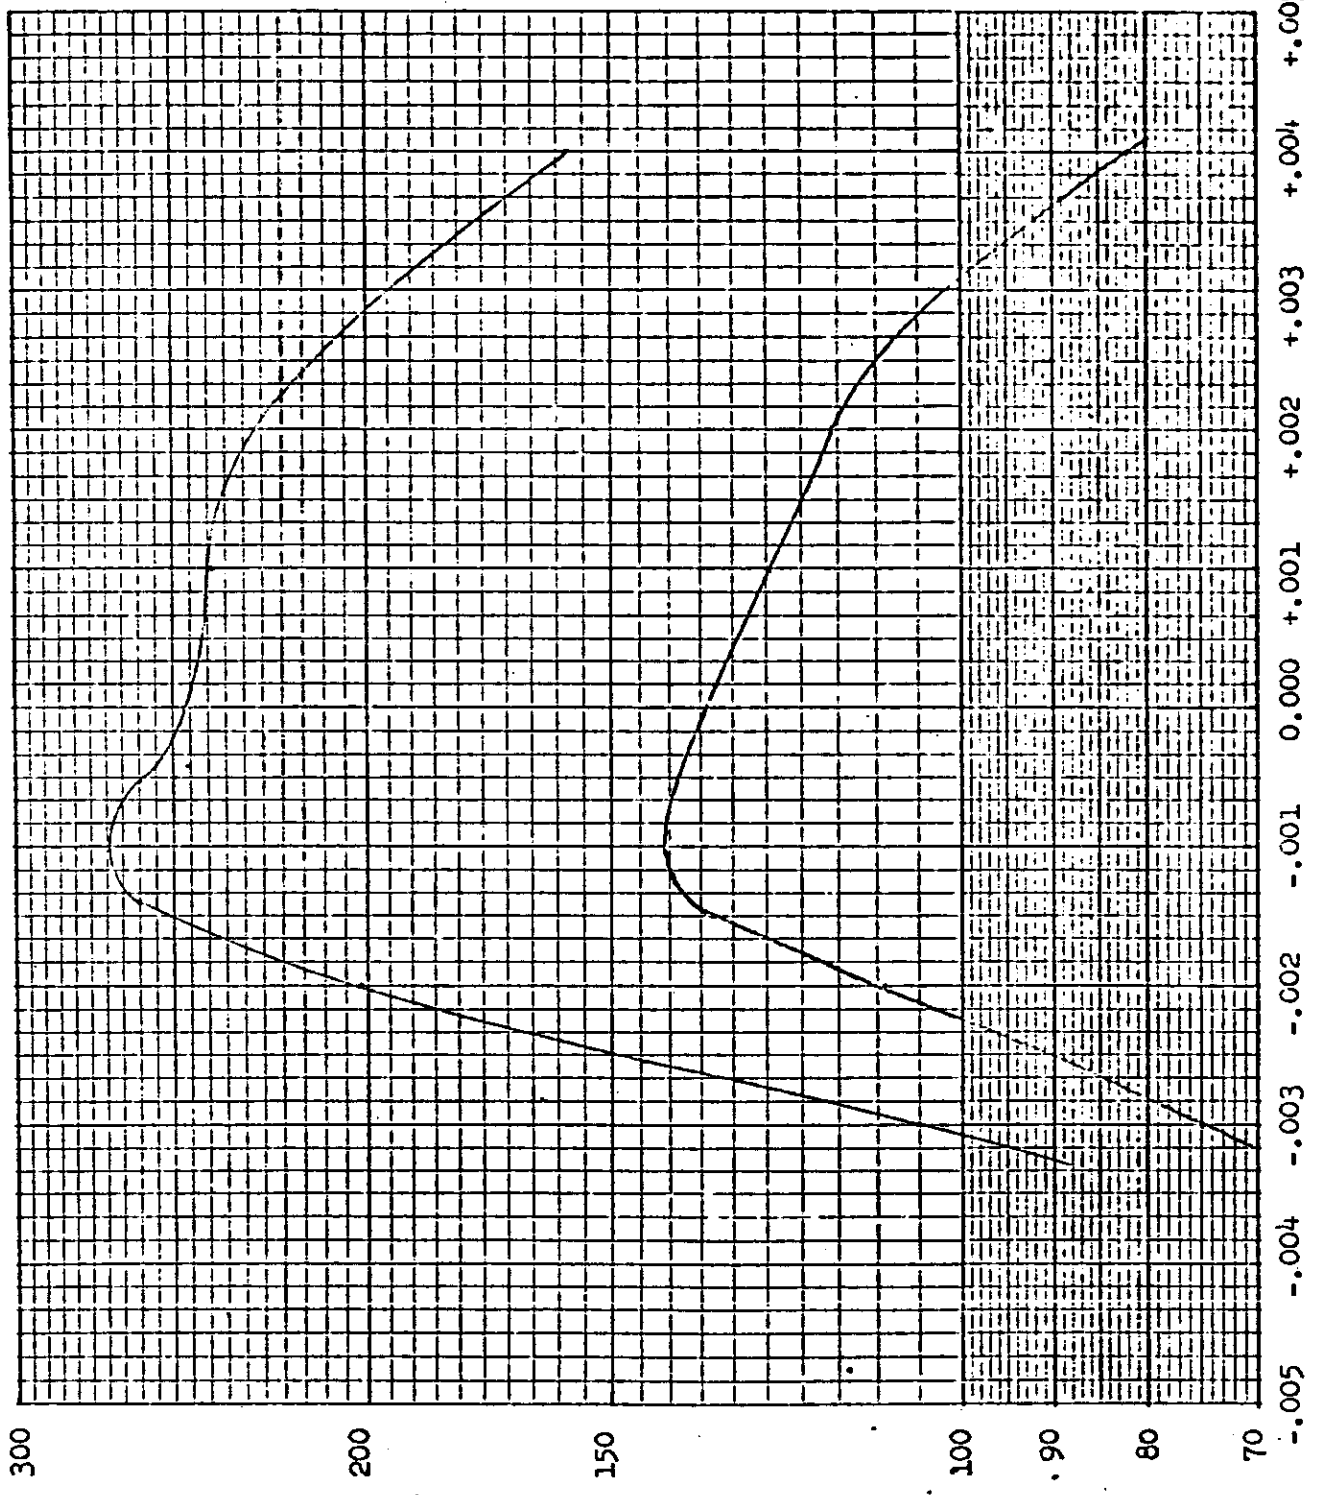
PRE-FLIGHT RESOLUTION, PAN CAMERA #314

A thru-focus dynamic resolution test of the CR-7 system was performed on 30 April 1969. This was after the second environmental test but before the third one. The maximum low contrast resolution of camera #314, using a Wratten 21 filter, was 145 lines per millimeter at the -0.001 inch focal position. The maximum low contrast resolution of camera #315, using a Wratten 25 filter, was 220 lines per millimeter at the zero focal position. It is noted that the camera

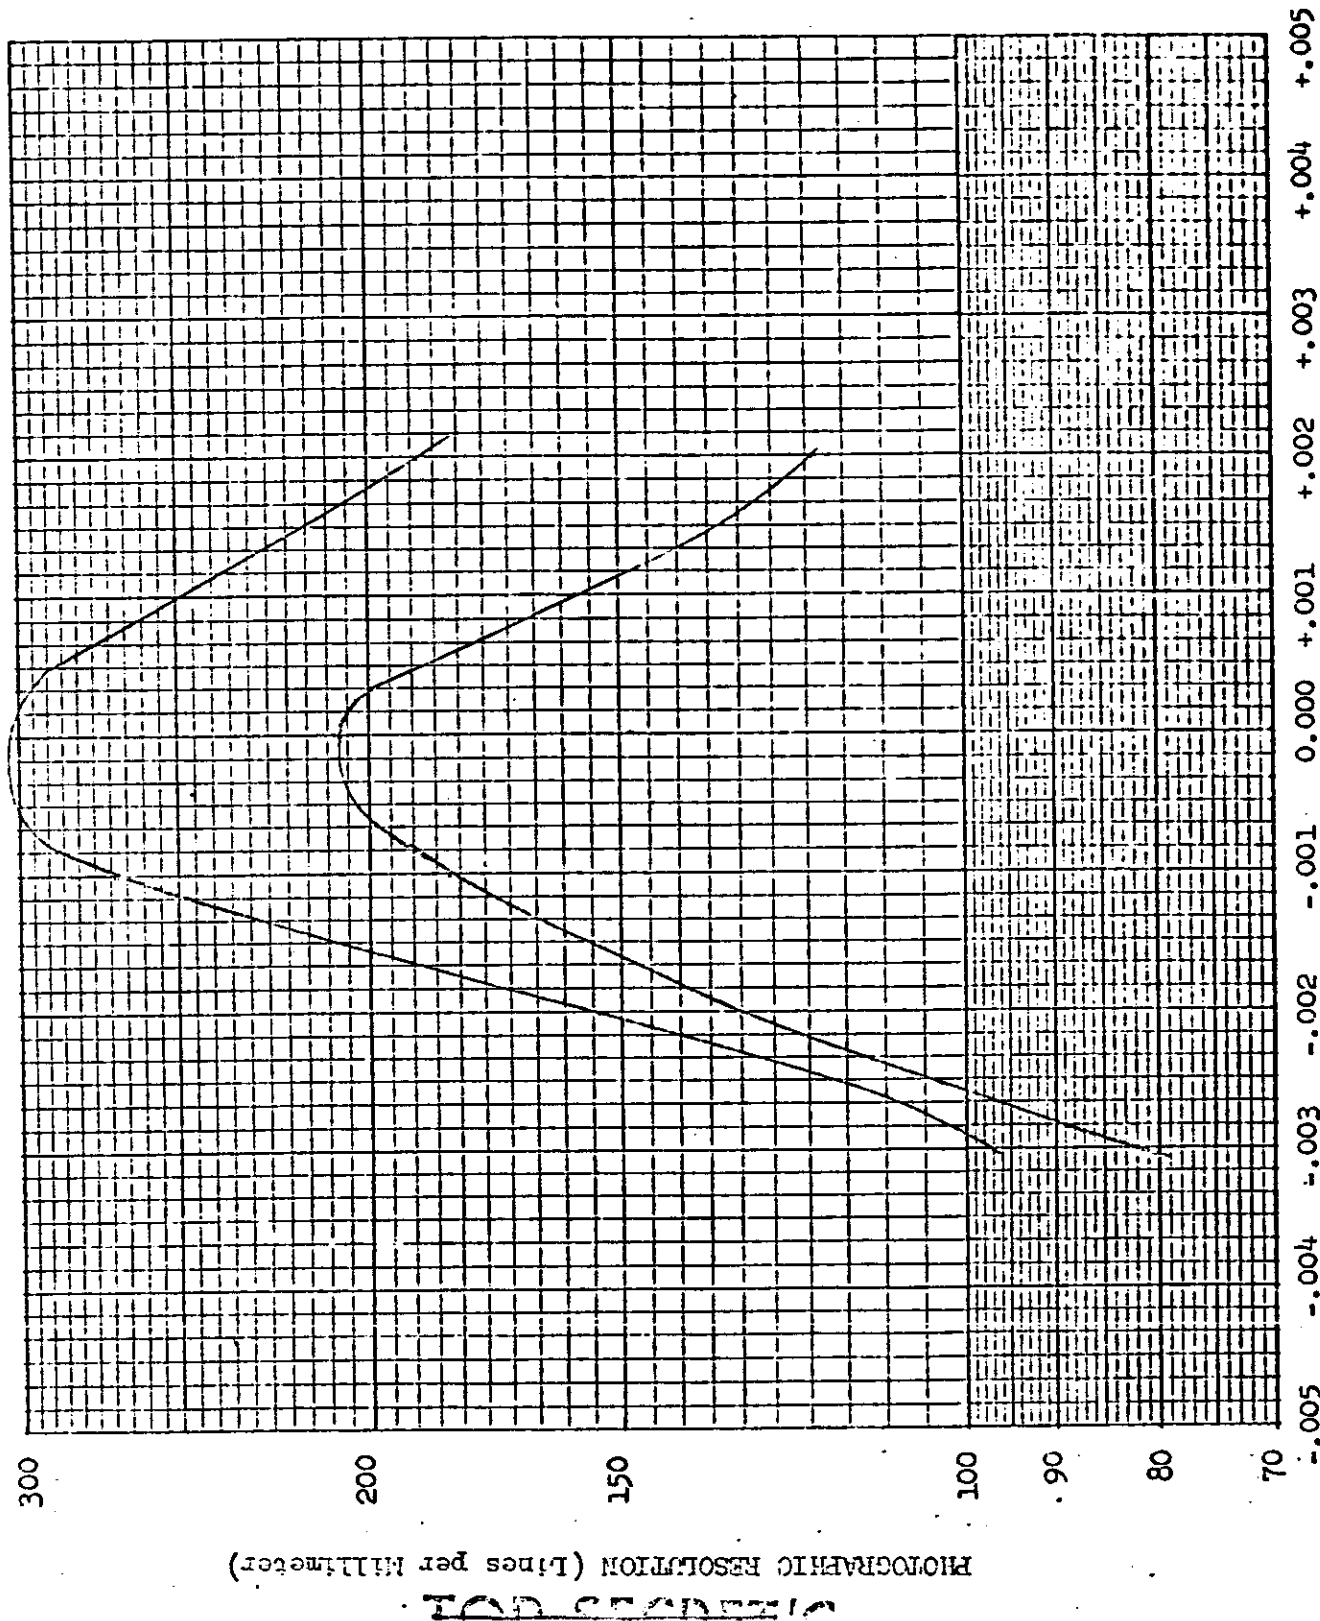
FIGURE 2-2

After the second environmental test, there was concern that soft-appearing rail lamp images from camera #315 might be indicative of film movement or a non-flat condition. An AGT on camera #315, using 3404 film, was run on 28 May 1969. The results were evaluated separately by Boston and A/P personnel. The results

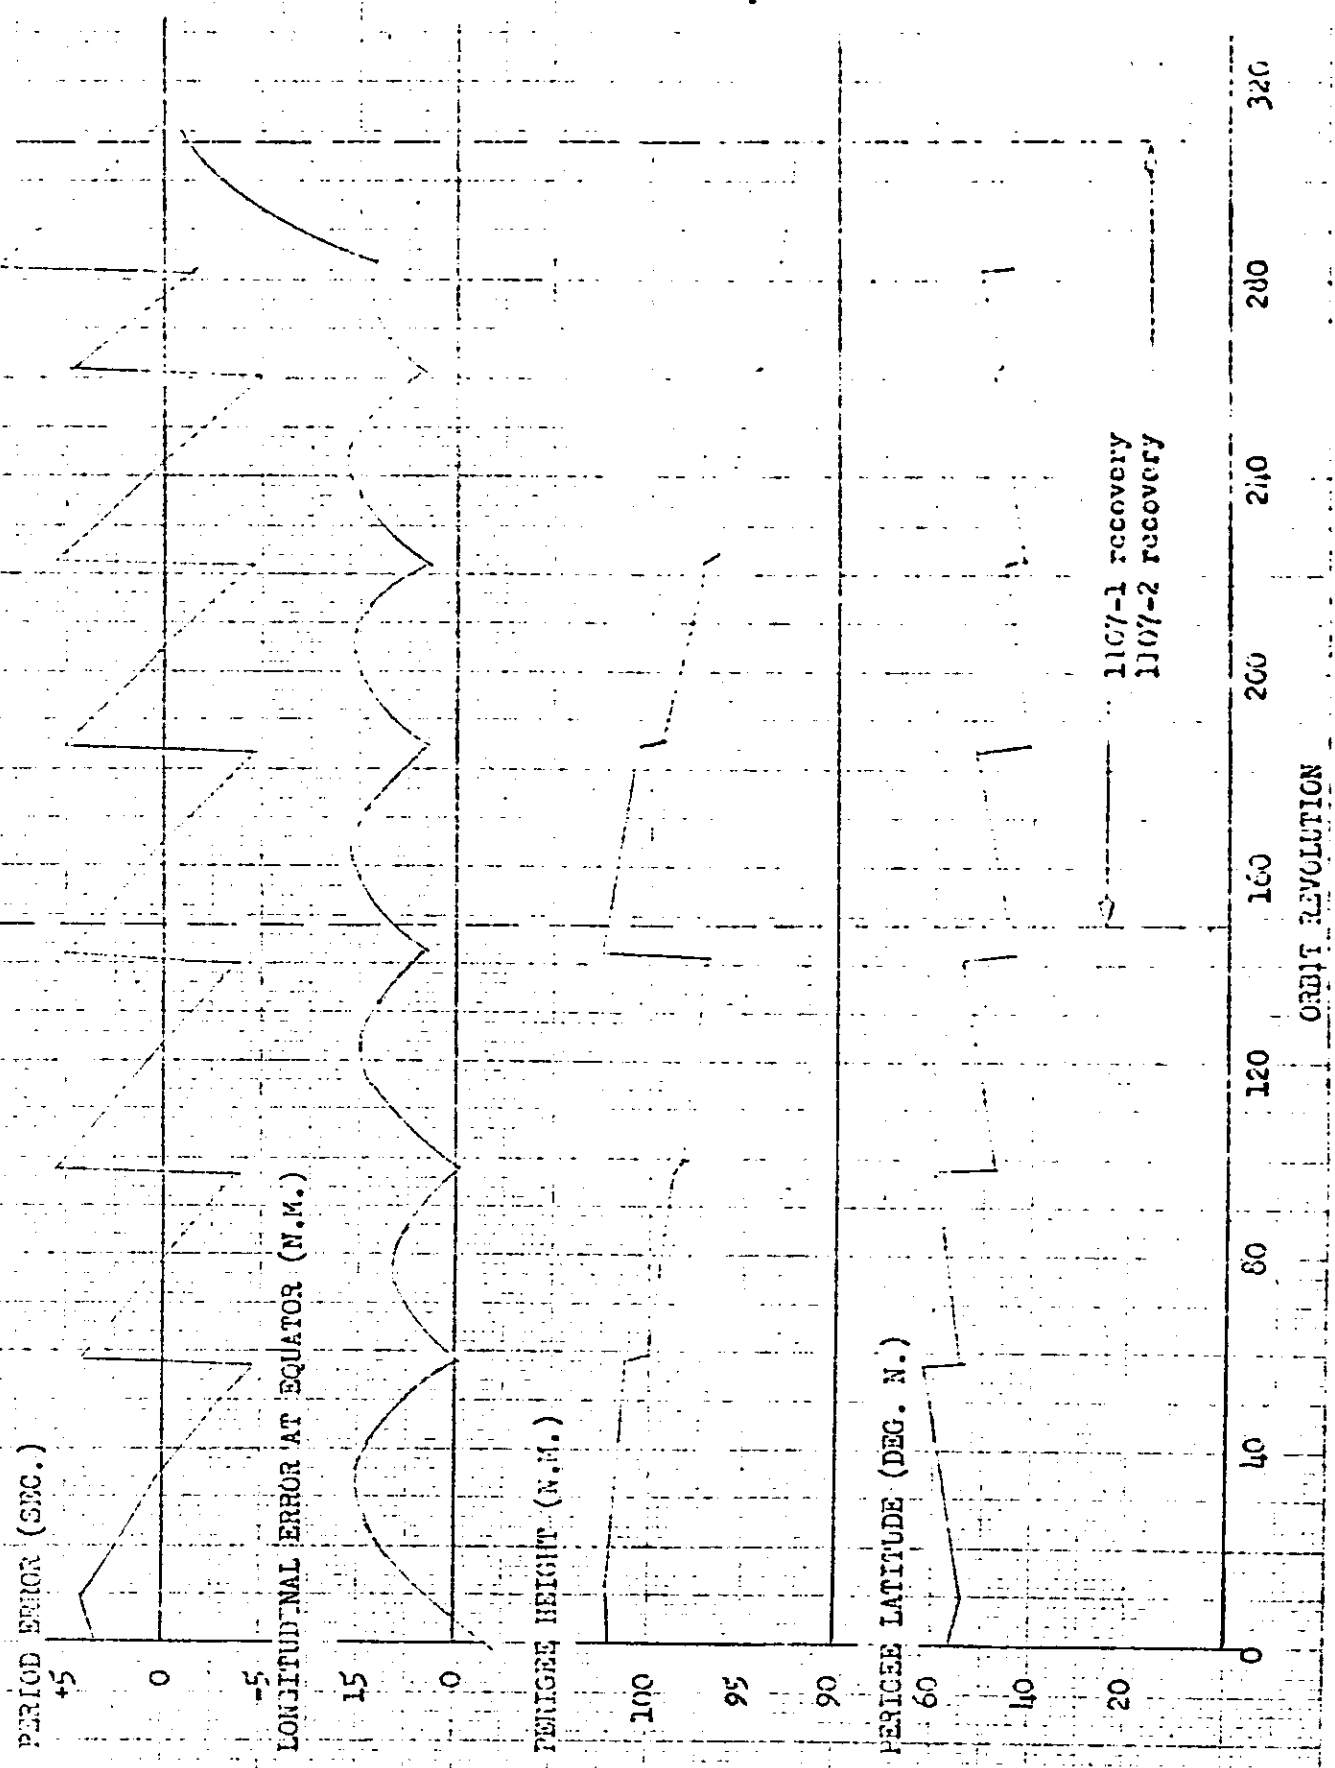
Figure 3-1 CR-7/1107 Orbit History

Ground track errors were approximately 5 nautical miles east to 17 nautical miles west of nominal at the equator. After the final firing on Rev. 279, the ground track error increased to 38 nautical miles west of

nominal at Rev. 299 where the last operation was taken. Figure 3-1 shows the orbit history maintained throughout the mission. A summary of the DMU firings is shown in Table 3-2. Figure 3-2 shows the frequency distribution of operations and mean frame altitude of Mission 1107.

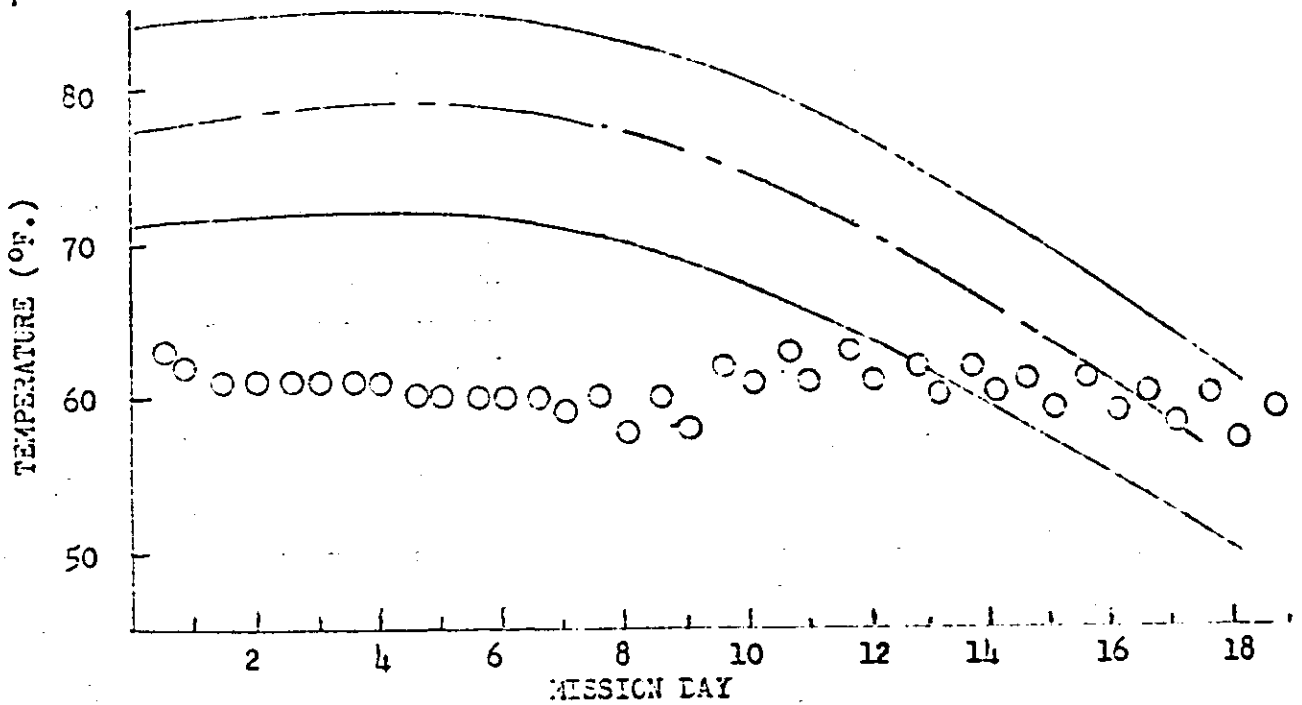
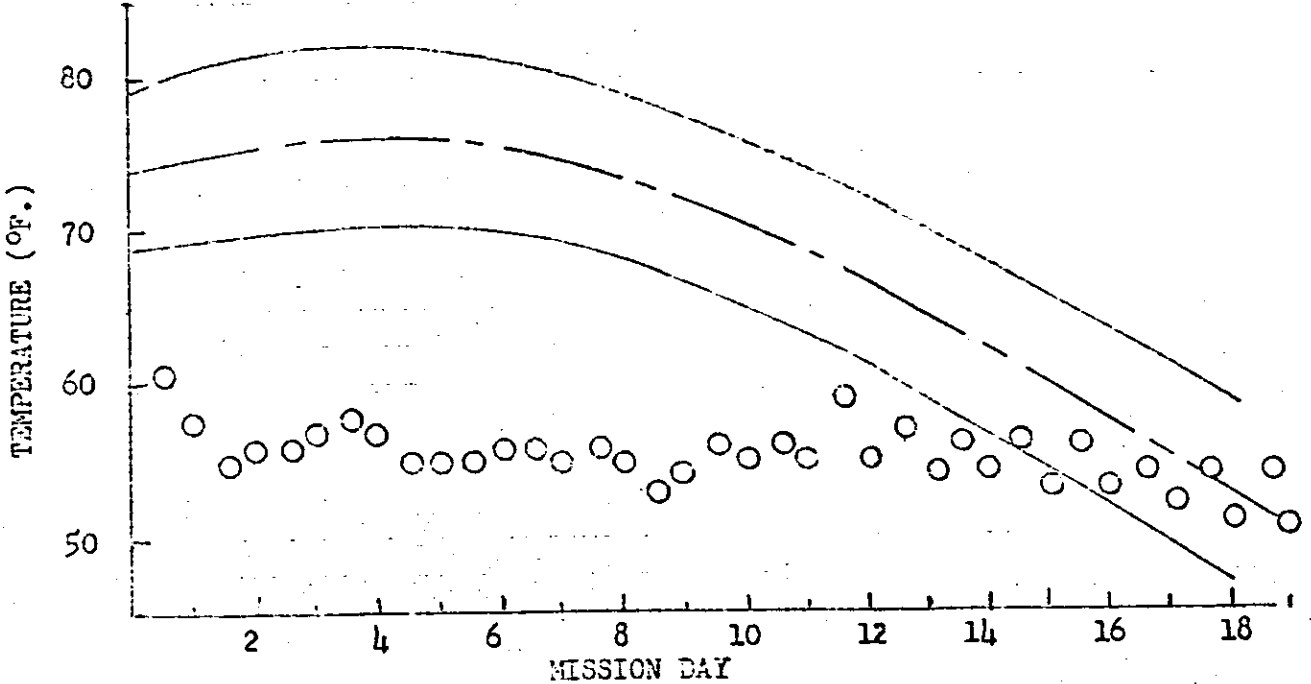
FIGURE 3-5 Panoramic camera temperatures. The dashed and solid lines indicate predicted temperatures and tolerances respectively. The circles are averages of recorded instrument temperatures.

Although average pan camera temperatures were stable throughout the missions, they did not conform to predictions. The forward-looking camera was colder than anticipated since it was not operating throughout the mission. Predicted average temperature ranges and observed average temperatures for both panoramic cameras are shown in Figure 3-5.
