CORONA J

PERFORMANCE EVALUATION REPORT

MISSION 1106-1 and 1106-2

FTV 1630, CR-6

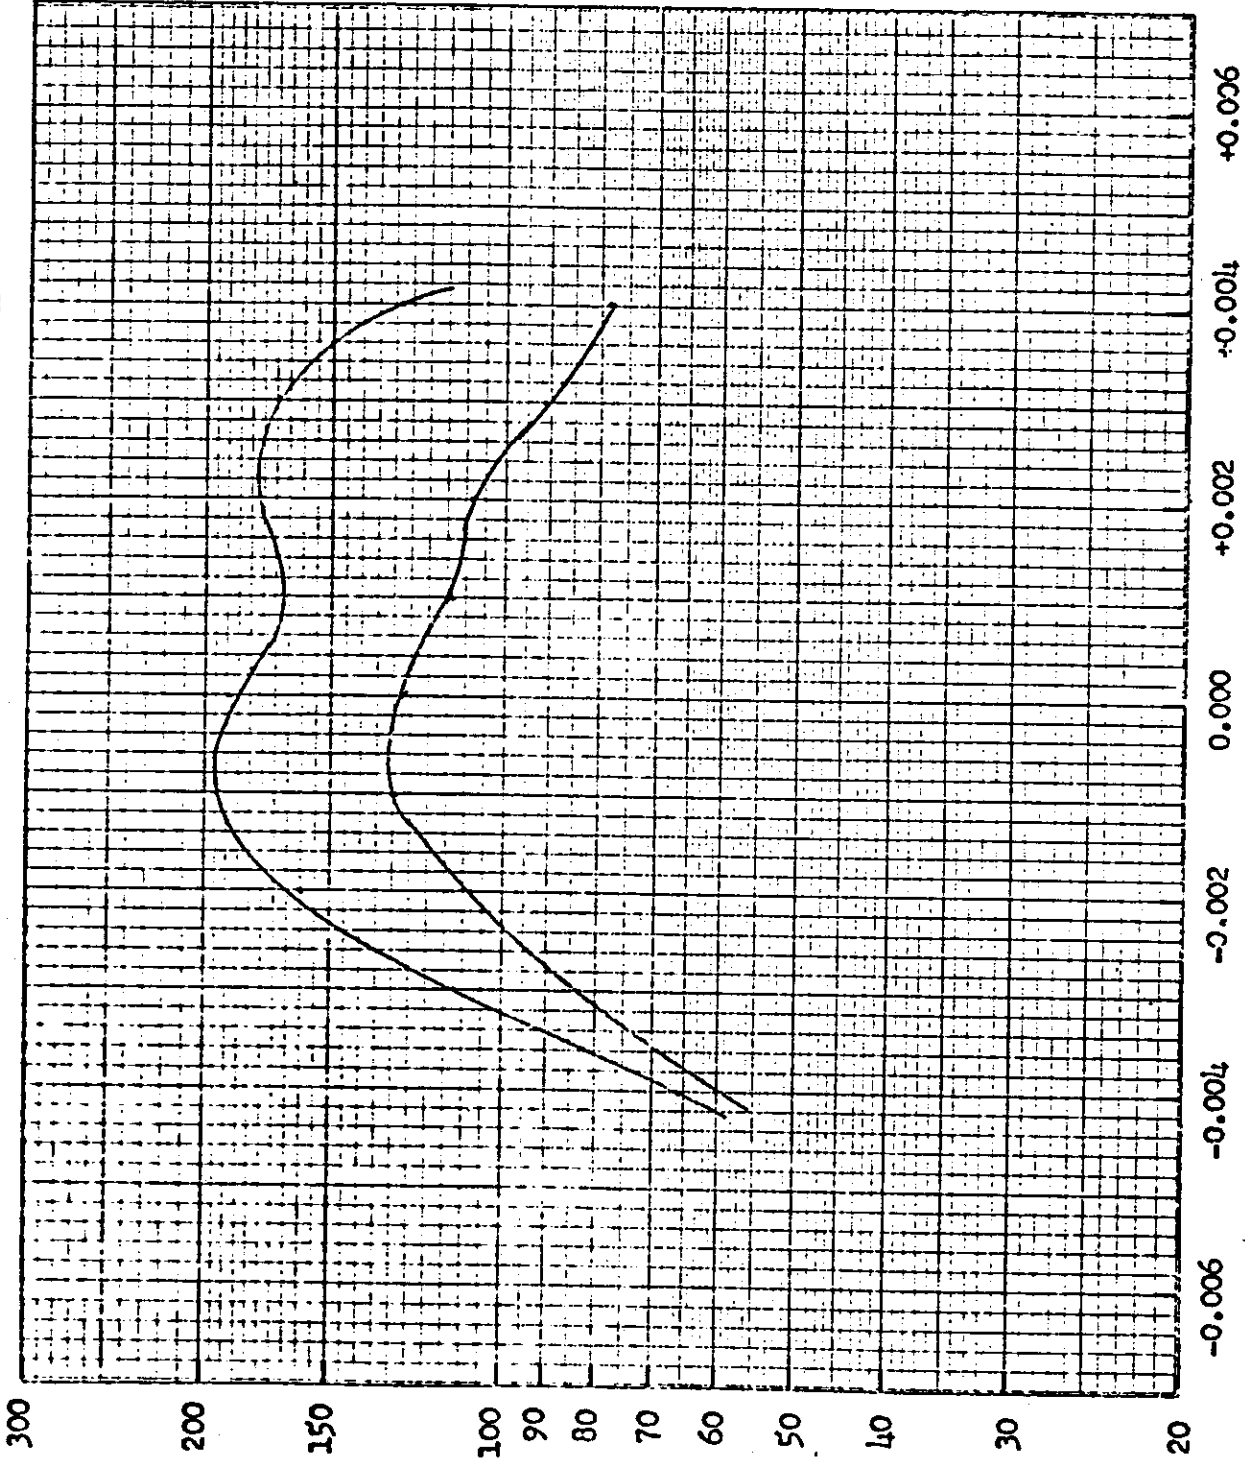
FIGURE 2-1

Initial resolution and theodolite tests were performed 4 January 1969. The resolution performance in the FMC direction indicated that there was degradation and excessive variation in target-to-target performance at each focus position. These quality degradations were induced by a target/camera IMC mismatch of approximately  $7\frac{1}{2}$  percent. The final resolution test verified that the IMC/scan performance disparity noted above had been corrected so that evaluation of system resolution performance was confidently performed.

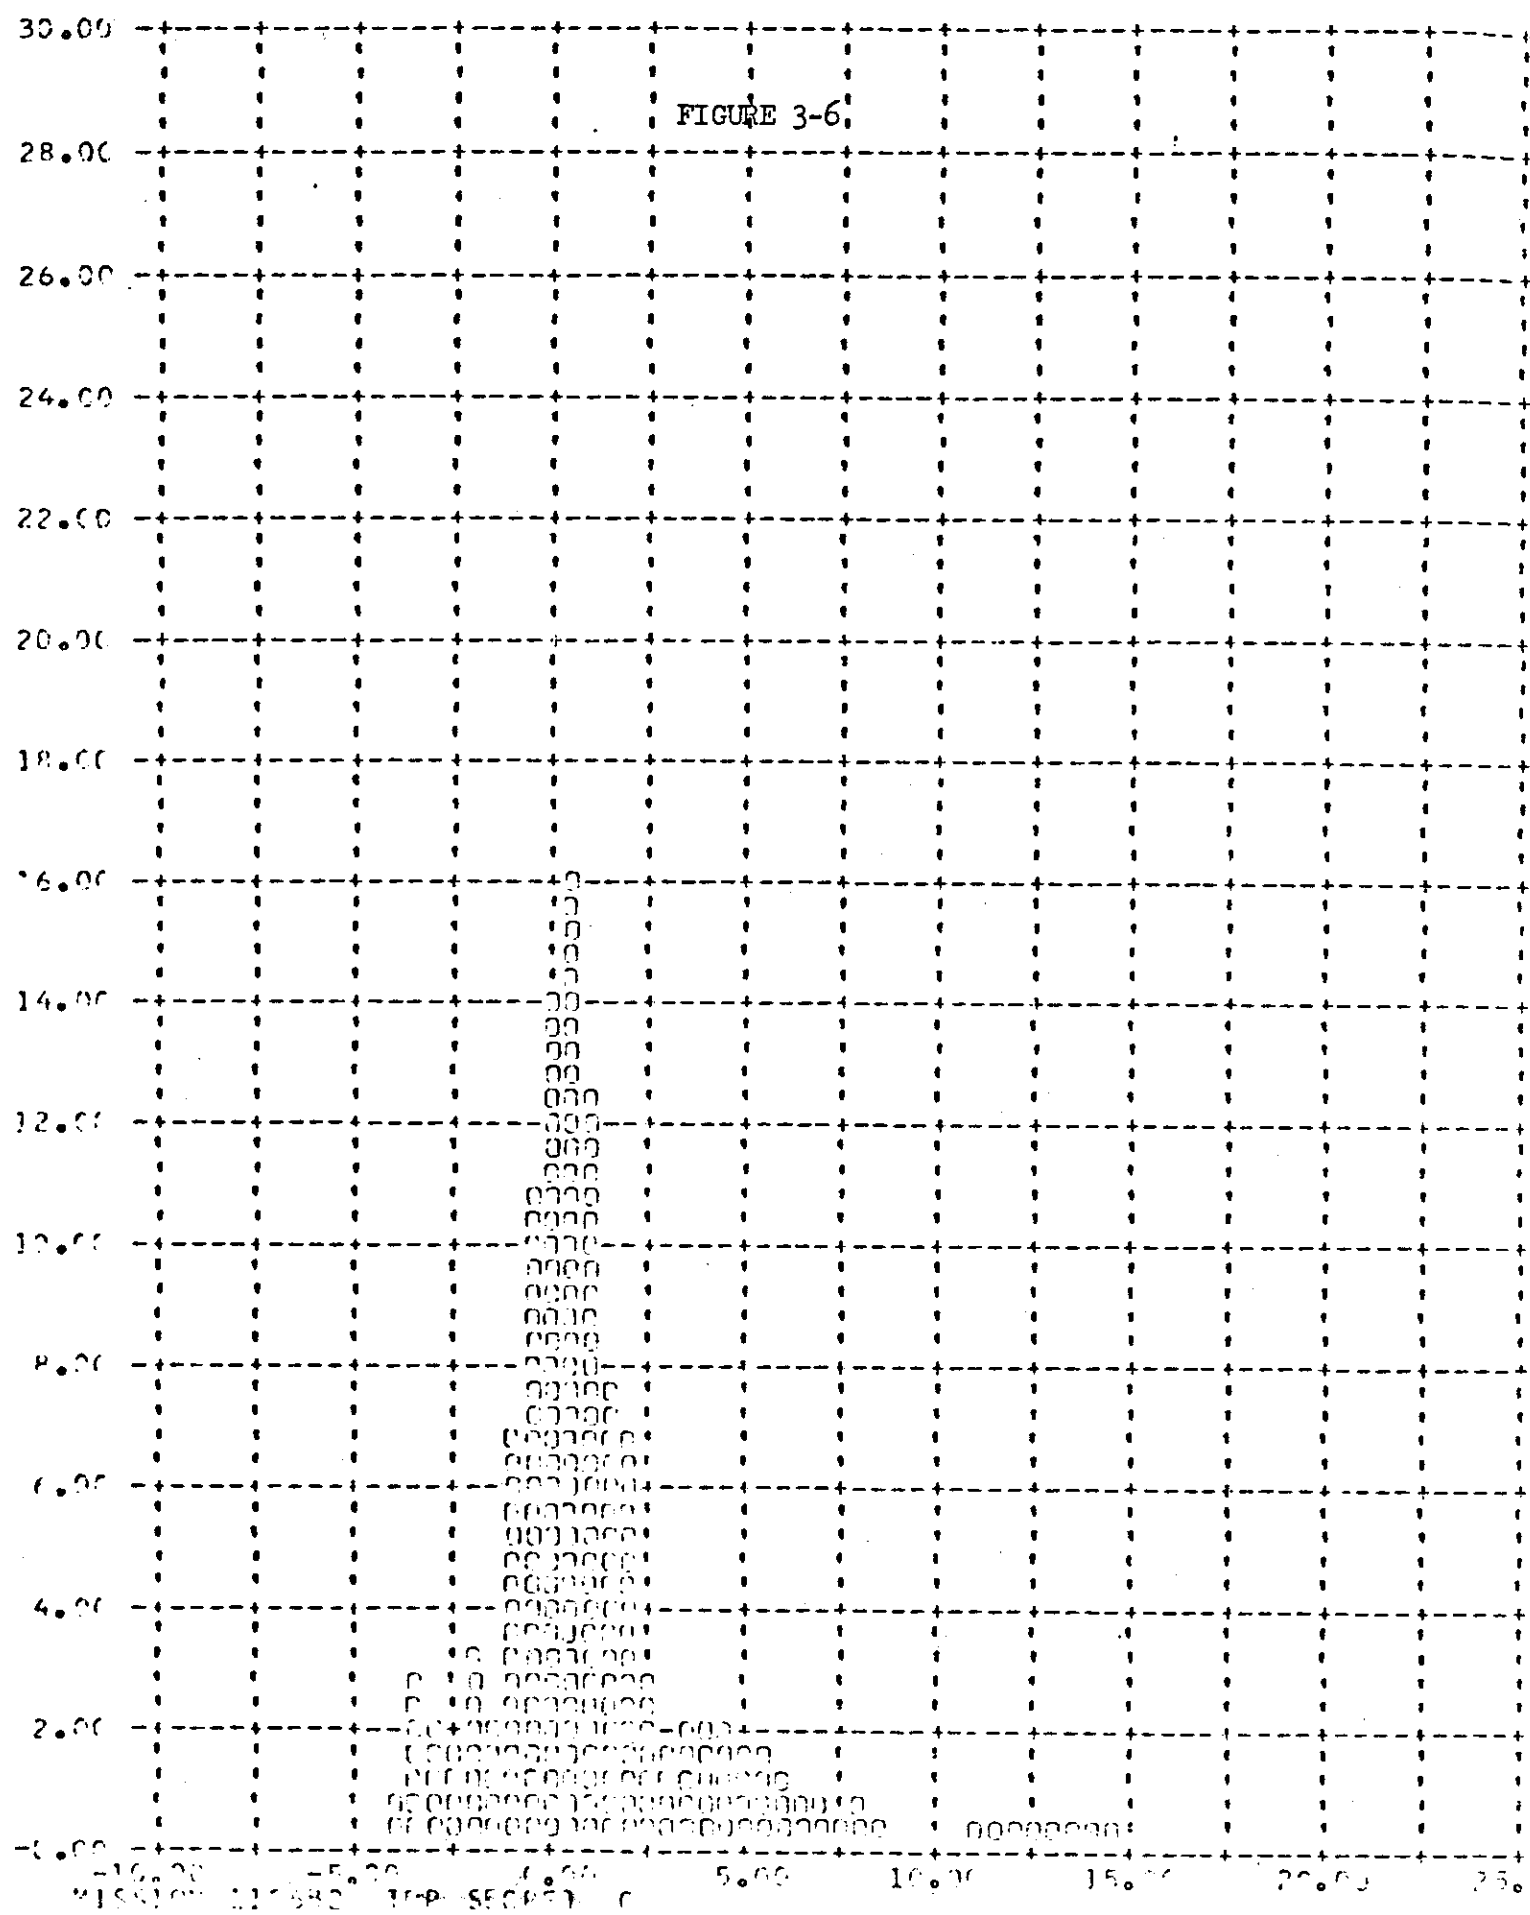
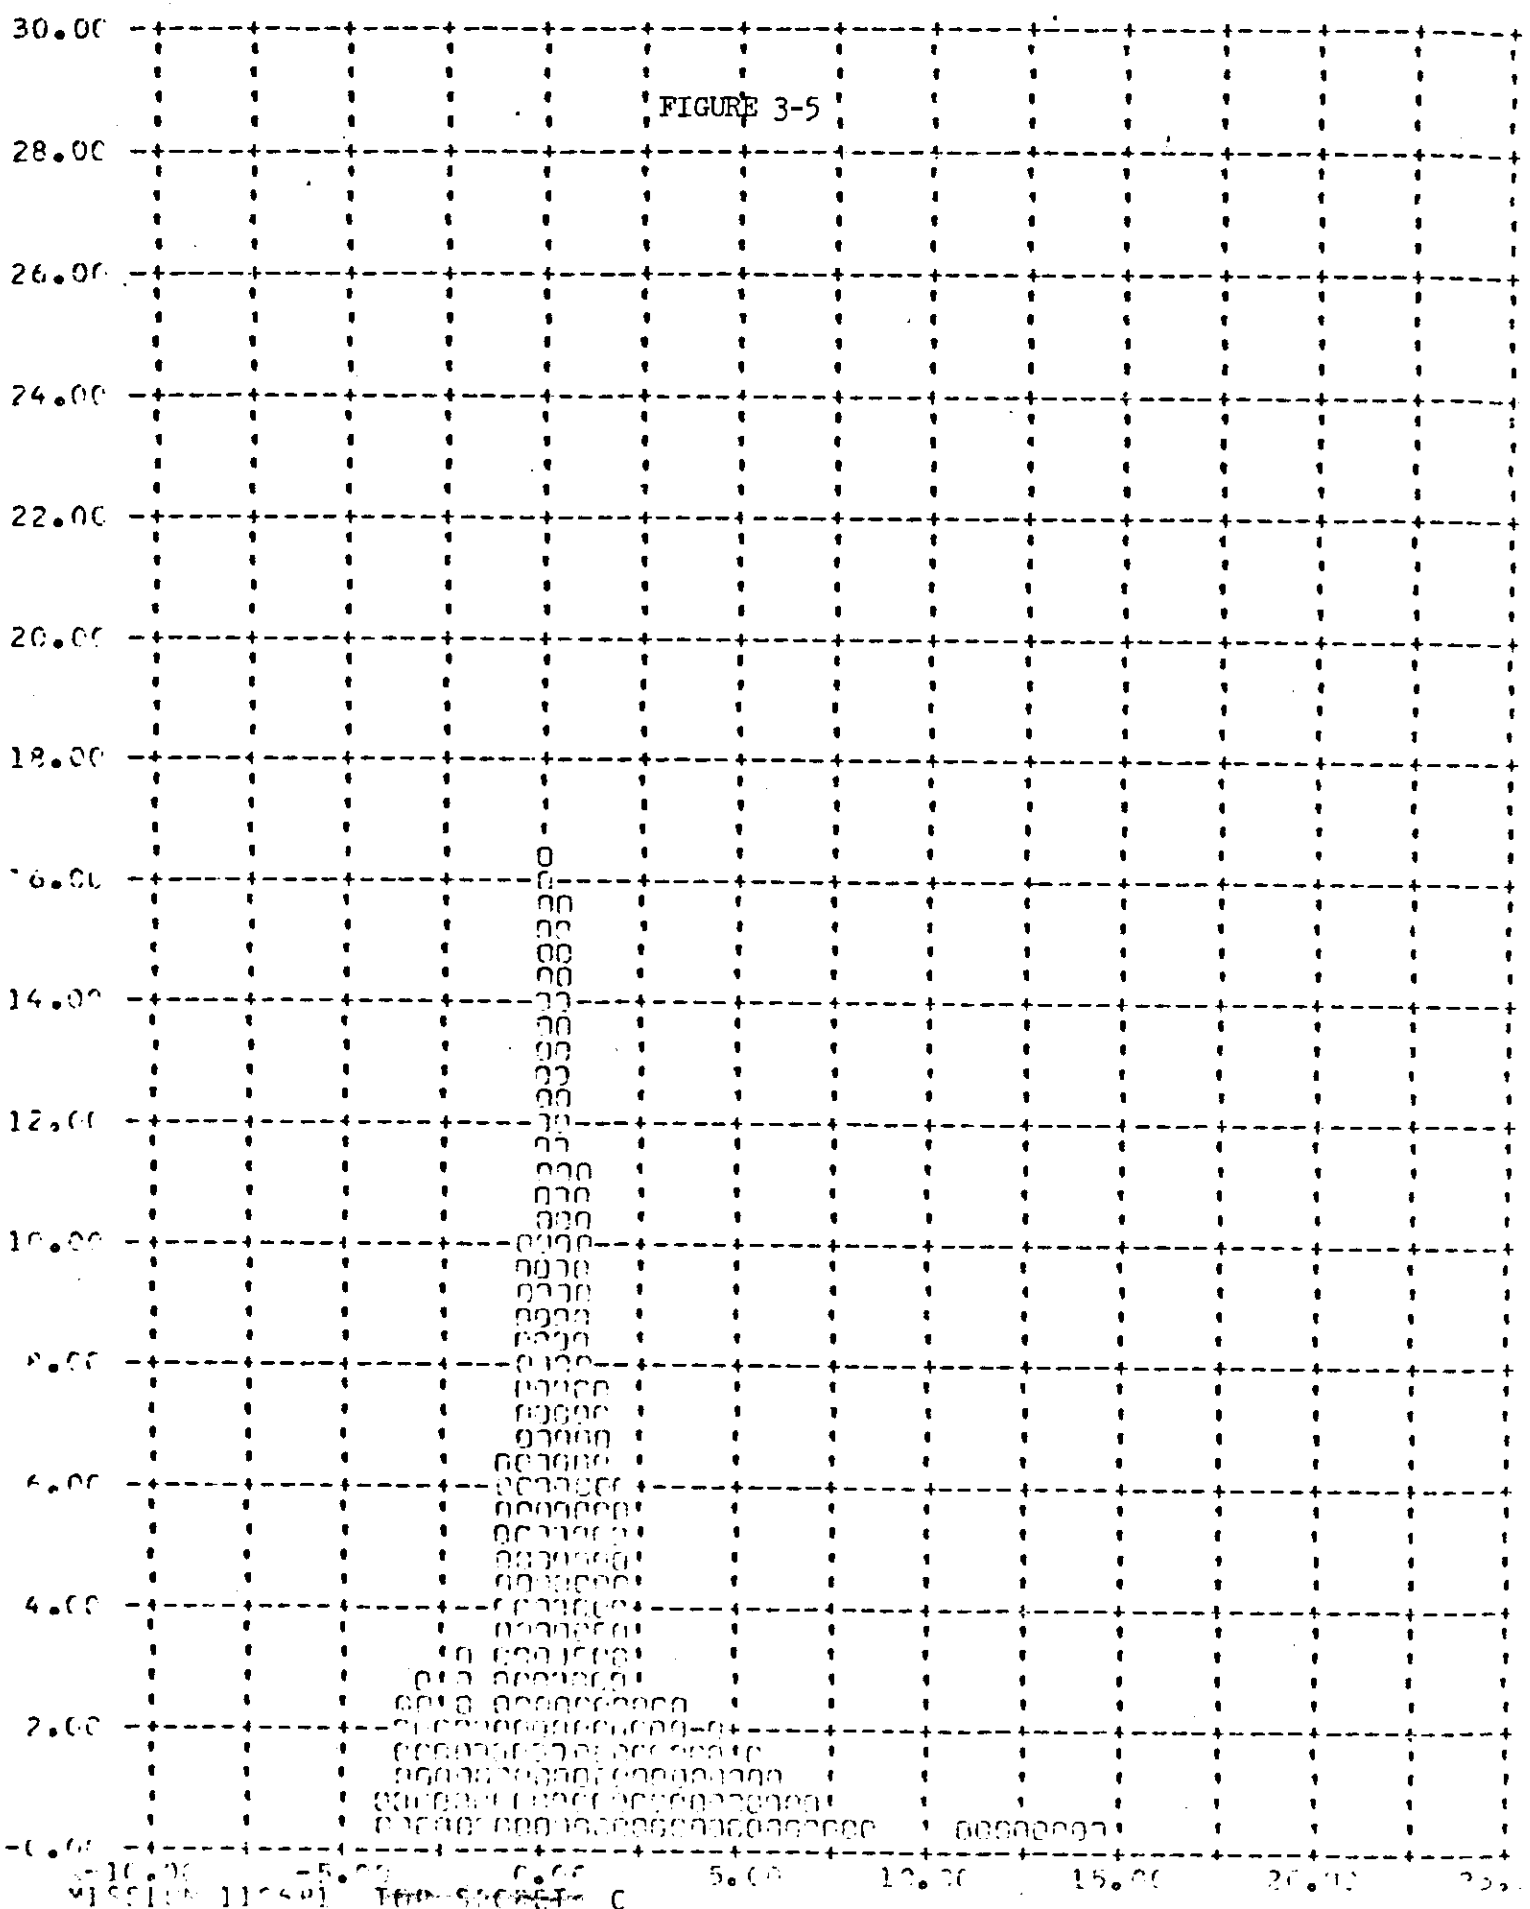
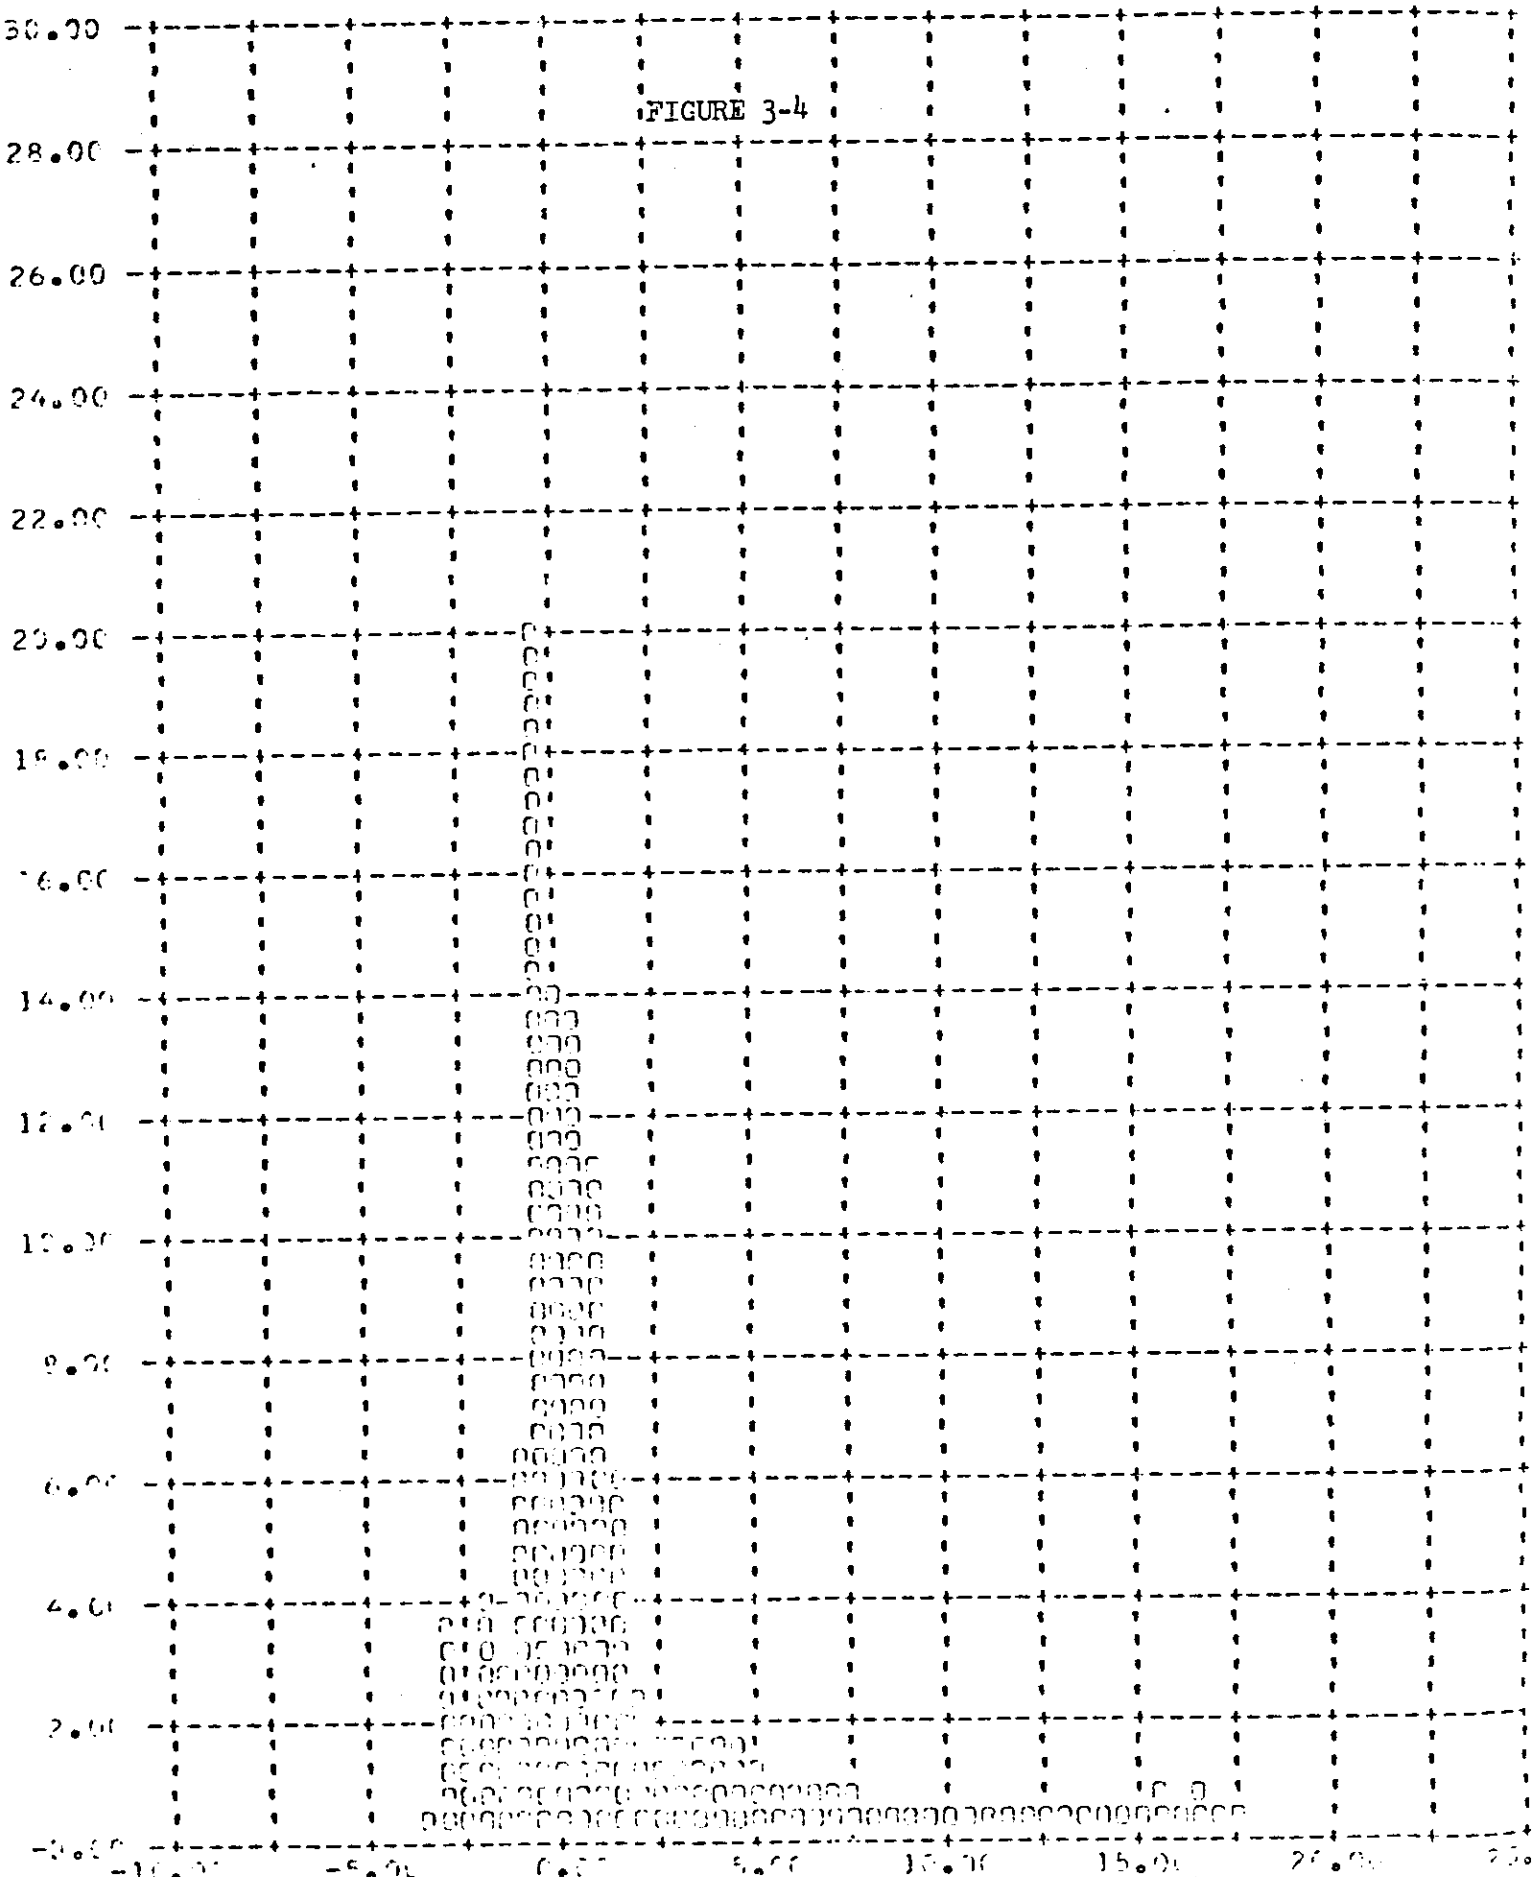
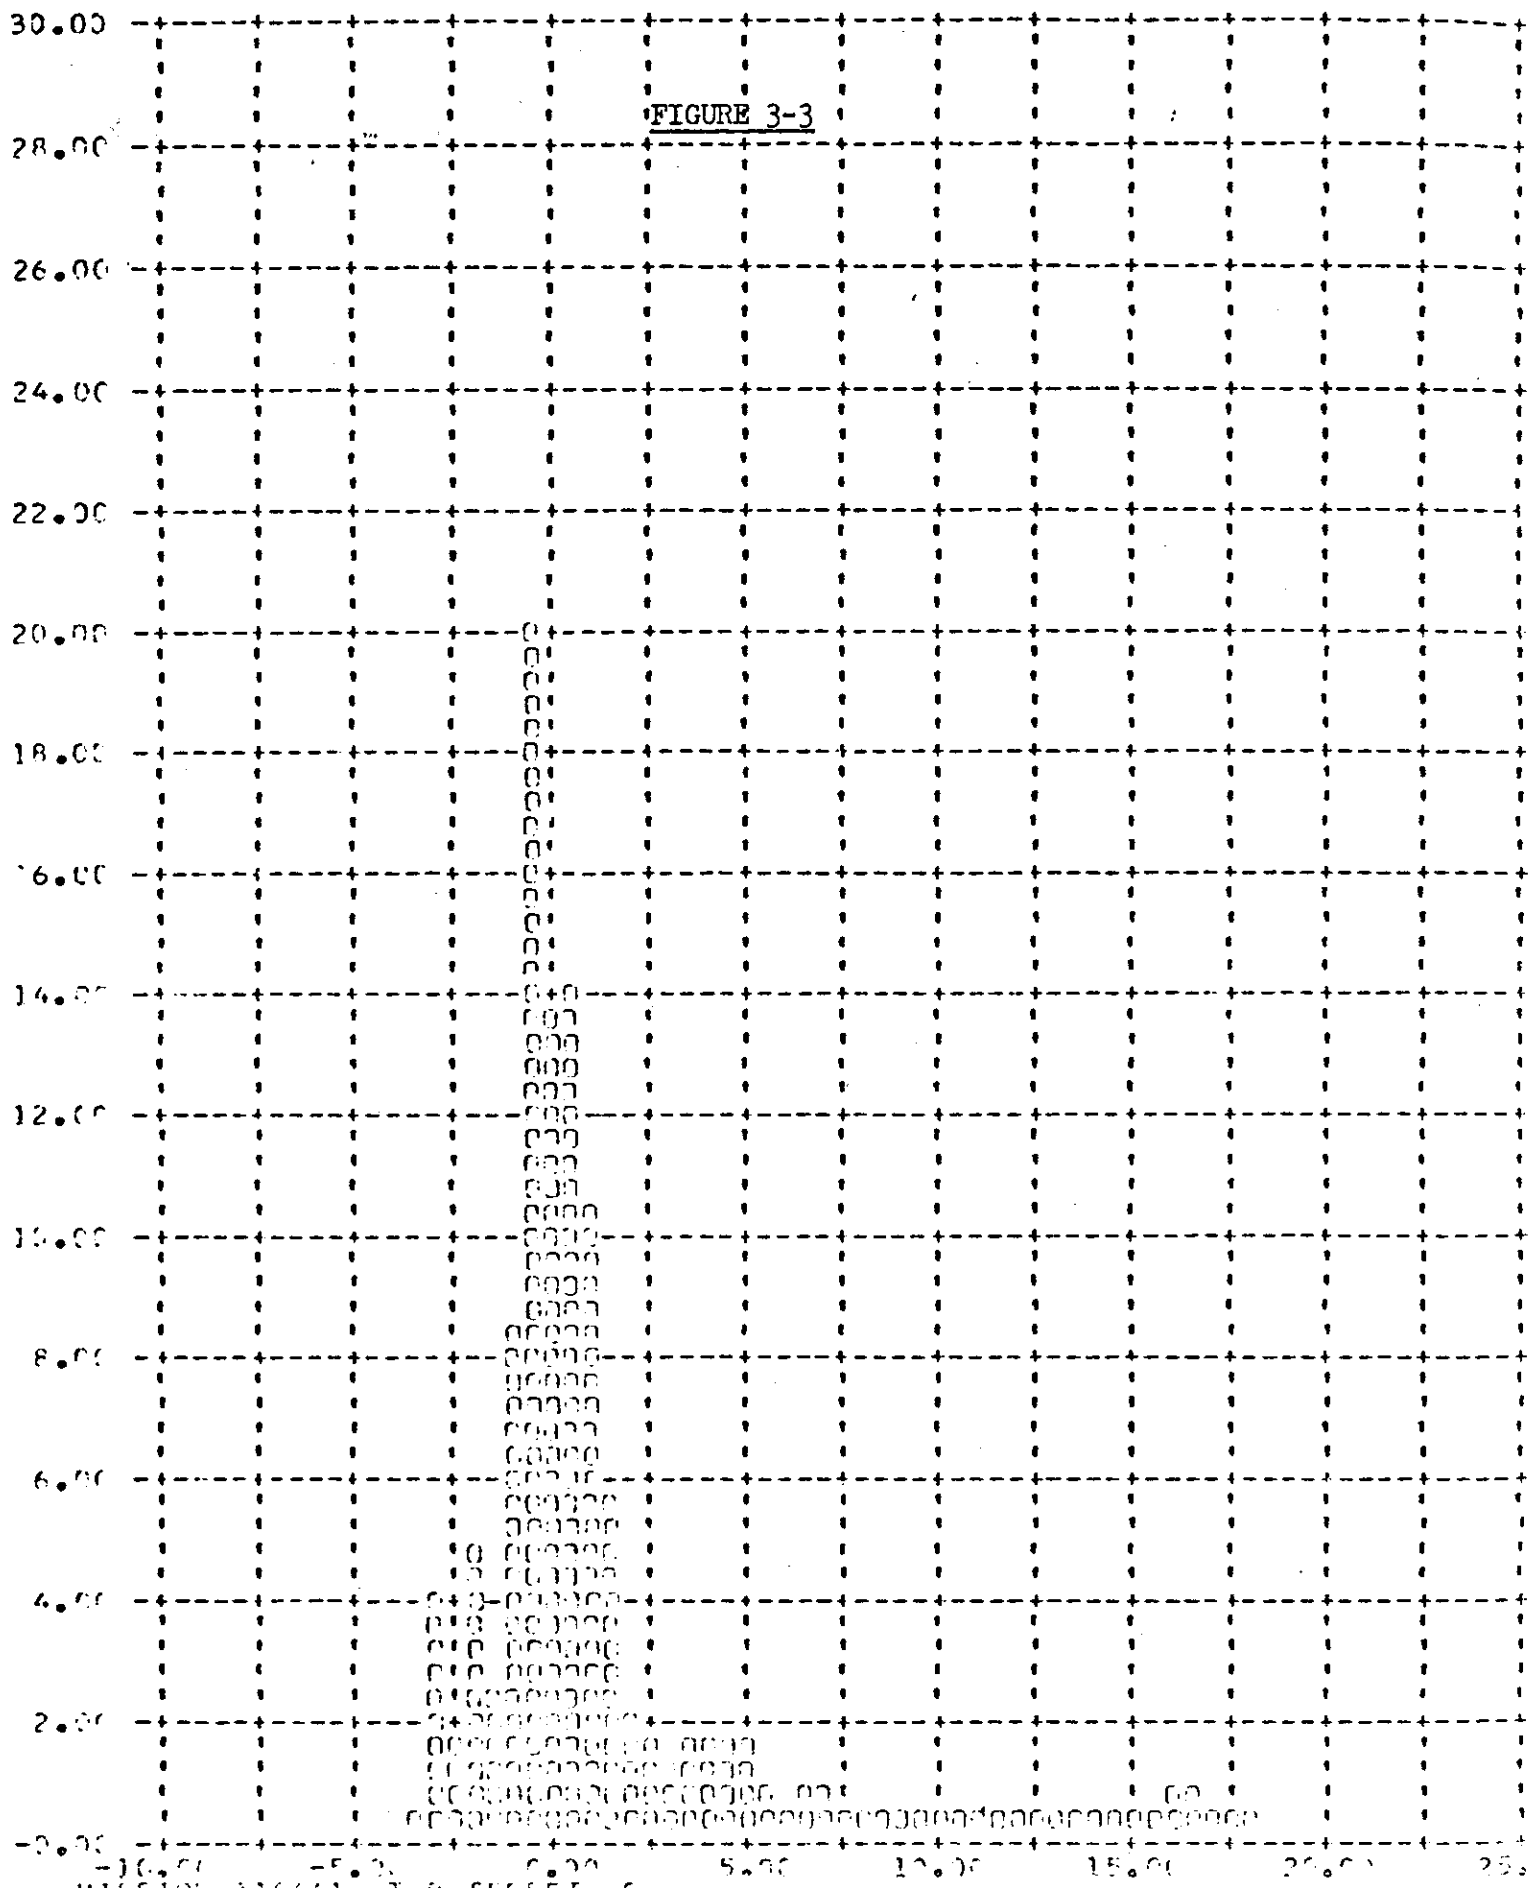
Operations on revs 1 thru 5 had a very large FMC mismatch as the ramp setting at the beginning of the mission was in a configuration consistent with normal programmer functioning. Once the exact nature of the programmer failure was determined information was provided for selecting the optimum start level position for the desired latitudes of operation. Start level selection was based mainly on obtaining the least mismatch over prime areas.

The V/H match performance is shown in figures 3-3 through 3-6. It can be observed from study of these V/H error plots, that good FMC match was achieved by real time command. Consequently image smear was held to a minimum as discussed in Section 6.
