CORONA J
PERFORMANCE EVALUATION REPORT
MISSION 1105-1 AND 1105-2
FTV 1646, CR-5

17 June 1969

SUBJECT: MISSION 1105 FINAL REPORT (CR-5)

This document constitutes the final payload test and performance evaluation report for Mission 1105 which was launched on 3 November 1968.

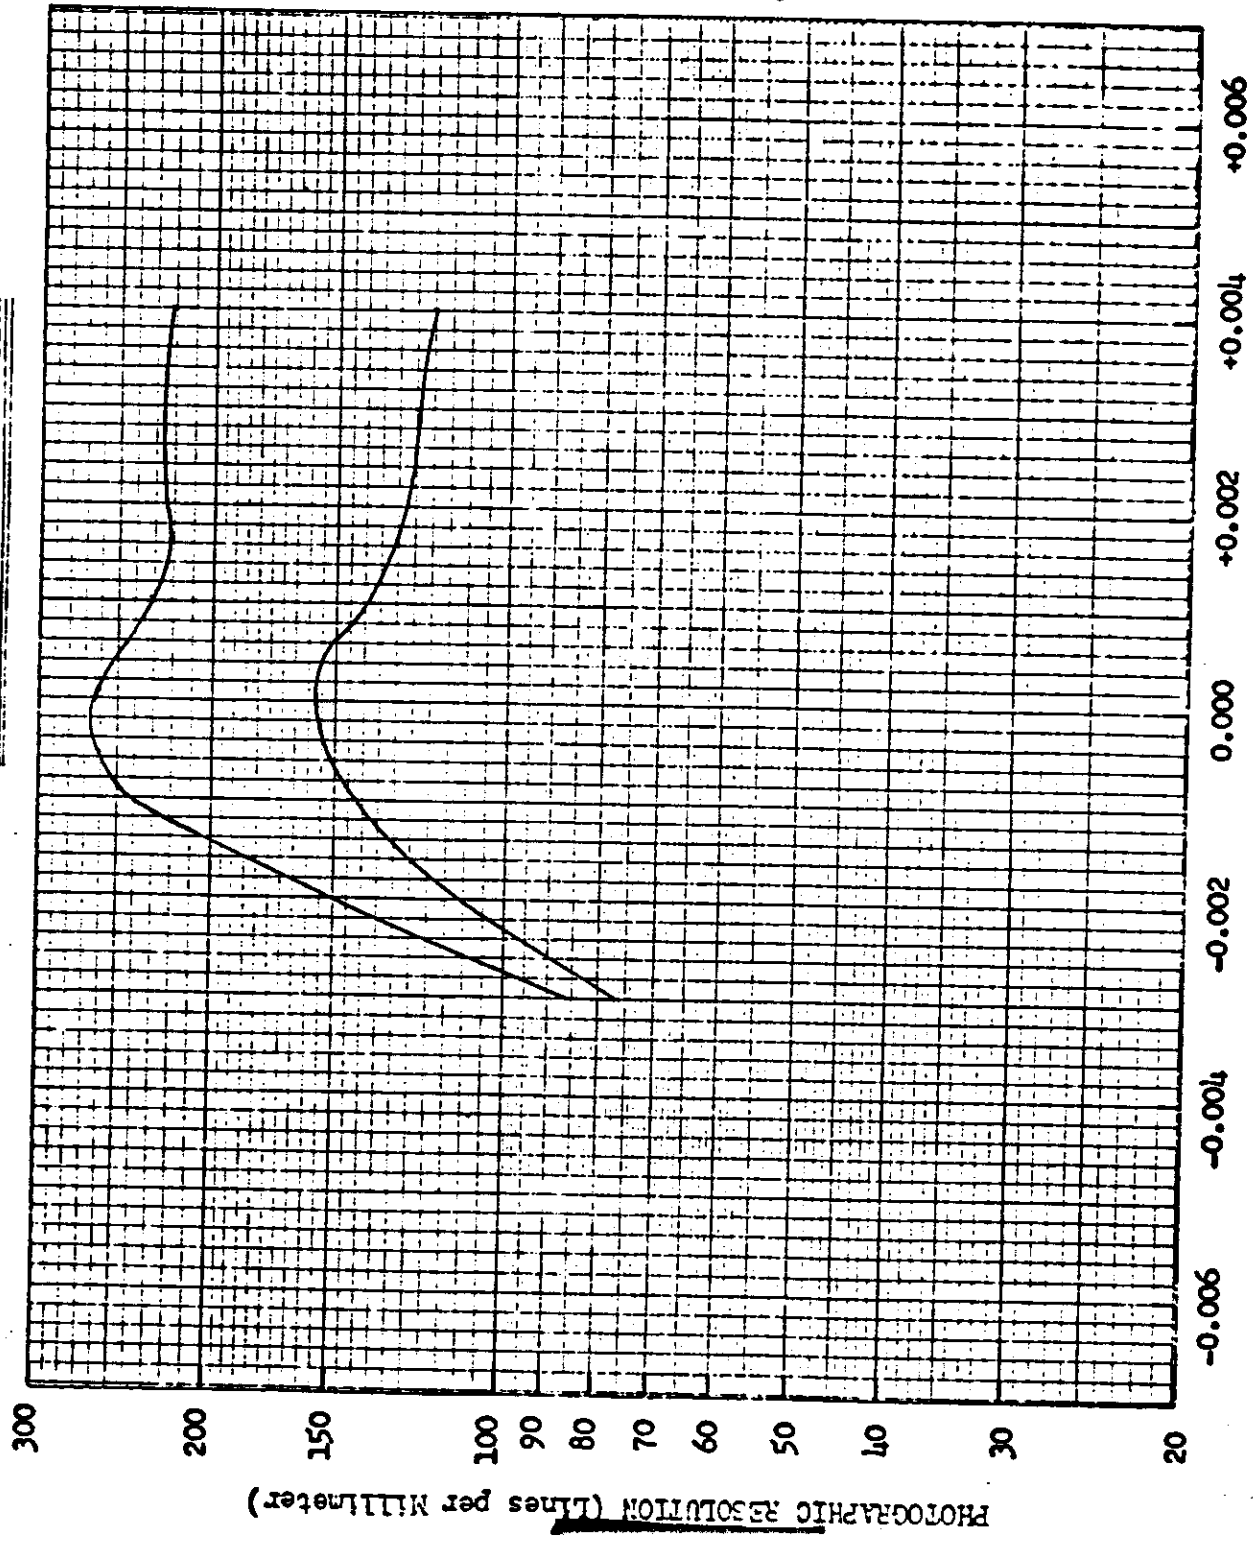
FIGURE 2-1

Further investigation by Boston revealed that an additional +0.0005 inch shim was desirable for panoramic camera #310.

Prior to the final resolution test pan camera #310 was shimmed +0.0005 inches. Final resolution results produced on 5 October 1968 are shown as follows:

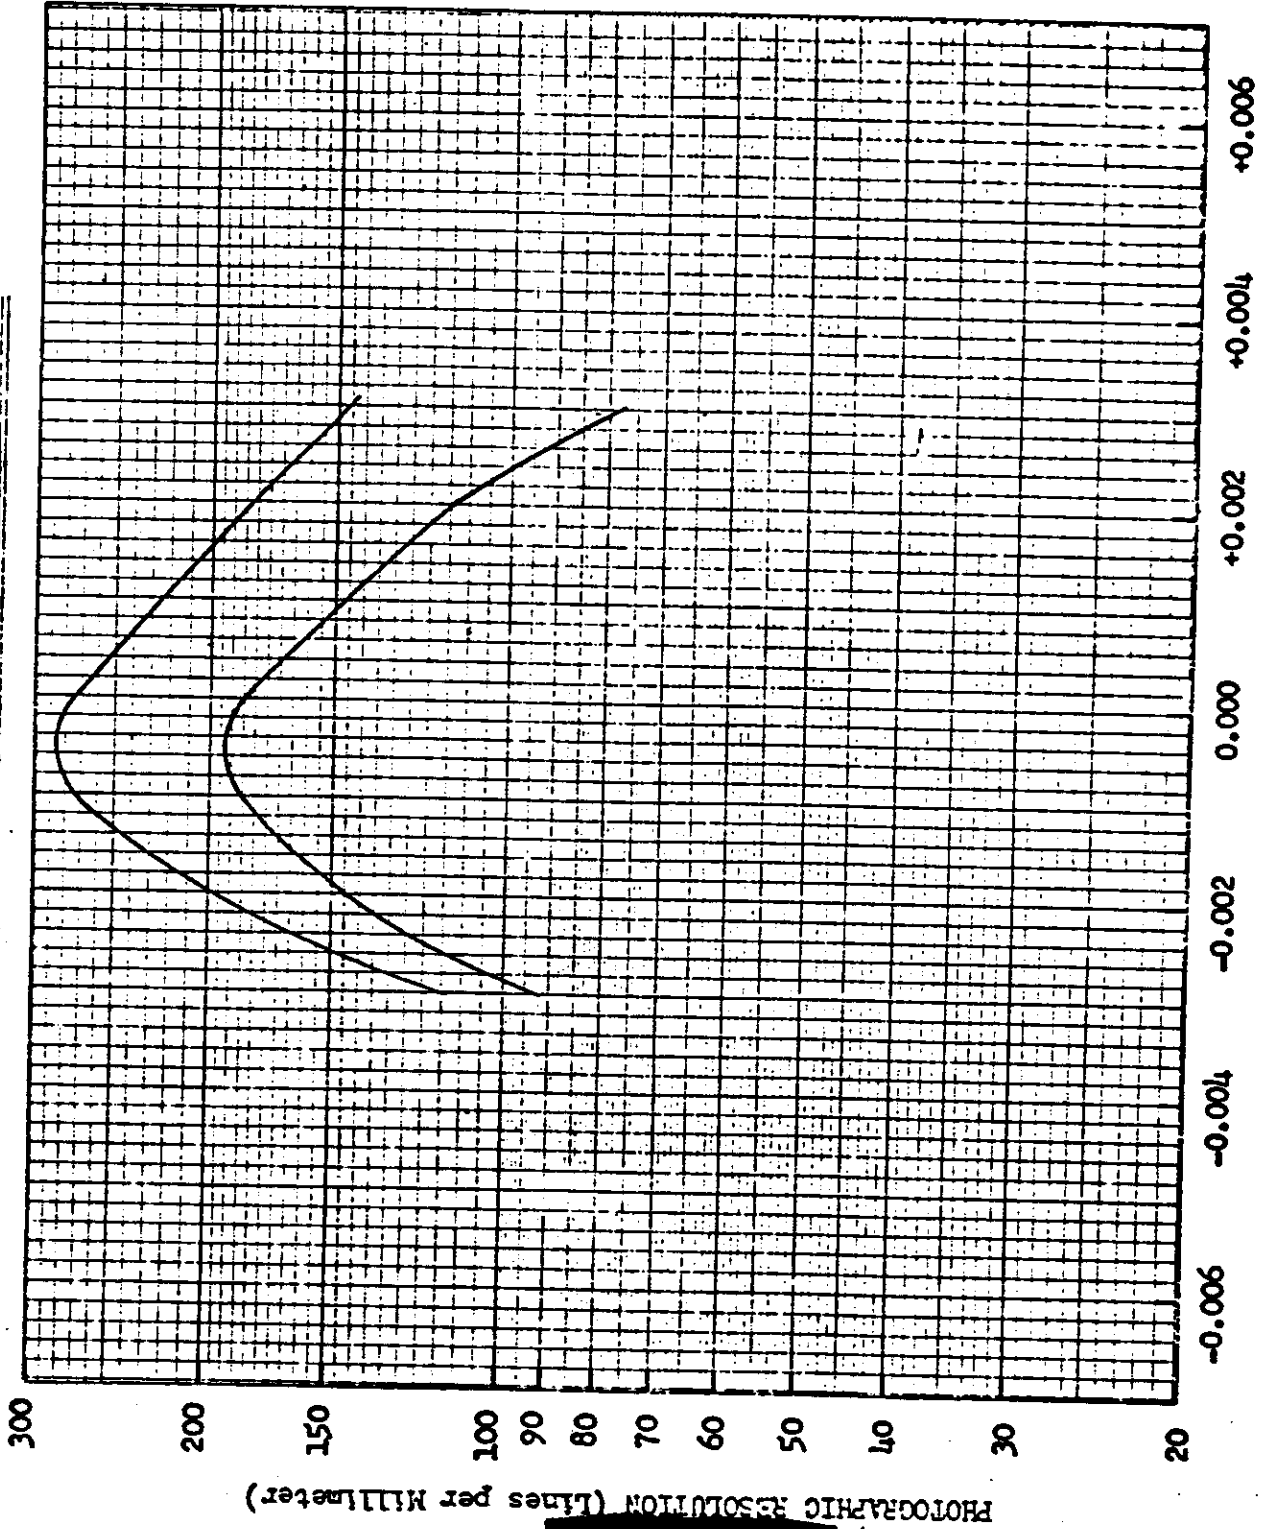
FIGURE 2-2

Camera No: 311
Payload No: CR-5
Resolution (1/mm) 279
High Contrast: 279
Low Contrast: 187
Film Type: SO-380 UTB
Test Date: 5 October 1968
