PHOTOGRAPHIC
EVALUATION REPORT

MISSION 1050

AUGUST 1969

NATIONAL PHOTOGRAPHIC INTERPRETATION CENTER

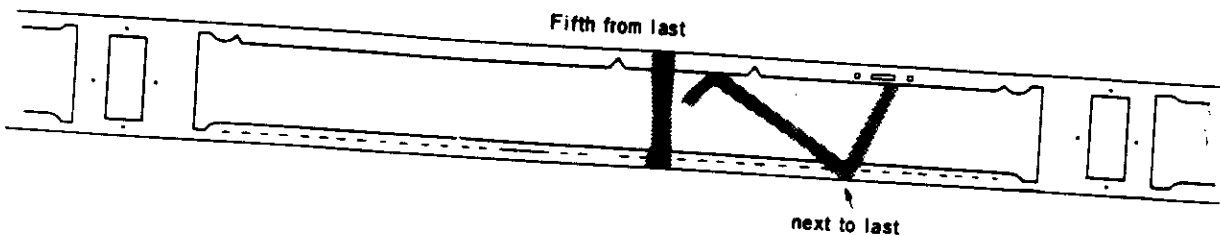
Graphic 1

4. Image Degradations:
 - a. Light Leaks: Light leak induced fog patterns of various sizes and shapes are present on the first, fifth, fifth from last, and next to last frame of most camera operations. These patterns cause some degradation to the imagery. Examples of these patterns are on pass 3D, frame 1; pass 3D, frame 5; and pass 9D, frames 112, 115, and 116. These patterns are displayed in Graphics 1 and 2, page 9.

- b. Static: Dendritic static is present intermittently along both edges of the material. The static is severe at times and on occasion enters the format. See Graphic 1, page 9 (Example: 9D, frame 15).

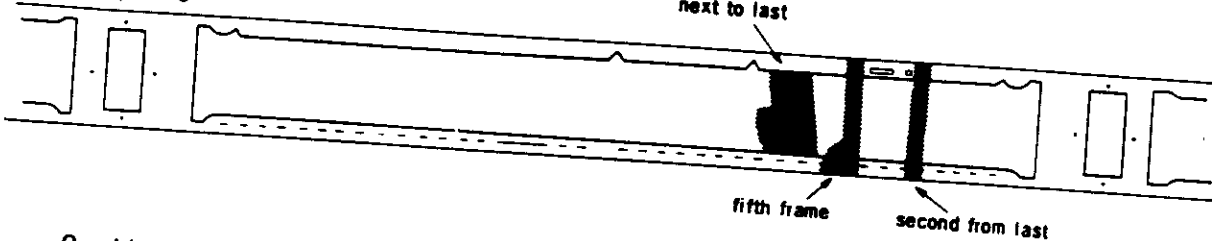
Graphic 3

a. Light Leaks: Fog patterns are present on the fifth, second from last, and next to last frame of most camera operations. (Examples: Pass 1D, frame 4; pass 11D, frames 5, 21, and 22.) These patterns are illustrated in Graphic 3, page 9.

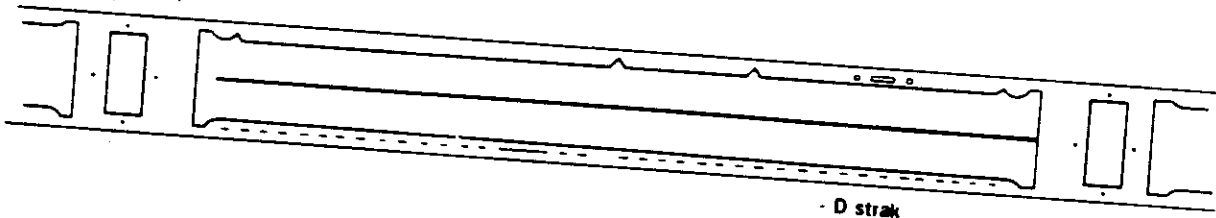
Graphic 4

c. Other: A minus density streak (0.25 inch wide), nearly parallel to the major axis of the film, is present intermittently throughout the missions. (Graphic 4, page 9.) Minus density bands, similar to those occurring in the fwd-looking material, are also present on the aft-looking material.
