PHOTOGRAPHIC
EVALUATION REPORT

MISSION 1050

AUGUST 1969

NATIONAL PHOTOGRAPHIC INTERPRETATION CENTER

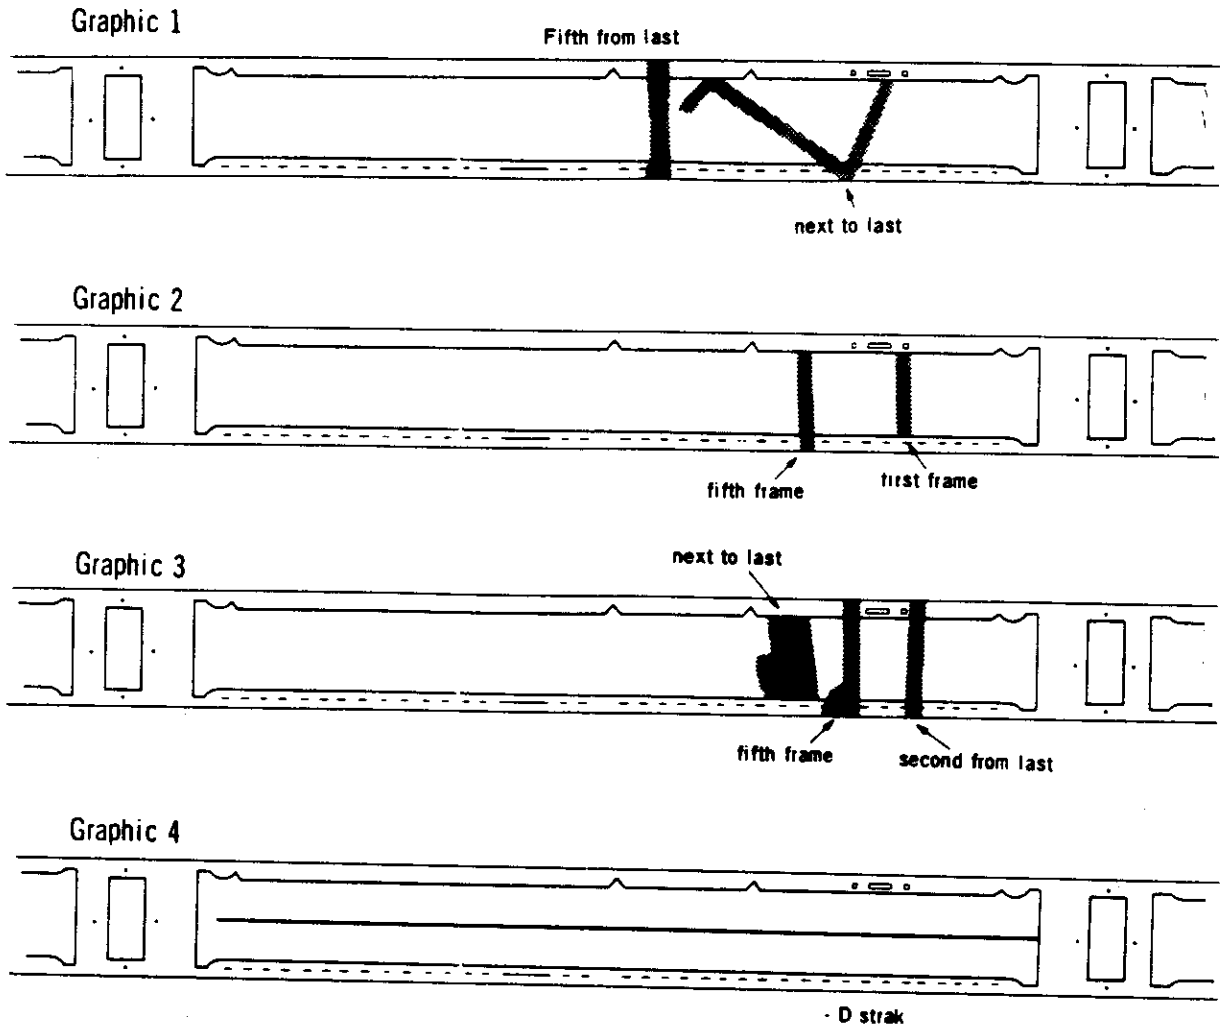
G. Graphic Display (Mission 1050)

4. Image Degradations:
 - a. Light Leaks: Light leak induced fog patterns of various sizes and shapes are present on the first, fifth, fifth from last, and next to last frame of most camera operations. These patterns cause some degradation to the imagery. Examples of these patterns are on pass 3D, frame 1; pass 3D, frame 5; and pass 9D, frames 112, 115, and 116. These patterns are displayed in Graphics 1 and 2, page 9.

- b. Static: Dendritic static is present intermittently along both edges of the material. The static is severe at times and on occasion enters the format. See Graphic 1, page 9 (Example: 9D, frame 15).

a. Light Leaks: Fog patterns are present on the fifth, second from last, and next to last frame of most camera operations. (Examples: Pass 1D, frame 4; pass 11D, frames 5, 21, and 22.) These patterns are illustrated in Graphic 3, page 9.

c. Other: A minus density streak (0.25 inch wide), nearly parallel to the major axis of the film, is present intermittently throughout the missions. (Graphic 4, page 9.) Minus density bands, similar to those occurring in the fwd-looking material, are also present on the aft-looking material.
