CORONA J
PERFORMANCE EVALUATION REPORT
MISSION 1107-1 and 1107-2
FTV 1652, CR-7

This report details the performance of the payload system during the operational phase of the Program [REDACTED] Flight Test Vehicle 1652.

This document constitutes the final payload test and performance evaluation report for Mission 1107 which was launched on 24 July 1969.

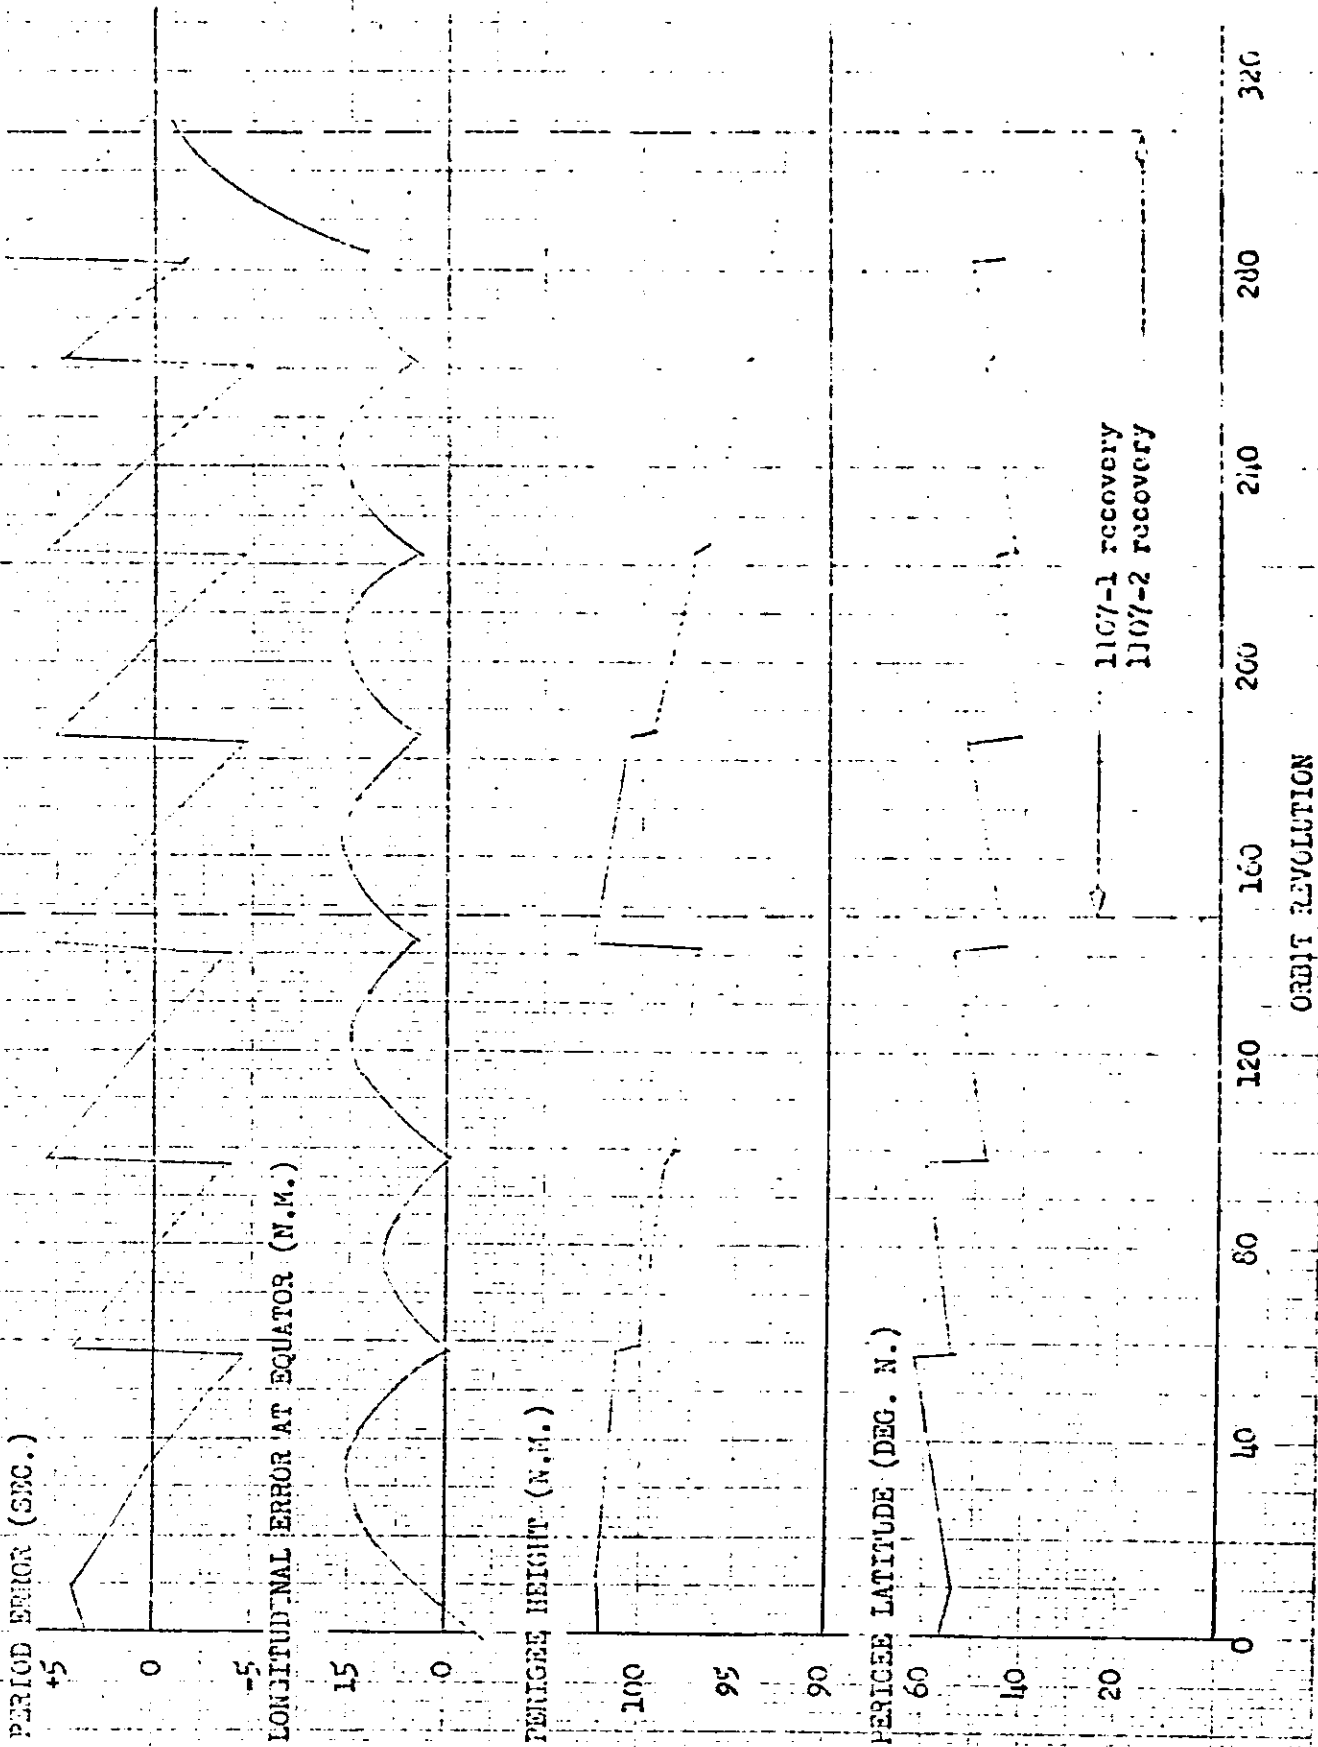
Figure 3-1 CR-7/1107 Orbit History

Ground track errors were approximately 5 nautical miles east to 17 nautical miles west of nominal at the equator. After the final firing on Rev. 279, the ground track error increased to 38 nautical miles west of

nominal at Rev. 299 where the last operation was taken. Figure 3-1 shows the orbit history maintained throughout the mission. A summary of the DMU firings is shown in Table 3-2. Figure 3-2 shows the frequency distribution of operations and mean frame altitude of Mission 1107.
