CORONA J

PERFORMANCE EVALUATION REPORT

MISSION 1050-1 and 1050-2

FTV 1651, J-43

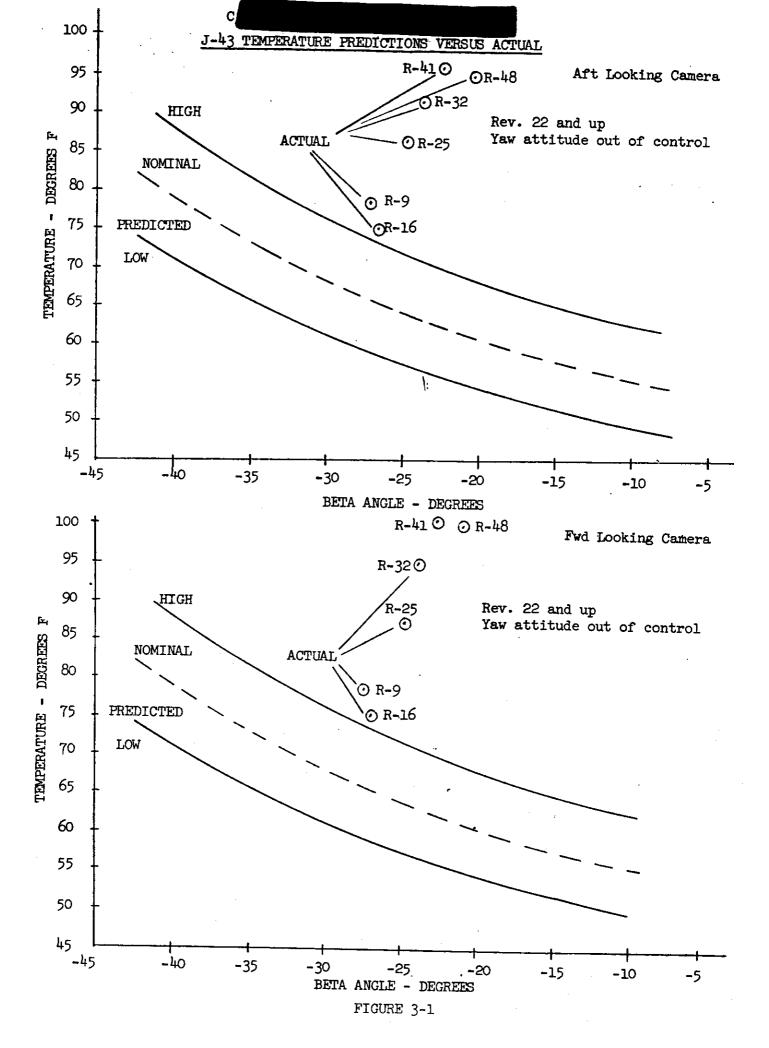
The thermal environment achieved with this system was slightly higher than the predictions. Temperature comparisons can only be made prior to Rev. 22 because of the loss of paint pattern orientation due to vehicle instability beginning on Rev. 22. The actual system temperature was approximately 76°F and 75°F for the master and slave cameras respectively as compared with a temperature prediction between 60°F and 74°F. Figure 3-1 shows a graphical plot of the actual average camera temperatures versus the predicted

temperature as a function of the beta angle in degrees. The temperatures shown for Revs. R-25, R-32, R-41, and R-48, Figure 3-2, are abnormally high due to the yaw attitude problem that developed on Rev. 22.

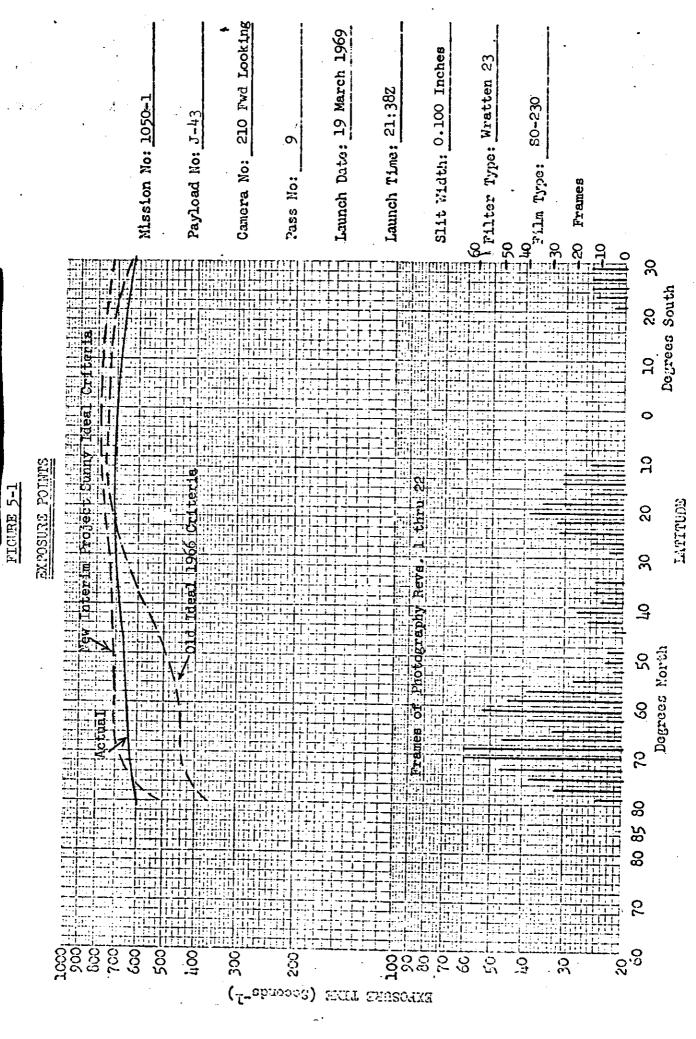
FORWARD CAMERA EXPOSURE TIME AND OPERATION VS LATITUDE

The actual slit choice for Mission 1050-1 and -2 was made and based upon a preliminary Project Sunny brightness model modified to produce a slight overexposure in flight use as seen in Figures 5-1 and 5-2. A comparison of the actual exposure with the old ideal curve dated 1966 indicates that Mission 1050 was somewhat underexposed.

Superimposed on Figures 5-1 and 5-2 is the frequency of camera operation versus latitude for Rev. 1 thru Rev. 22. Following Rev. 22 the flight vehicle lost attitude control primarily in the yaw direction. As a result exposure plots for Rev. 23 and up are not shown.
