CORONA J

PERFORMANCE EVALUATION REPORT

MISSION 1106-1 and 1106-2

FTV 1630, CR-6

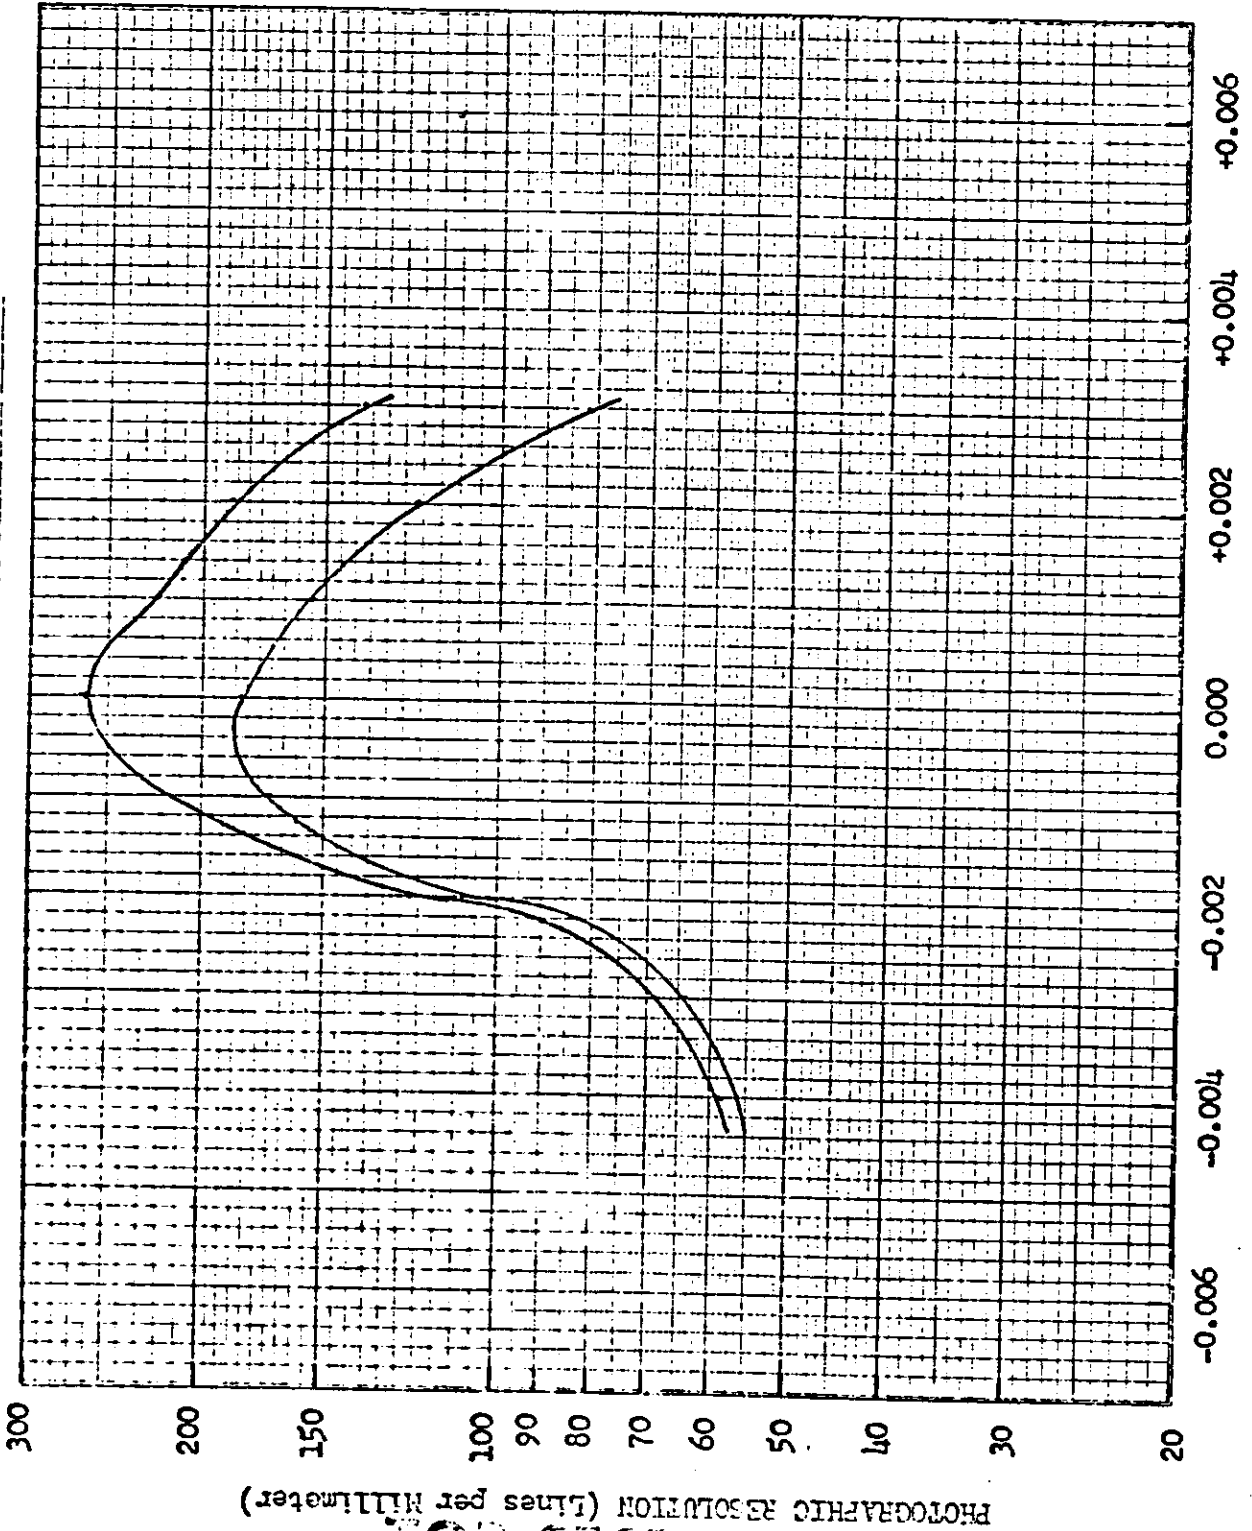
FIGURE 2-2

Fwd-looking Instrument No. 313

Maximum low contrast resolution 200 lines/mm at -0.0004" peak focal position.

The final test data for both instruments is shown in figures 2-1 and 2-2. Both instruments met the system requirements specification.

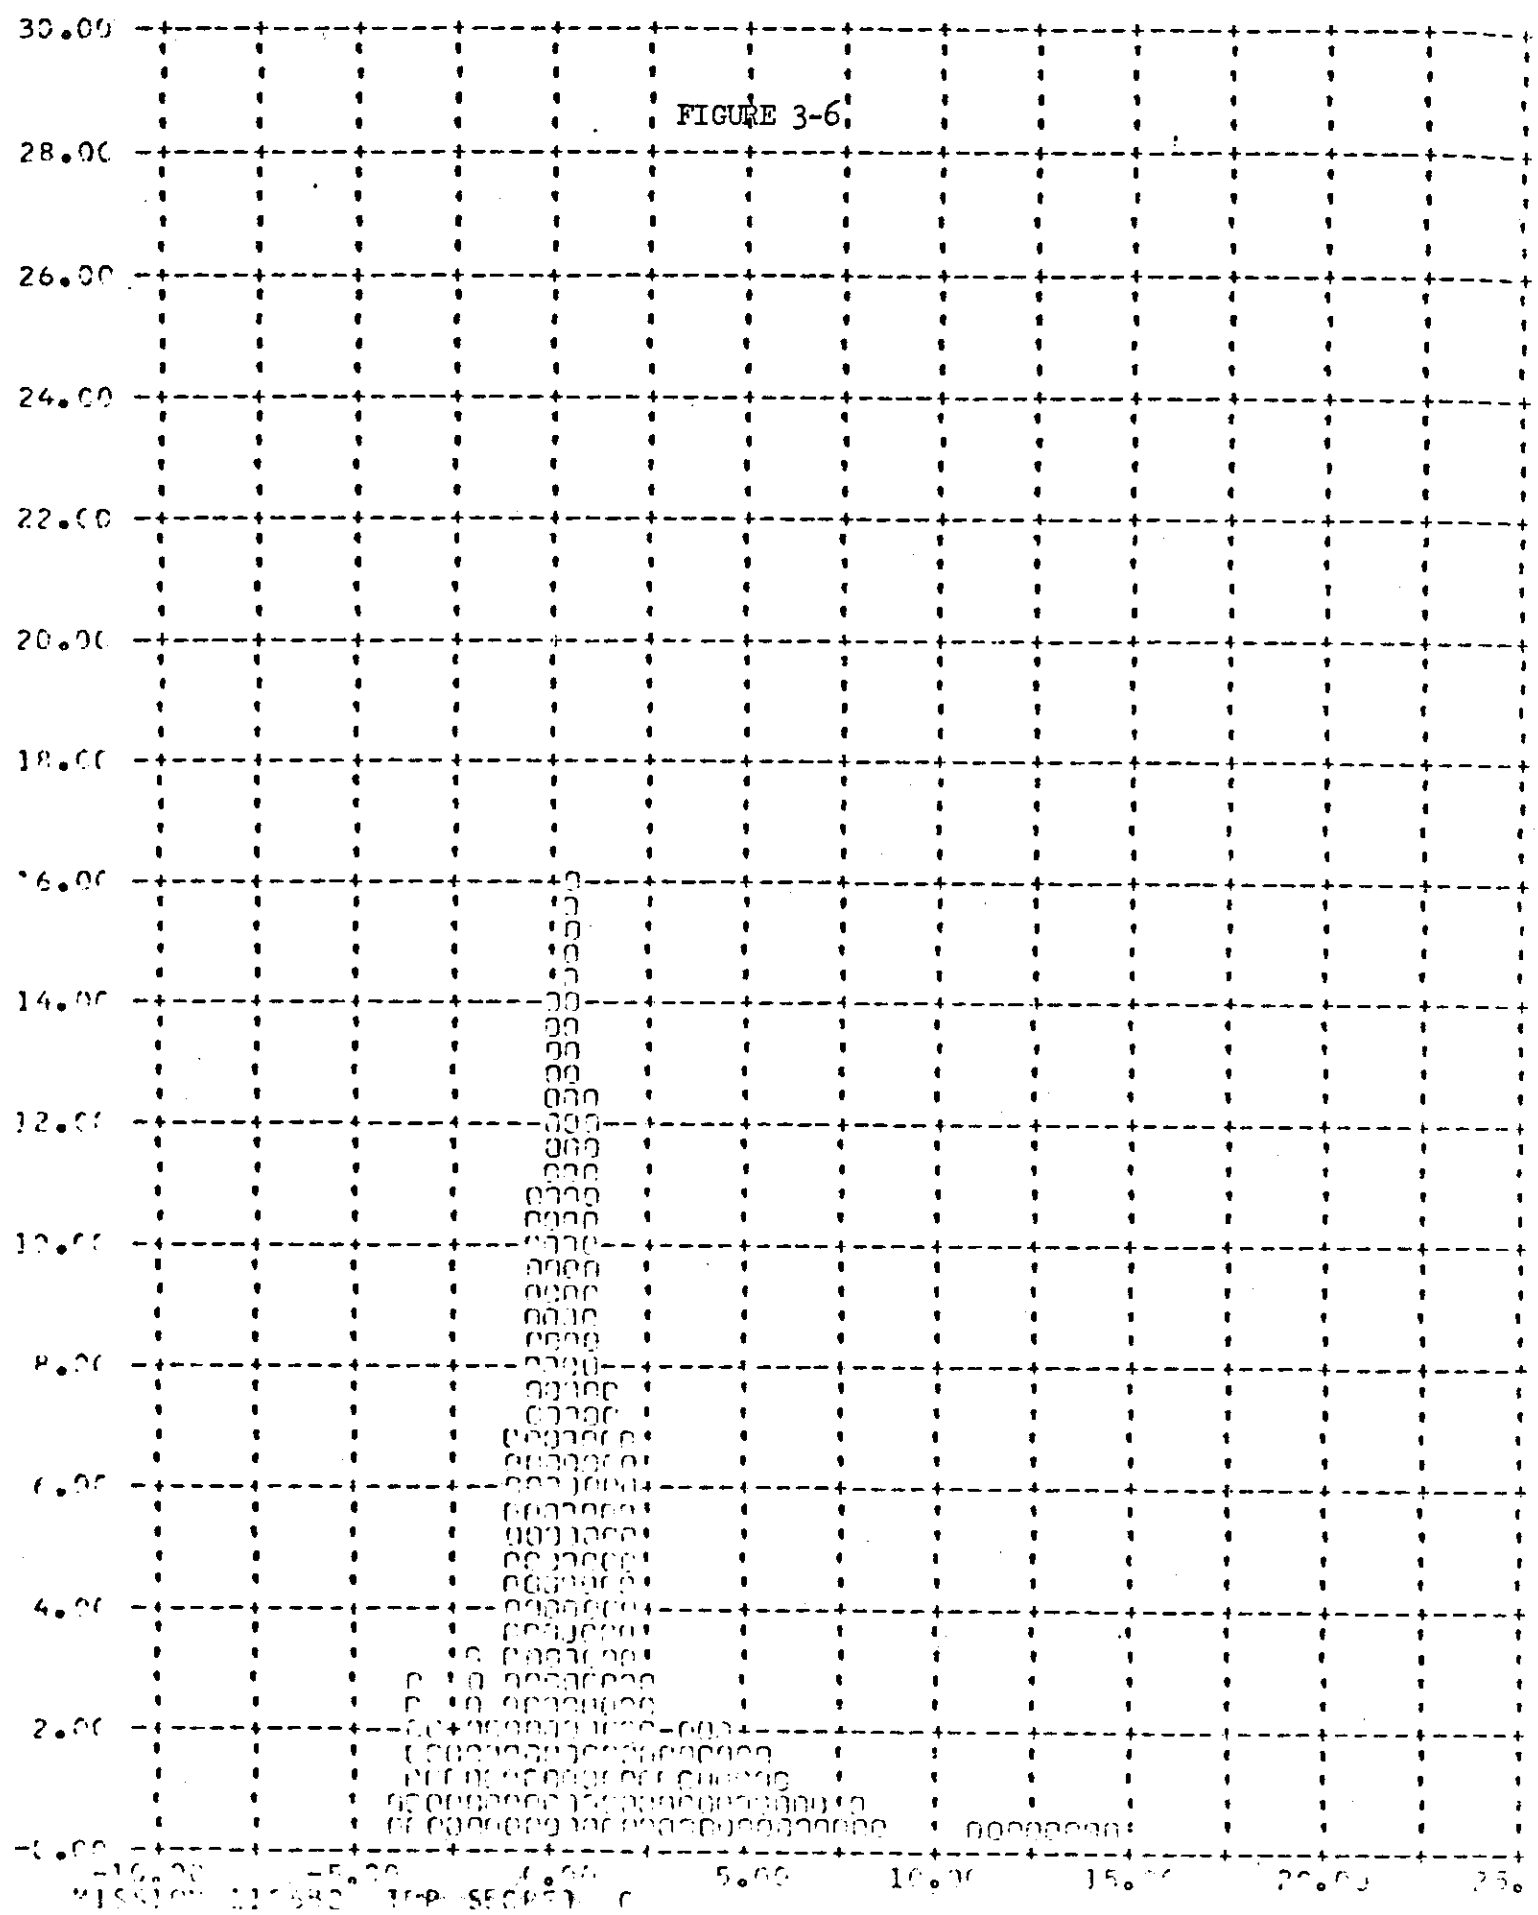
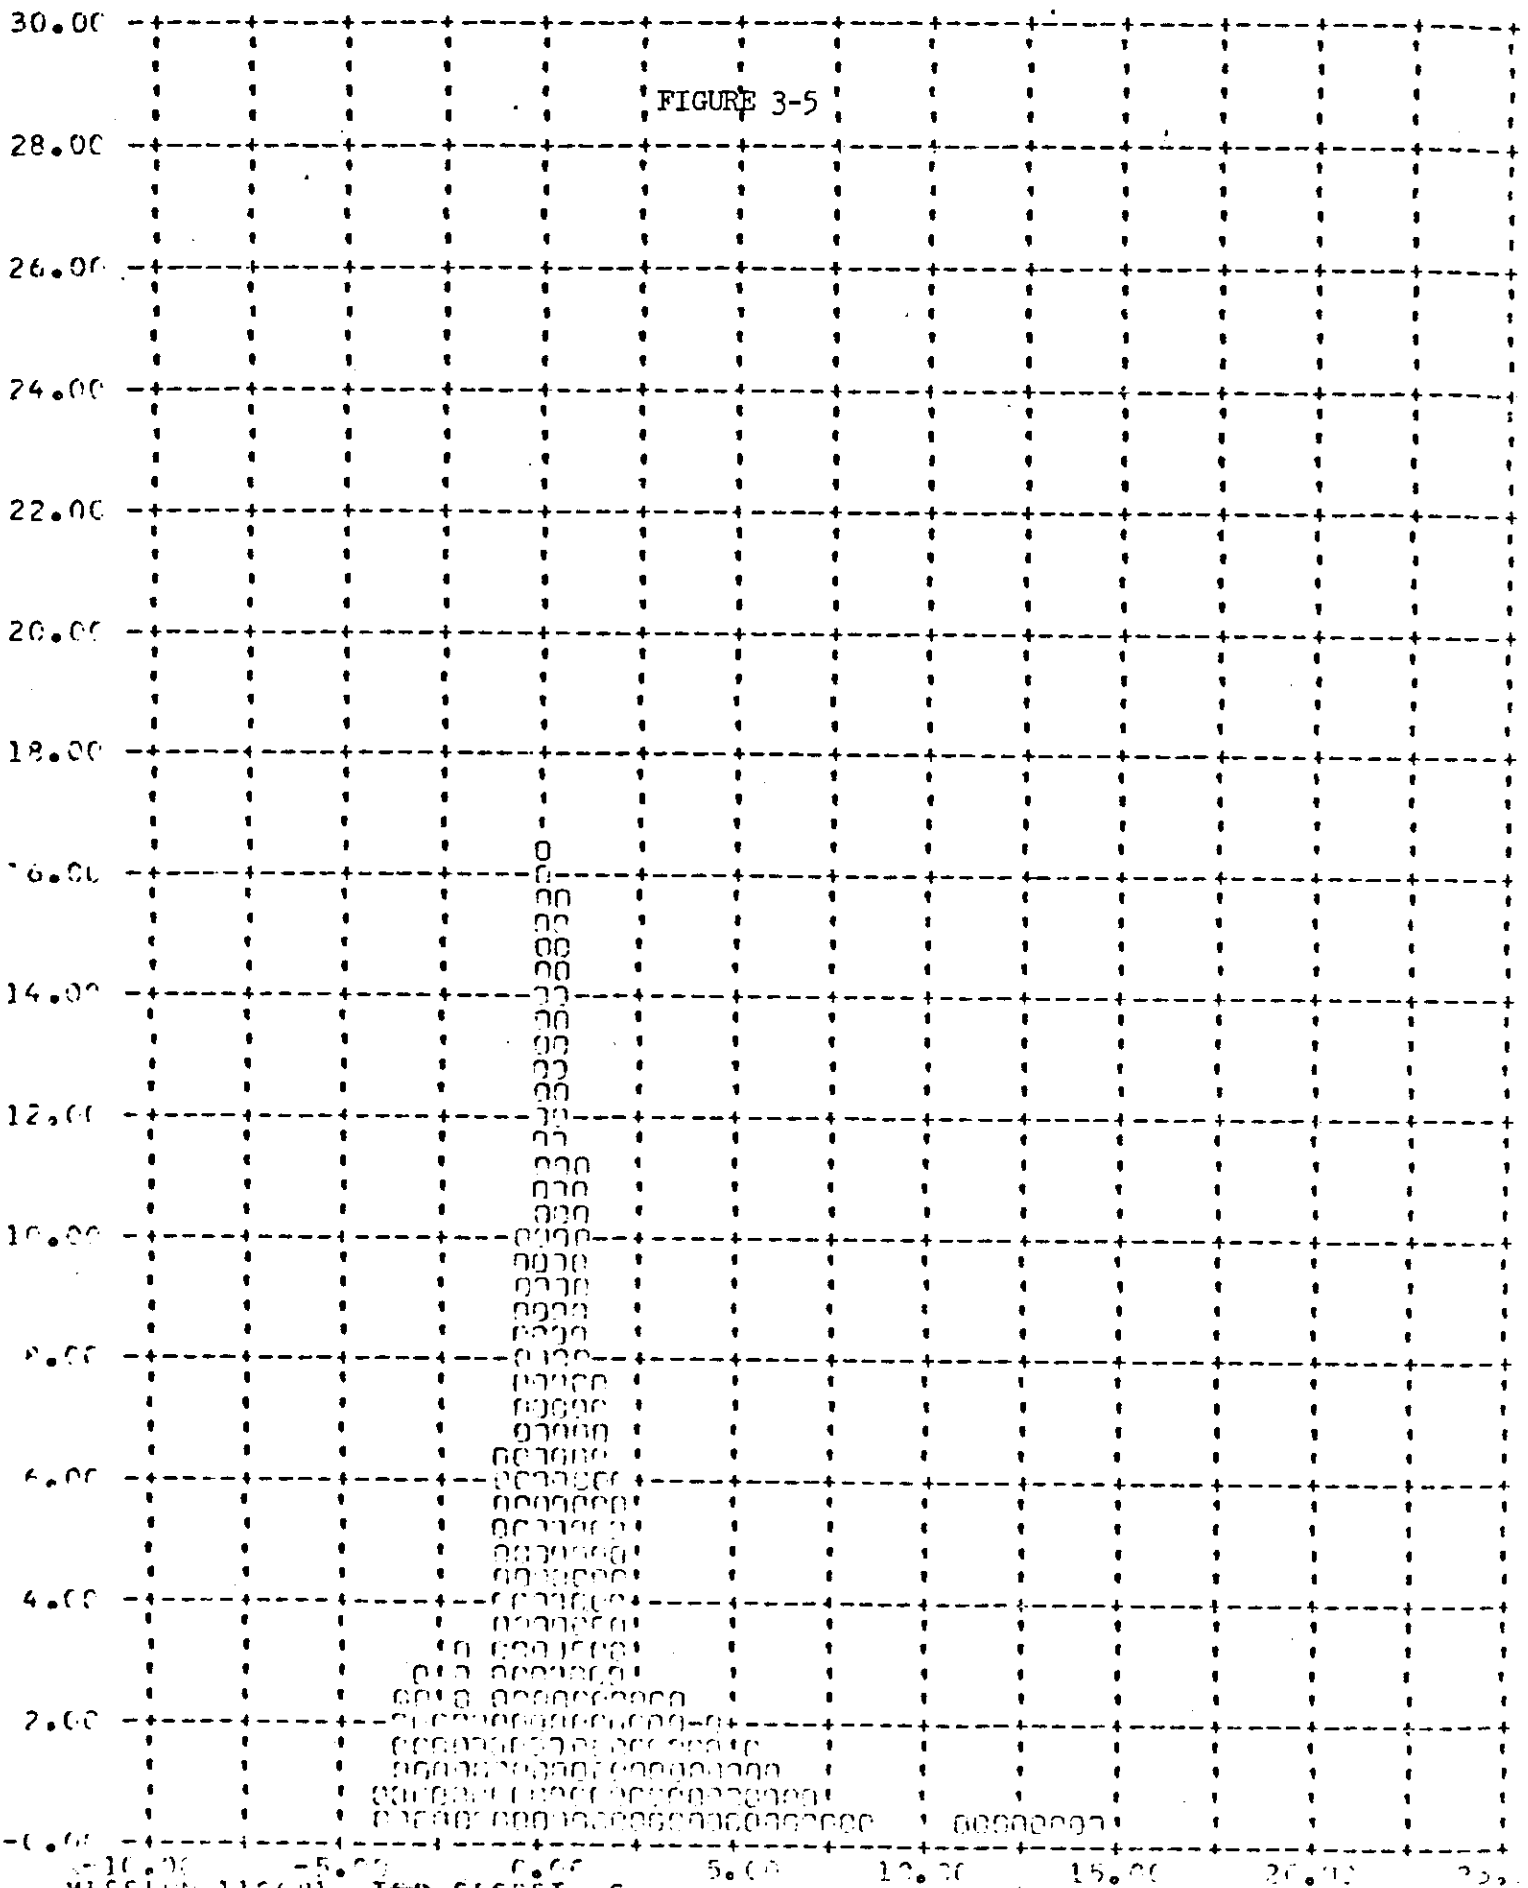
The normal method of matching the pan camera operations with the V/H of the orbit could not be utilized during this flight due to the failure of the FMC programmer. All operations were run at start level cycle rates, which were nearly constant, being varied by the oblateness function only. Mismatch was minimized by adjusting the programmer start level with the Real Time Command function UHF-121.

Operations on revs 1 thru 5 had a very large FMC mismatch as the ramp setting at the beginning of the mission was in a configuration consistent with normal programmer functioning. Once the exact nature of the programmer failure was determined information was provided for selecting the optimum start level position for the desired latitudes of operation. Start level selection was based mainly on obtaining the least mismatch over prime areas.

The V/H match performance is shown in figures 3-3 through 3-6. It can be observed from study of these V/H error plots, that good FMC match was achieved by real time command. Consequently image smear was held to a minimum as discussed in Section 6.
