CORONA J
PERFORMANCE EVALUATION REPORT
MISSION 1052-1 and 1052-2
FTV 1653, J-46

This report presents the final performance evaluation of Corona Mission 1052. The purpose of this report is to define the performance characteristics of the J-46 payload system and to evaluate the technical characteristics of the mission, including analysis of any in-flight anomalies.

This document constitutes the final payload test and performance evaluation report for Mission 1052 which was launched on 22 September 1969.

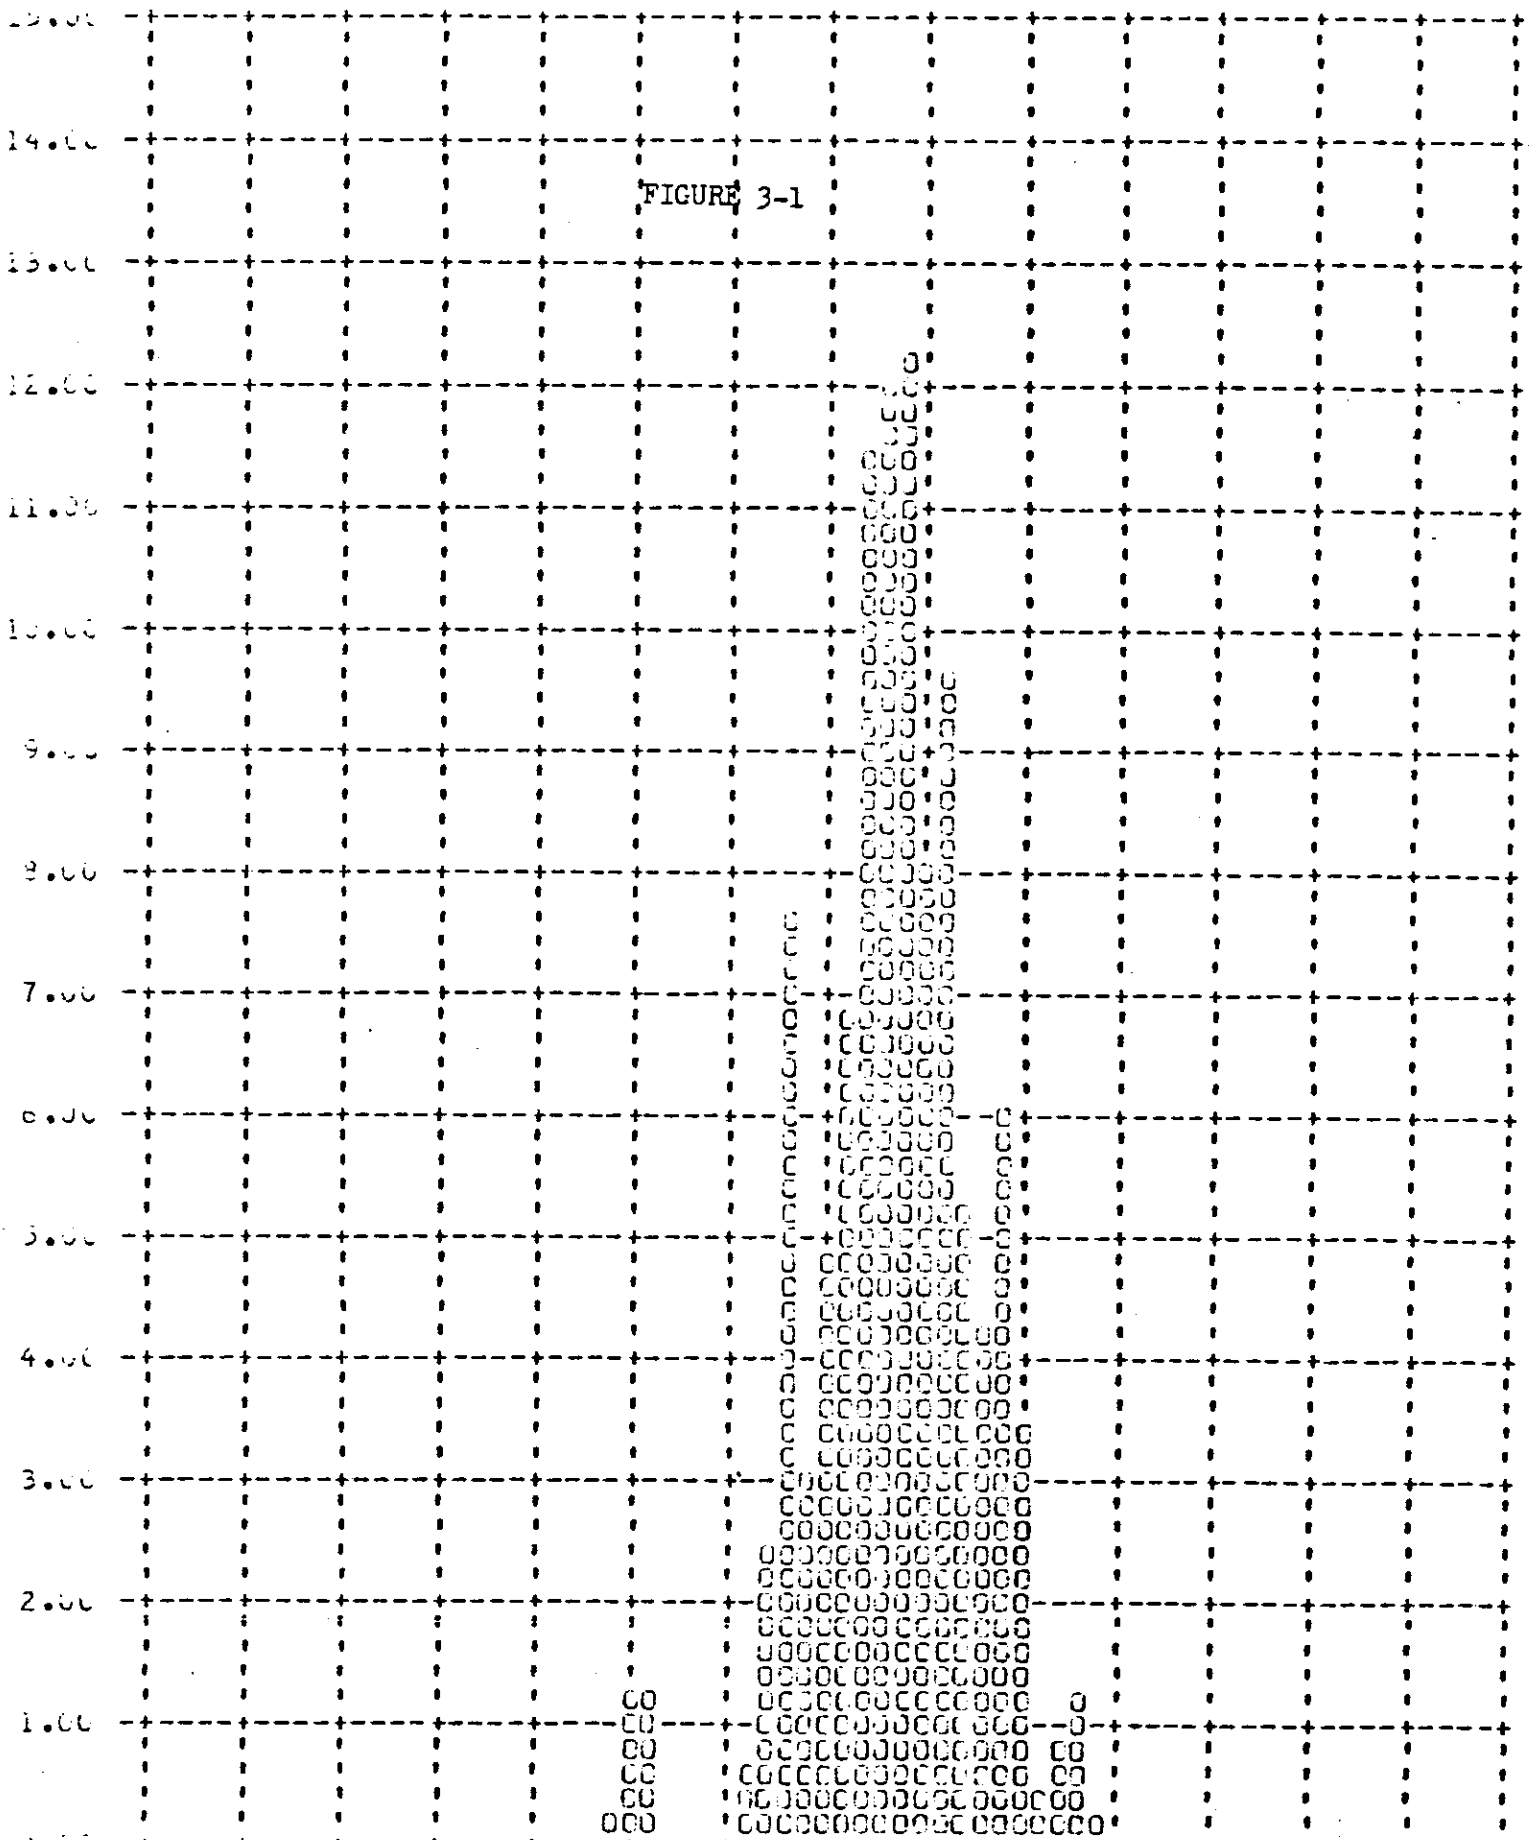
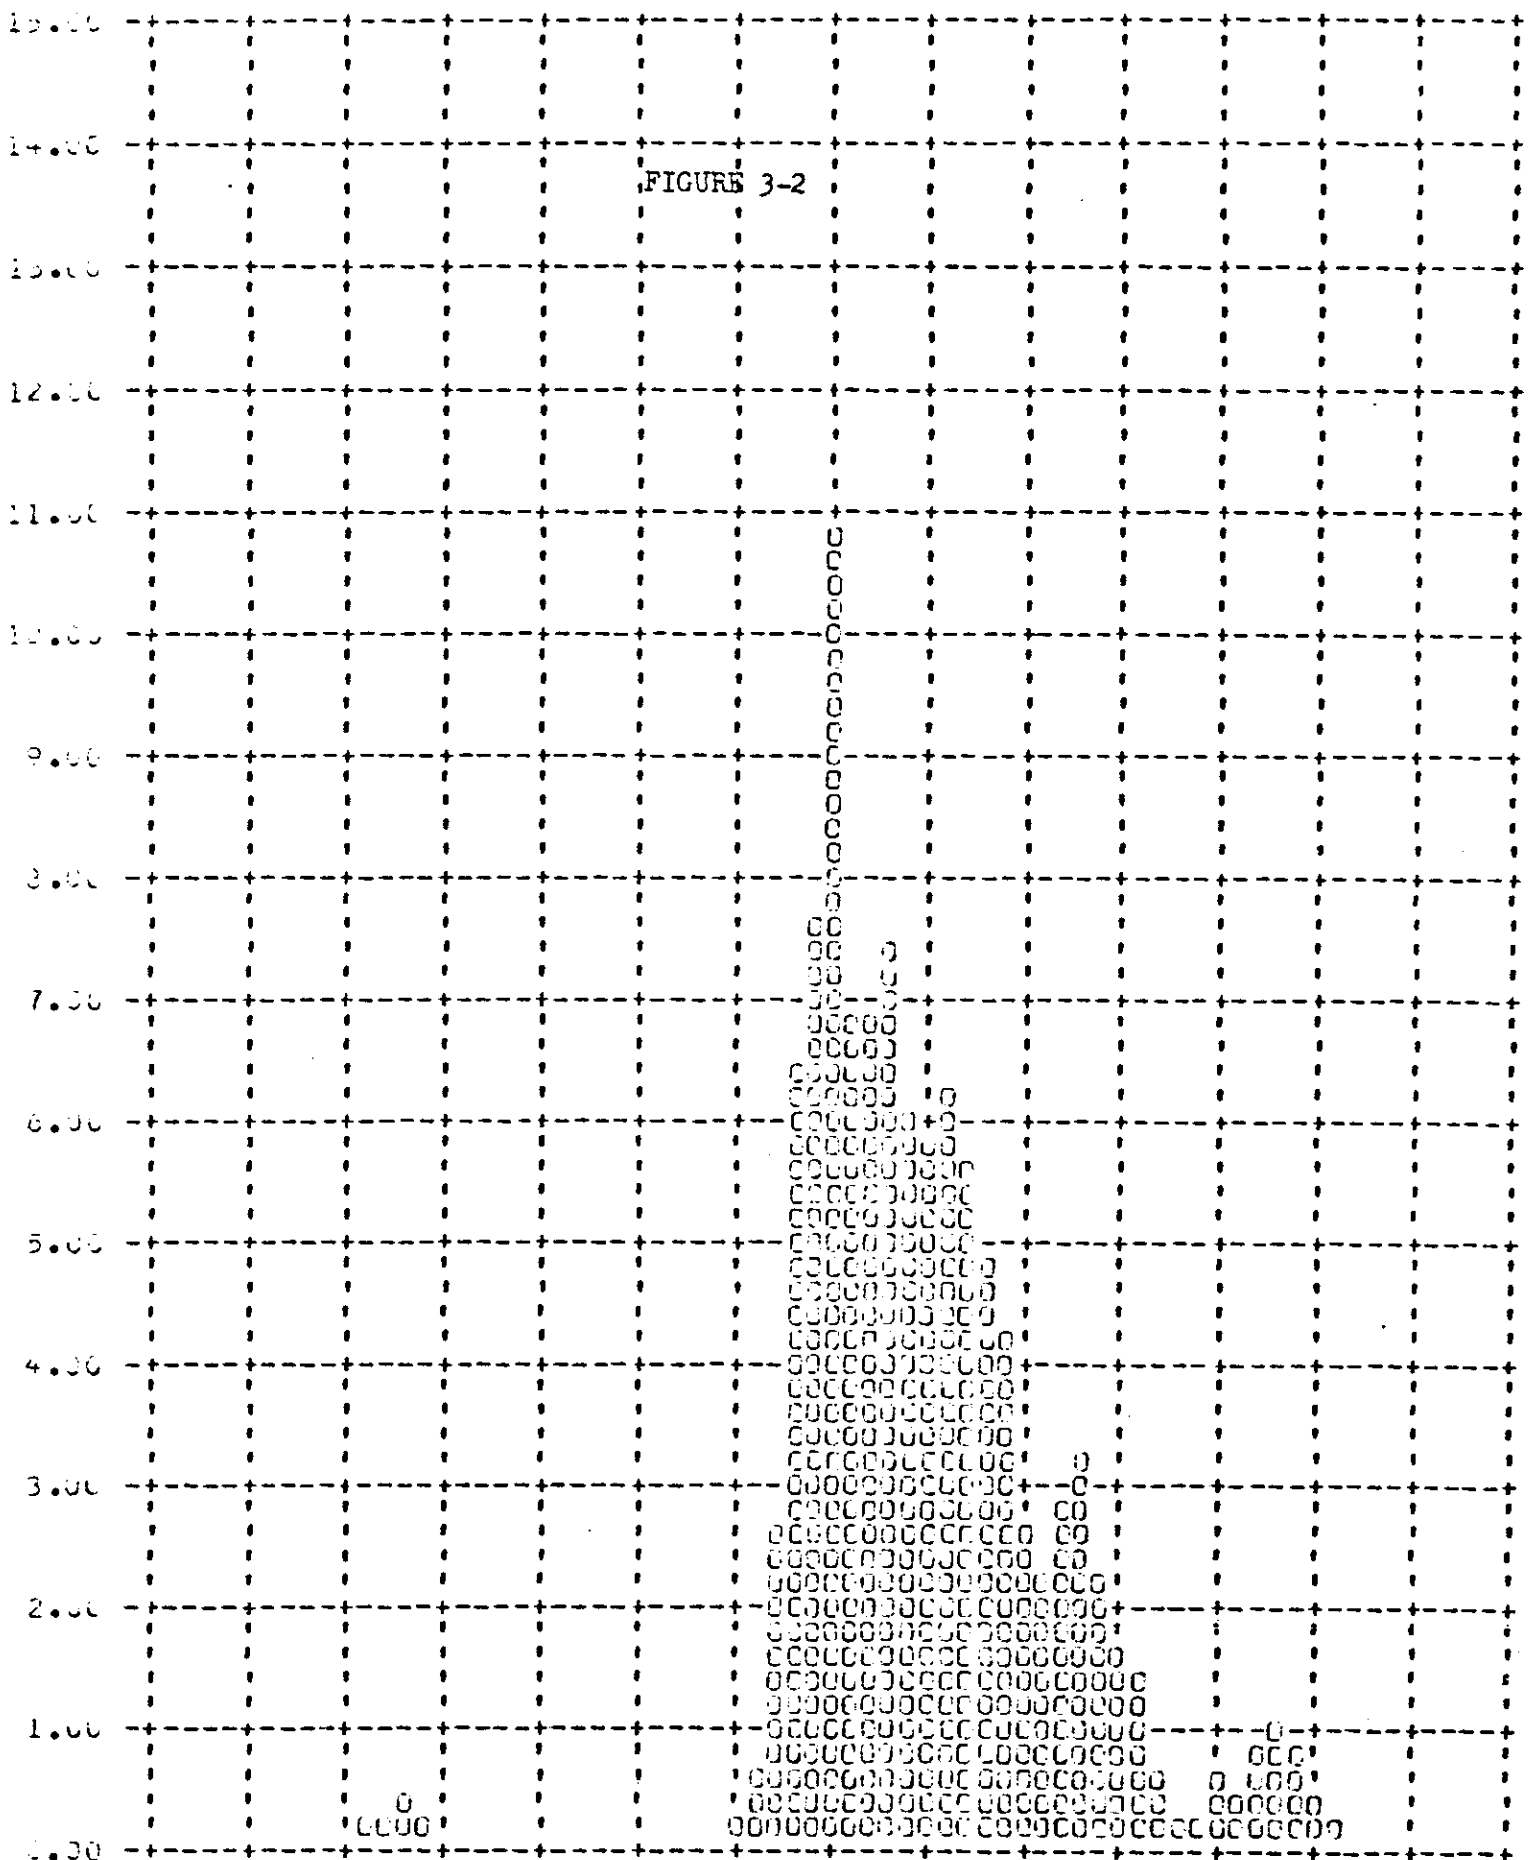
FIGURE 3-2

The actual V/H ratio error for each camera for each mission is shown in Figures 3-1 through 3-4. It can be observed from these plots that good FMC match was achieved. Consequently image smear was held to a minimum as discussed in Section 6.

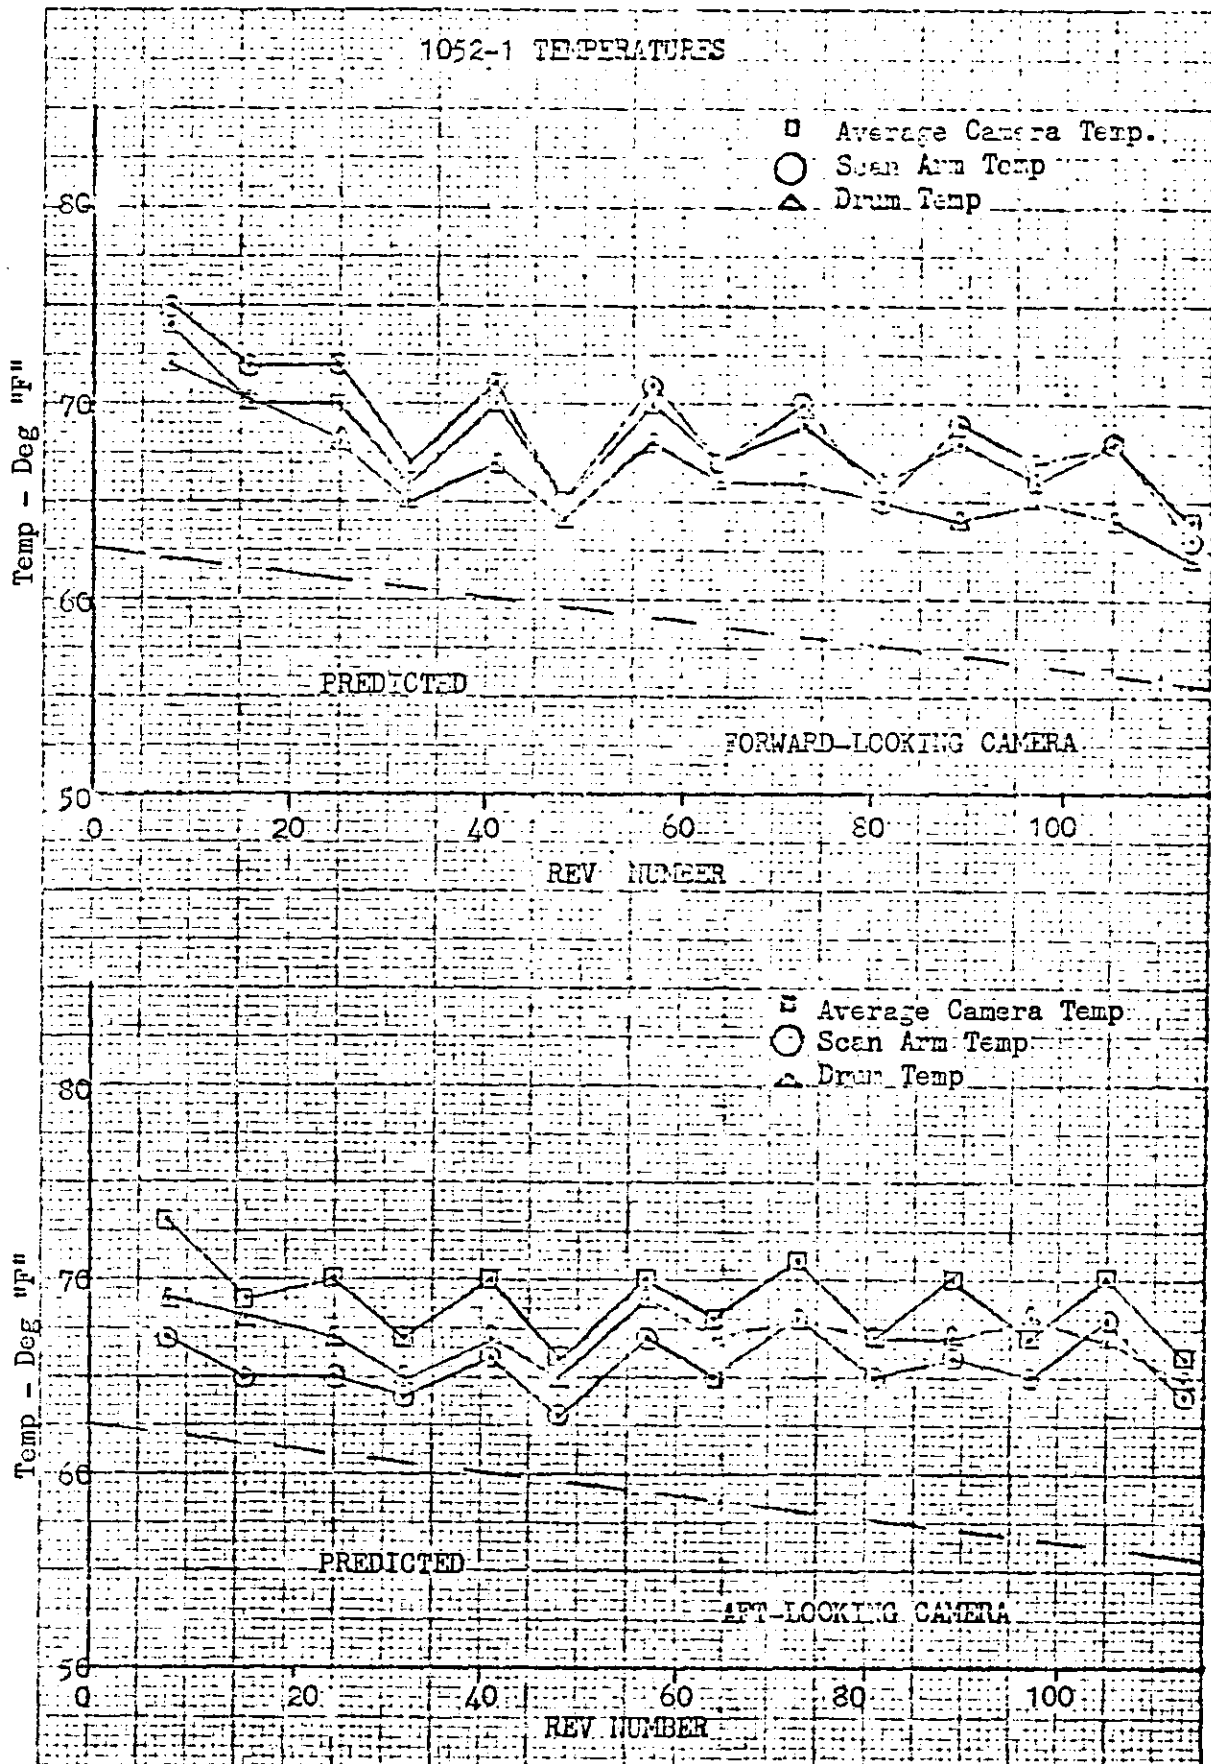
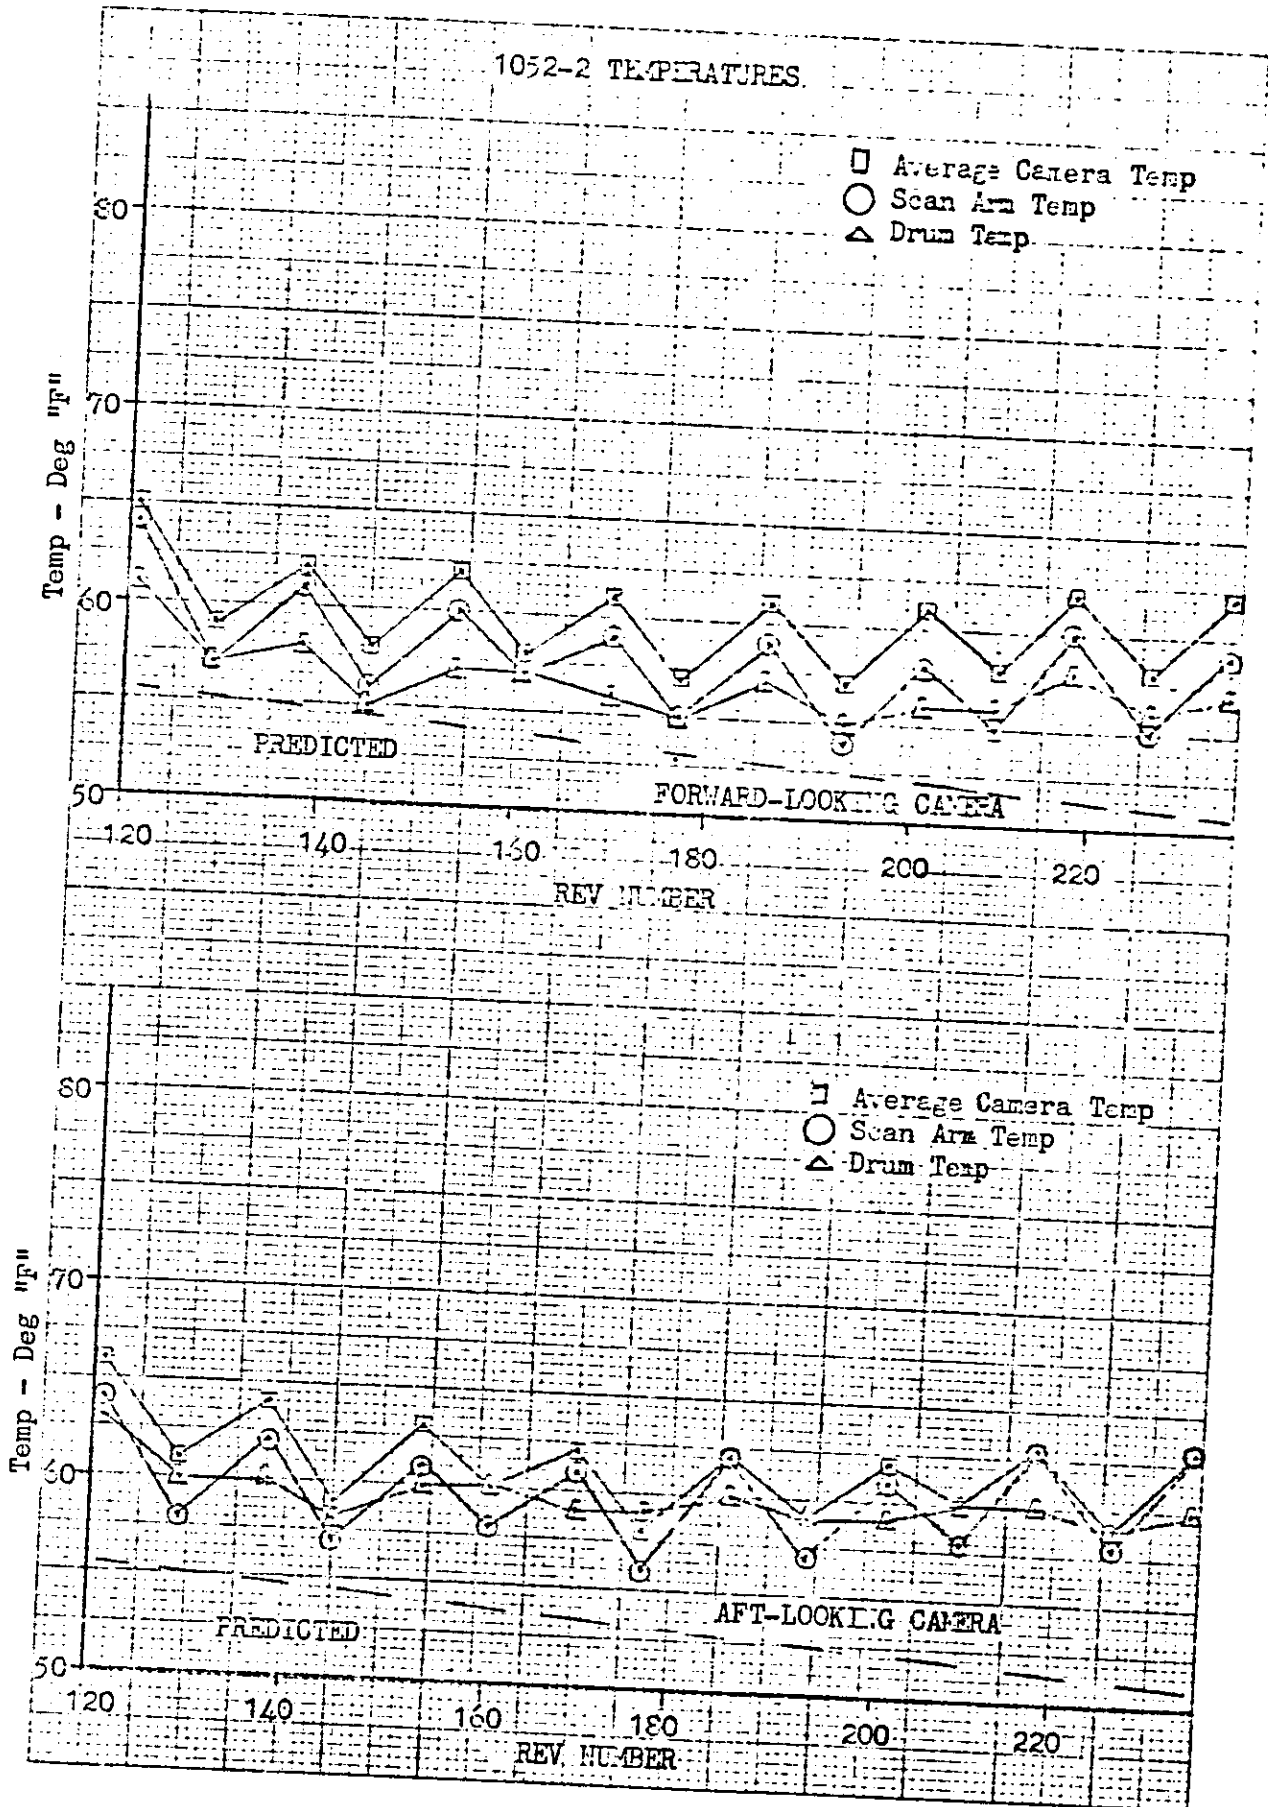
FIGURE 3-5

The thermal environment achieved with this system was near the pre-flight predictions. The actual system temperatures were 70° F and 69° F for the master and slave cameras respectively for the beginning of the -1 mission and 68° F and 70° F at the end of the -1 mission. The -2 mission system temperatures were 65° F and 66° F for the start and 58° F and 60° F for the end of the -2 mission for the master and slave cameras respectively. A graph depicting average camera temperatures versus predicted temperatures is included in Figures 3-5 and 3-6.
