CORONA J
PERFORMANCE EVALUATION REPORT
MISSION 1052-1 and 1052-2
FTV 1653, J-46

This report presents the final performance evaluation of Corona Mission 1052. The purpose of this report is to define the performance characteristics of the J-46 payload system and to evaluate the technical characteristics of the mission, including analysis of any in-flight anomalies.

This document constitutes the final payload test and performance evaluation report for Mission 1052 which was launched on 22 September 1969.

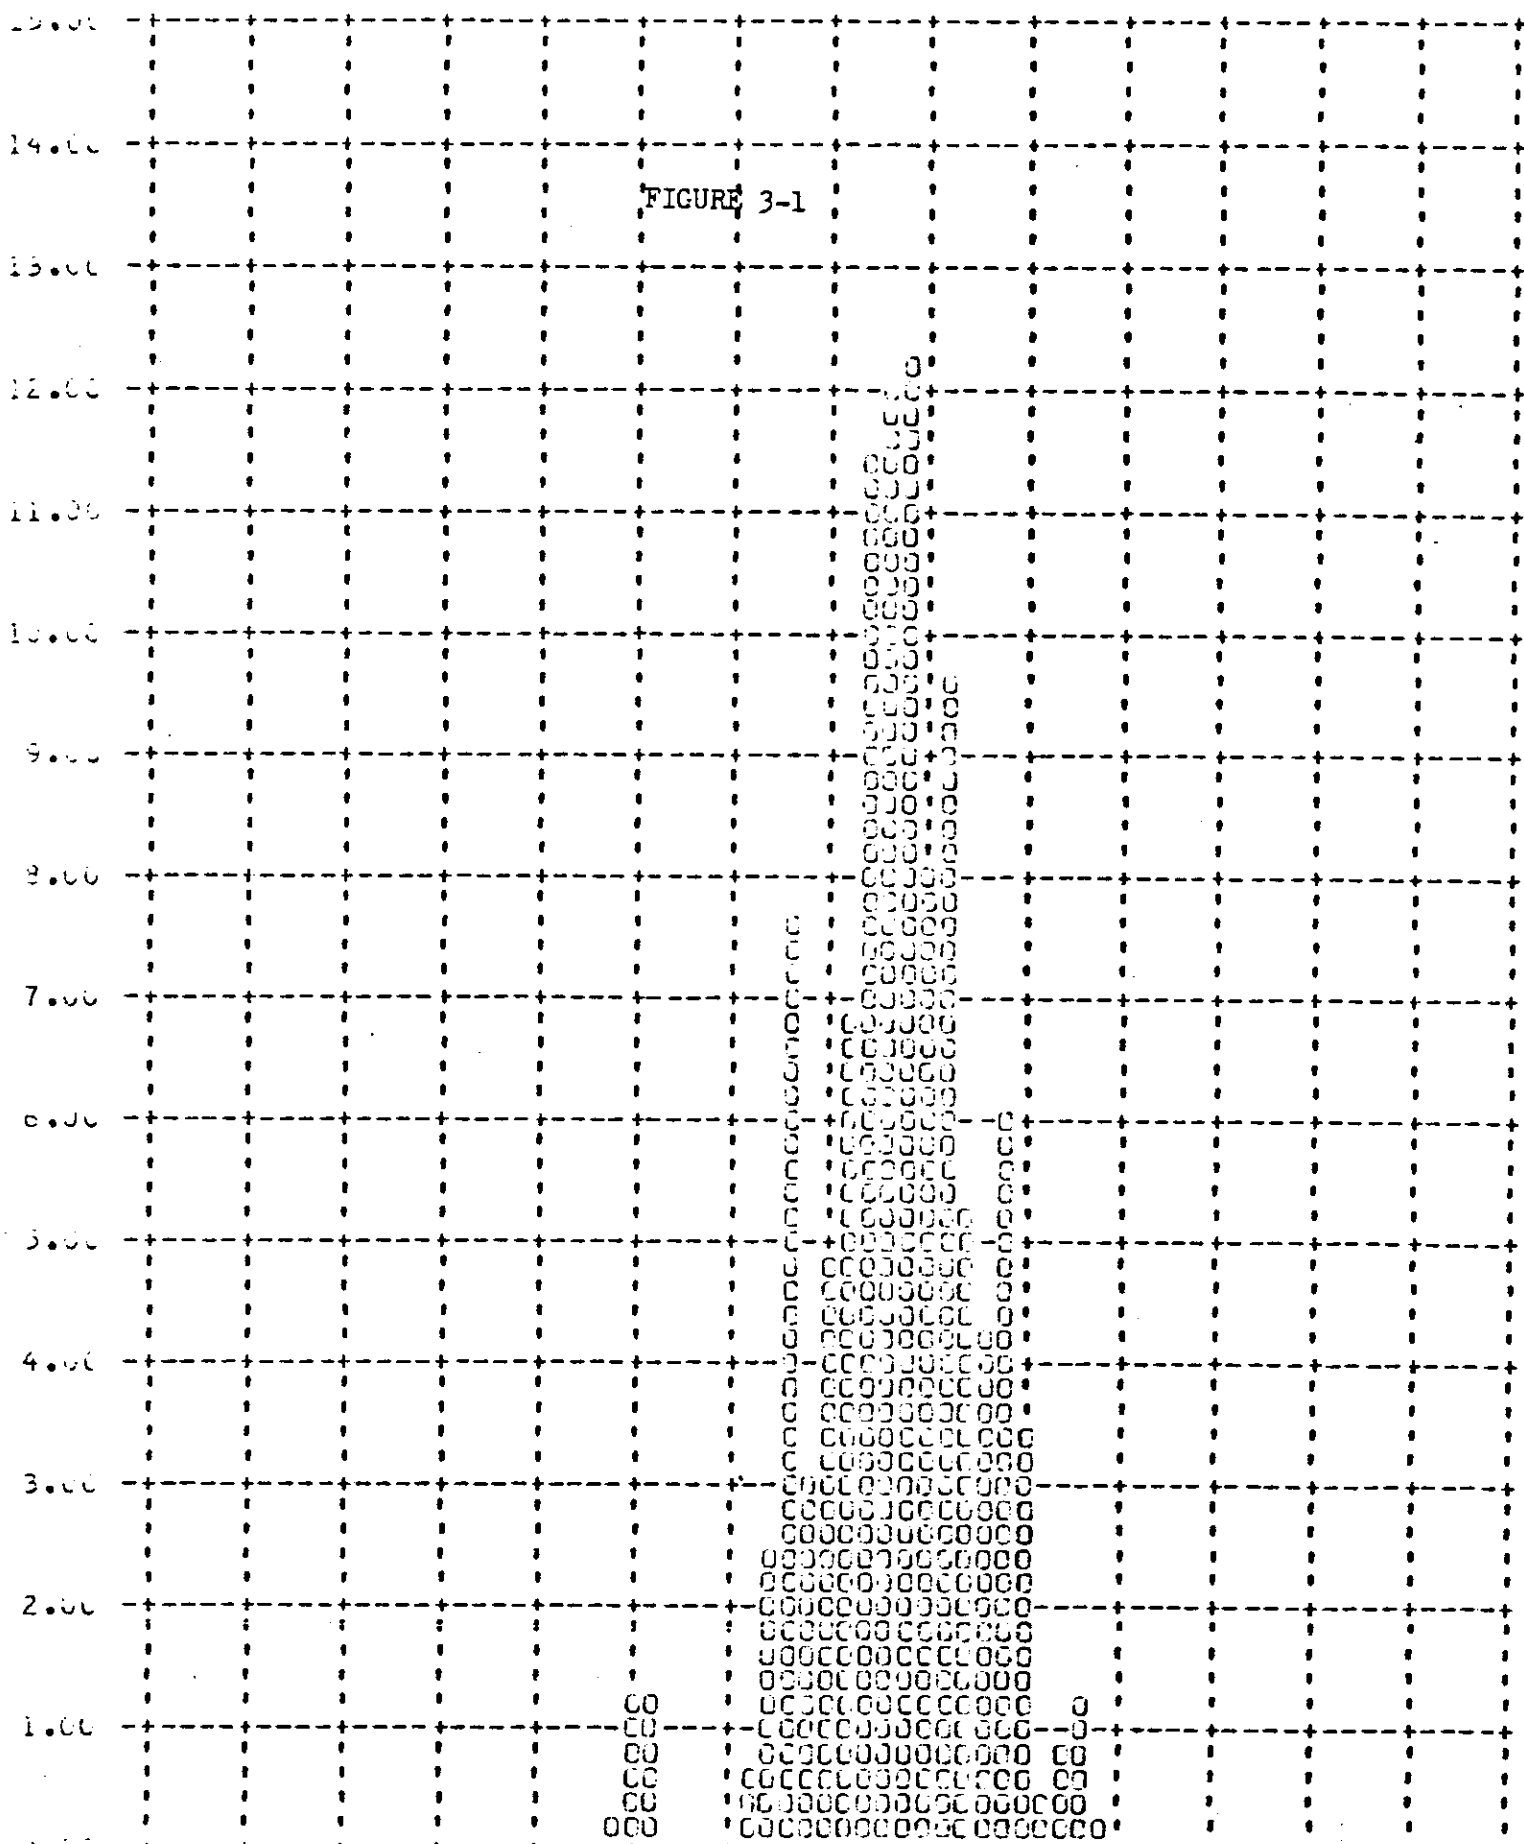
FIGURE 3-1

The actual V/H ratio error for each camera for each mission is shown in Figures 3-1 through 3-4. It can be observed from these plots that good FMC match was achieved. Consequently image smear was held to a minimum as discussed in Section 6.
