CORONA J
PERFORMANCE EVALUATION REPORT
MISSION 1110-1 and 1110-2
FTV 1656, CR-11

This report details the performance of the payload system during the operational phase of the Program [REDACTED] Flight Test Vehicle 1656.

Lockheed Missiles and Space Company has the contractual responsibility for evaluating payload performance. This document is the final payload test and performance evaluation report for Mission 1110-1 and 1110-2 which was launched on 20 May 1970.

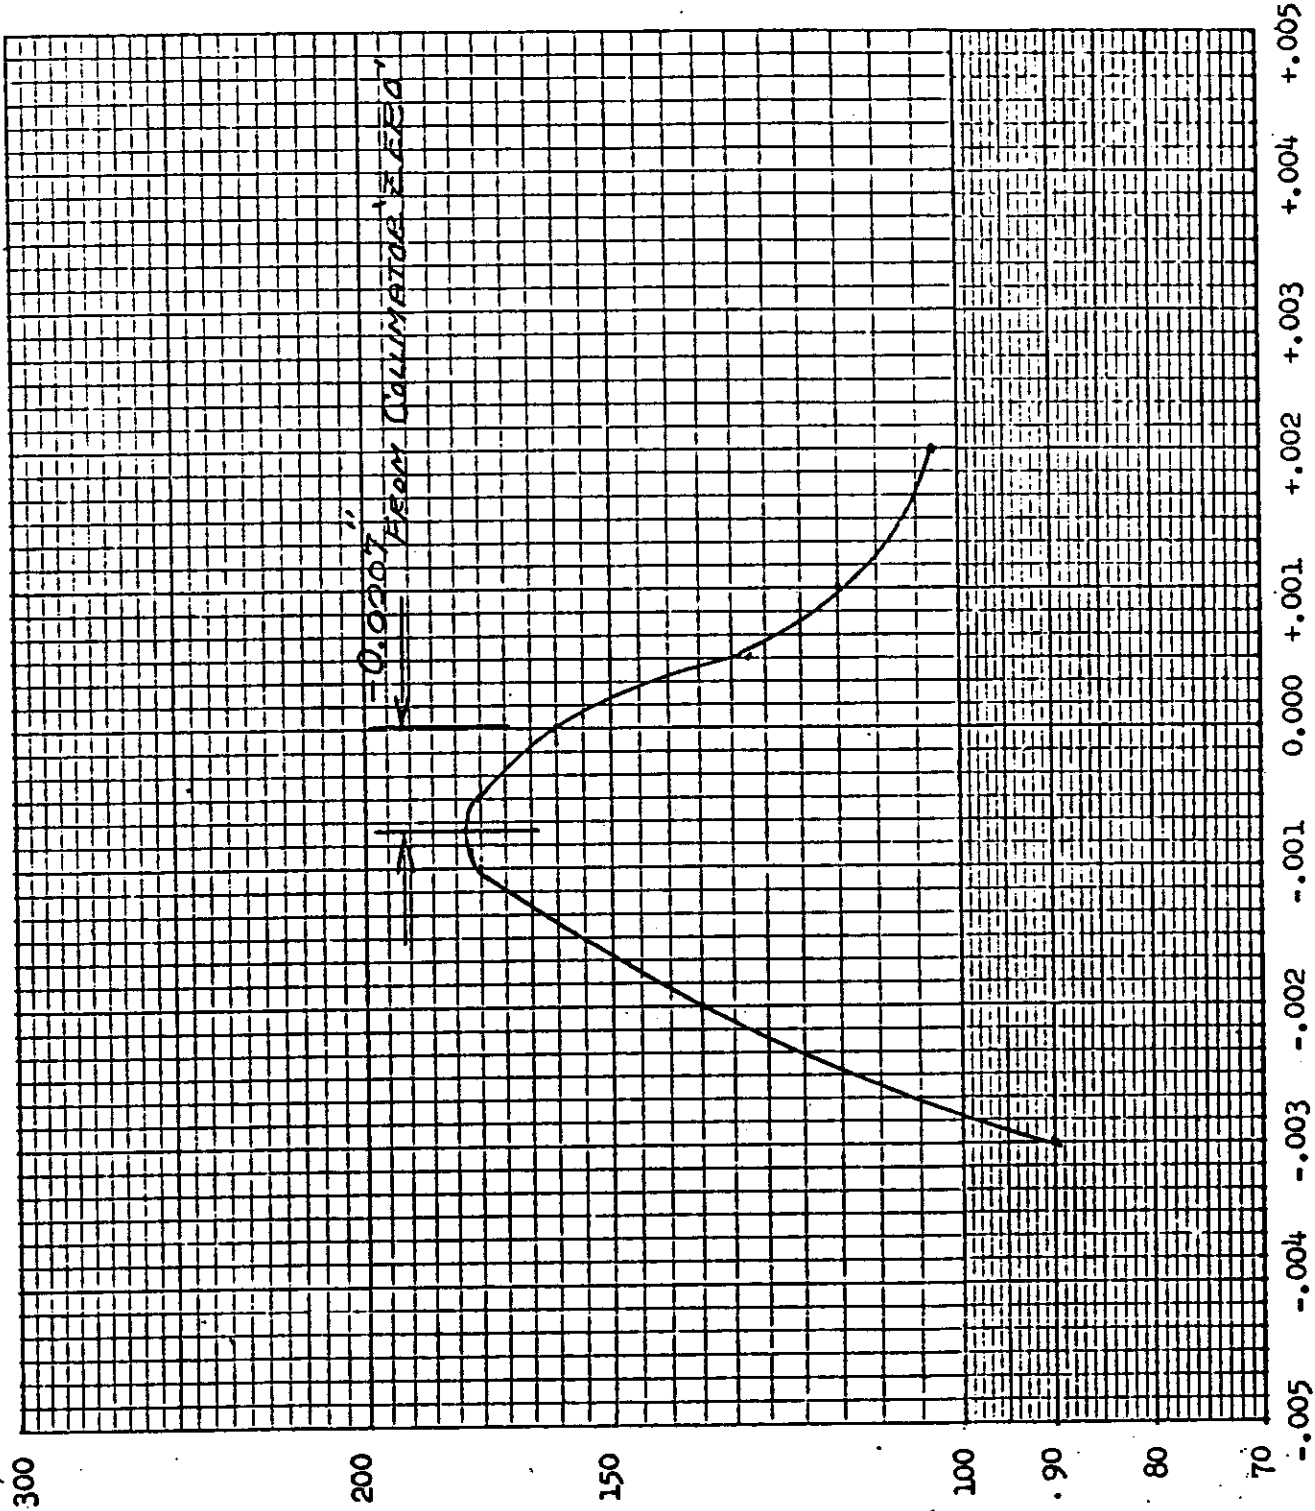
FIGURE 2-1

Maximum low contrast resolution 125 lines/mm at -0.0010 inches peak focal position.

Fwd-looking Camera No. 323

Maximum low contrast resolution 178 lines/mm at -0.0007 inches peak focal position.

The final test data for both cameras is shown in Figures 2-1 and 2-2. Both cameras met the system requirements specification.

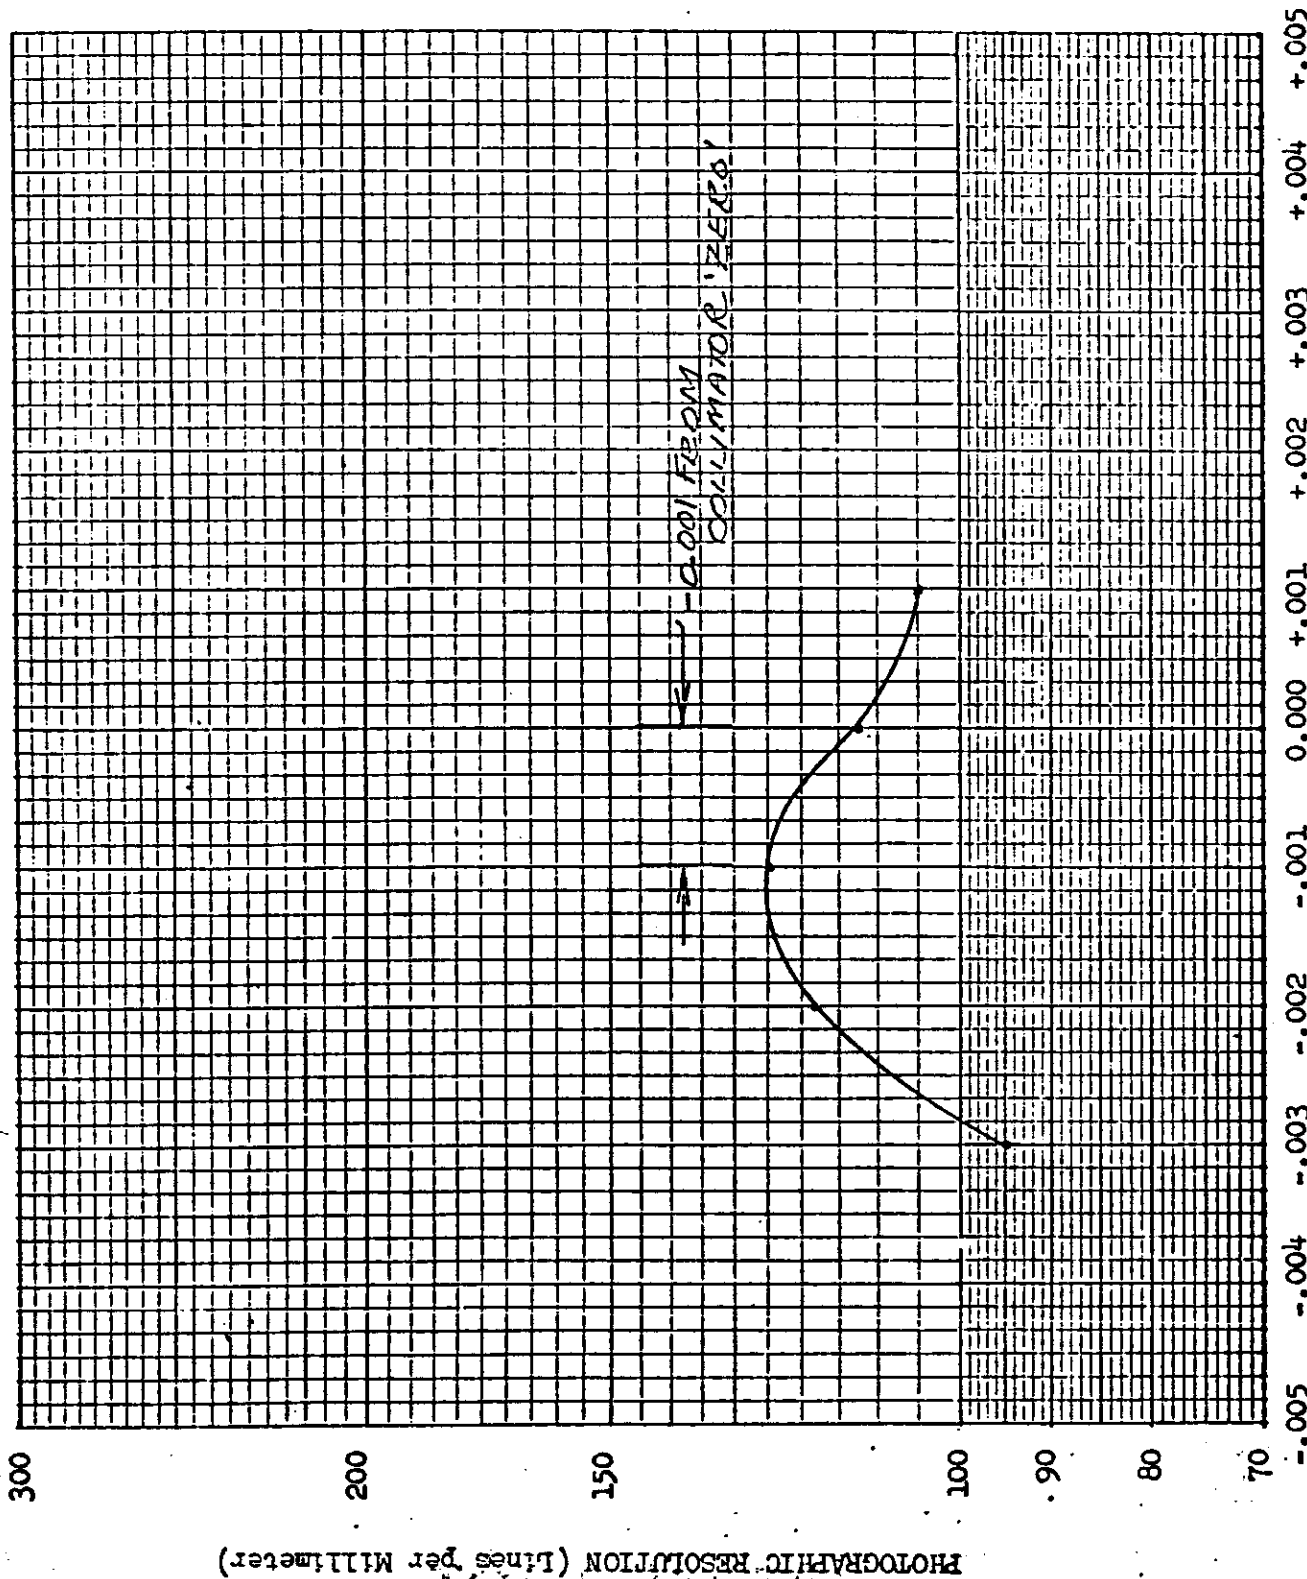
THROUGH FOCUS INCREMENTS (Inches)
FIGURE 2-2

Results of the through-focus resolution test on pan cameras 322 and 323 show the following characteristics:

Aft-looking Camera No. 322

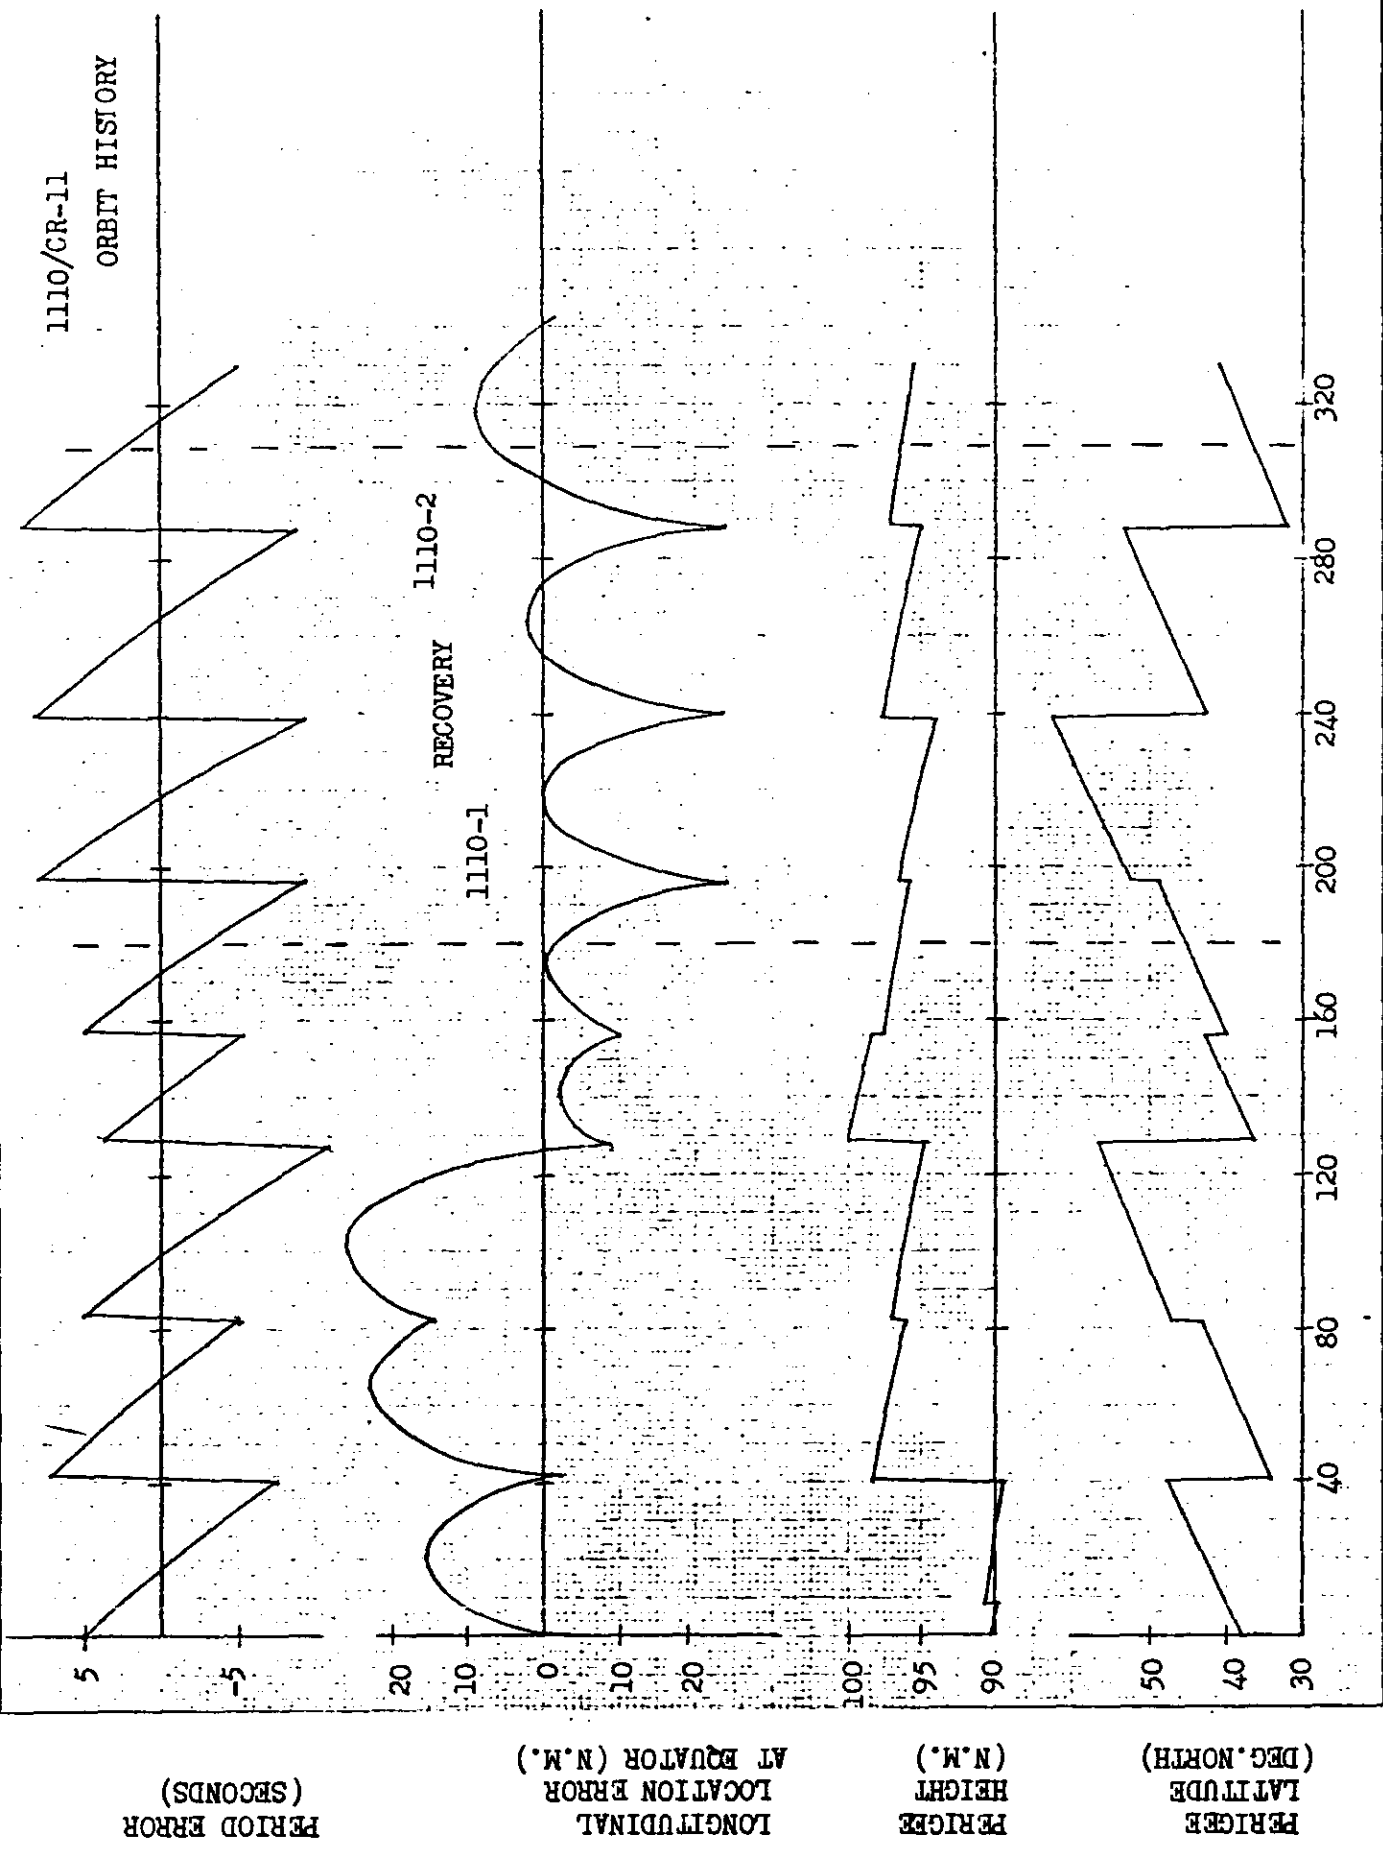
ORBIT REVOLUTION
FIGURE 3-1

Seven DMU rockets were fired during the mission to maintain ground track and period control. The Ground Track Error at the ascending node ranged from 25.8 nautical miles west to 23.3 nautical miles east. The DMU firings programmed, were satisfactory for attaining mission objectives. The following is a summary of DMU firings:

Figures 3-1 and 3-2 are plots of orbit history and operation distribution data.

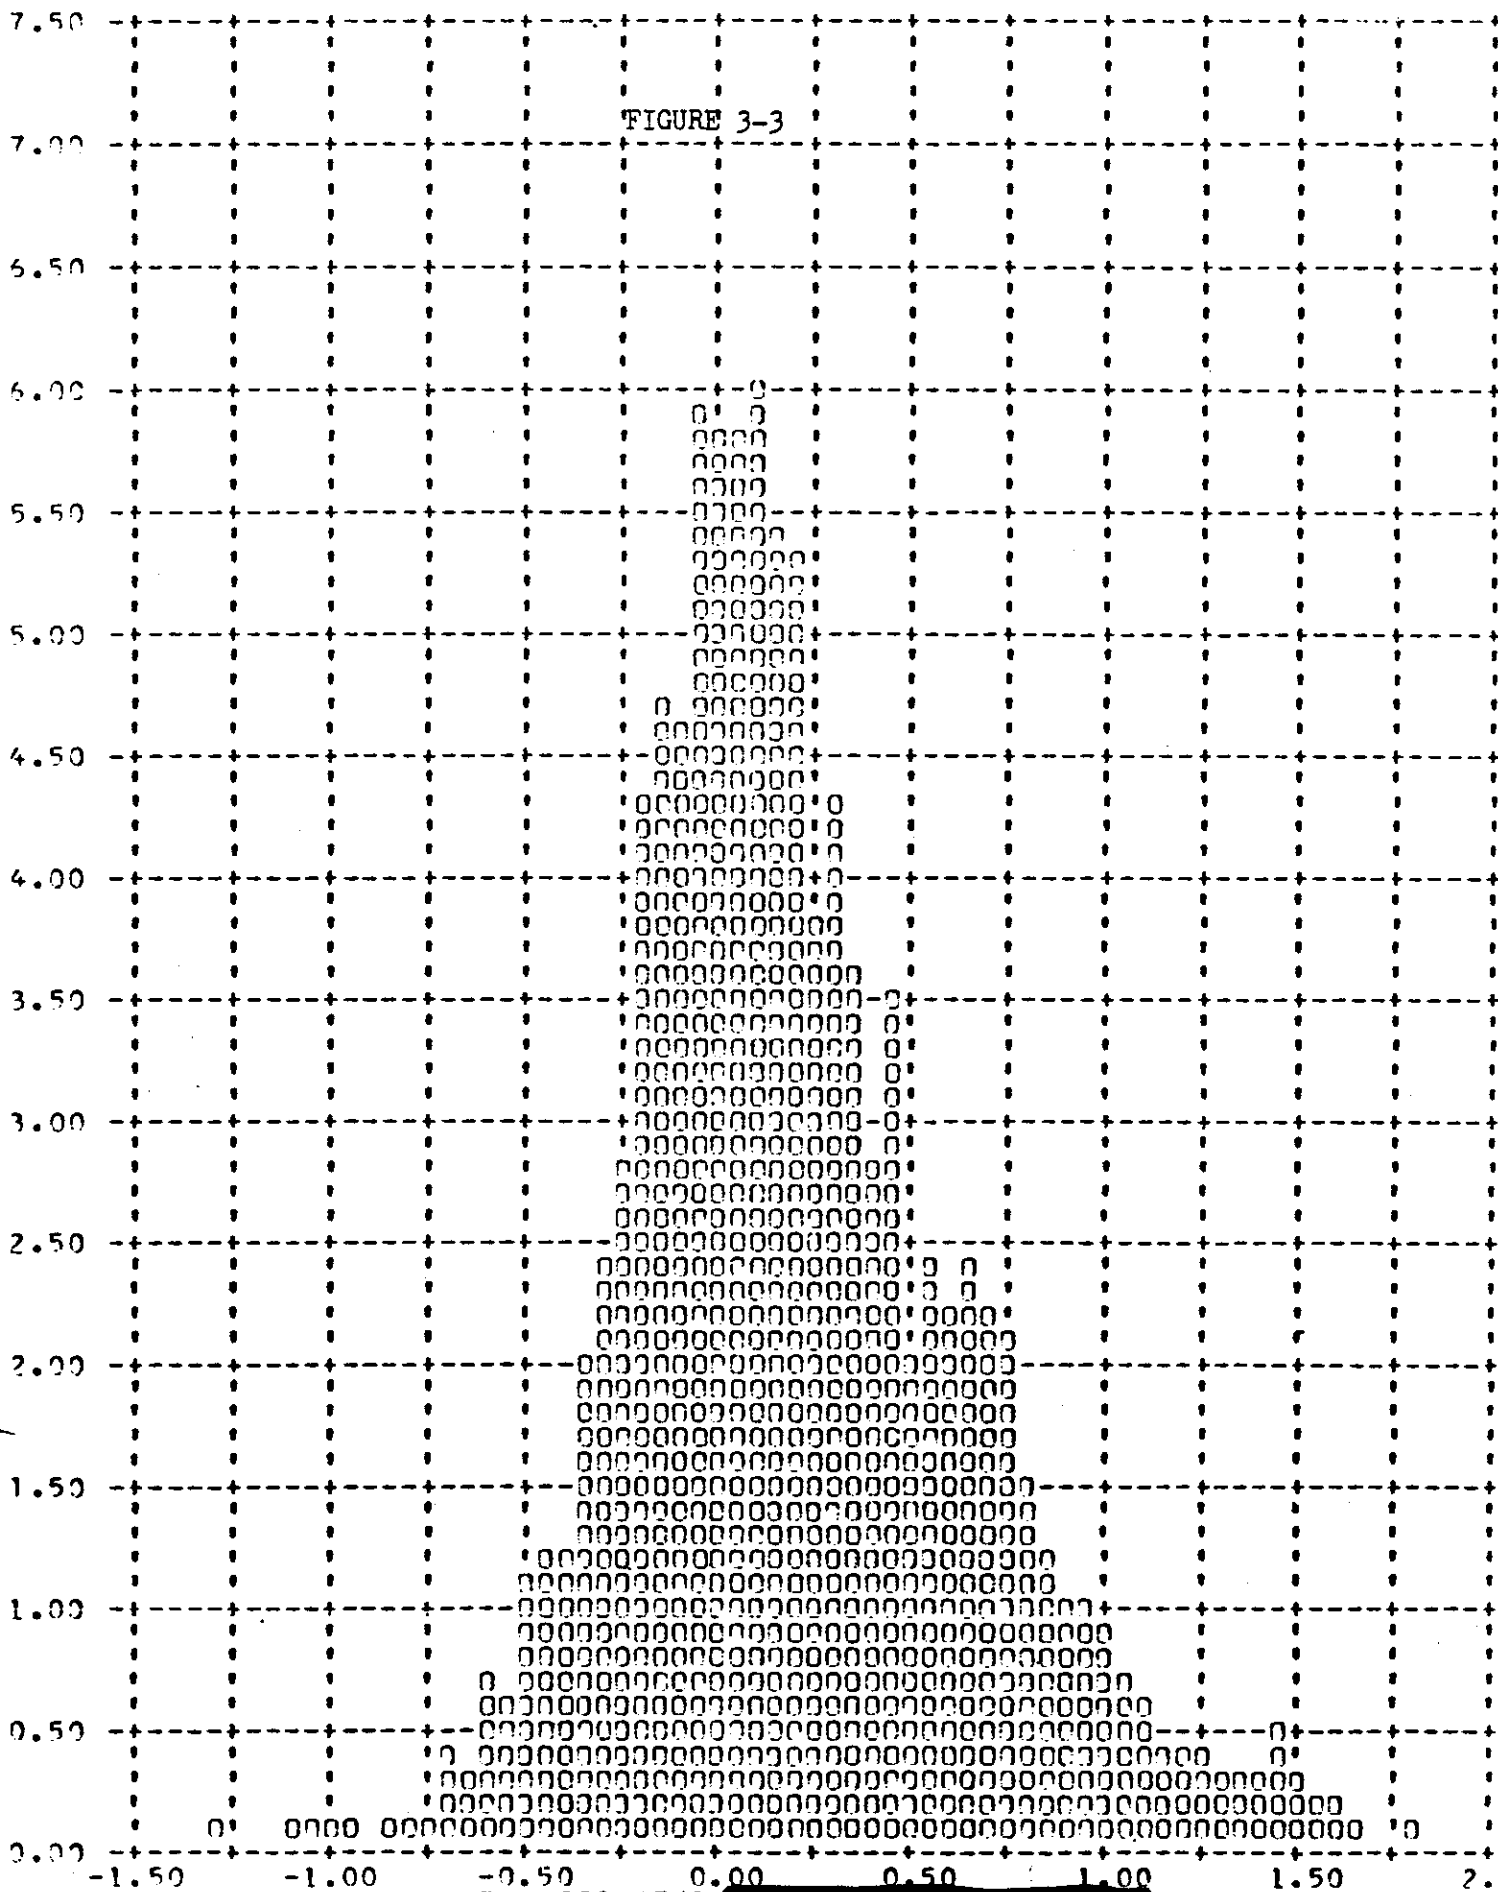
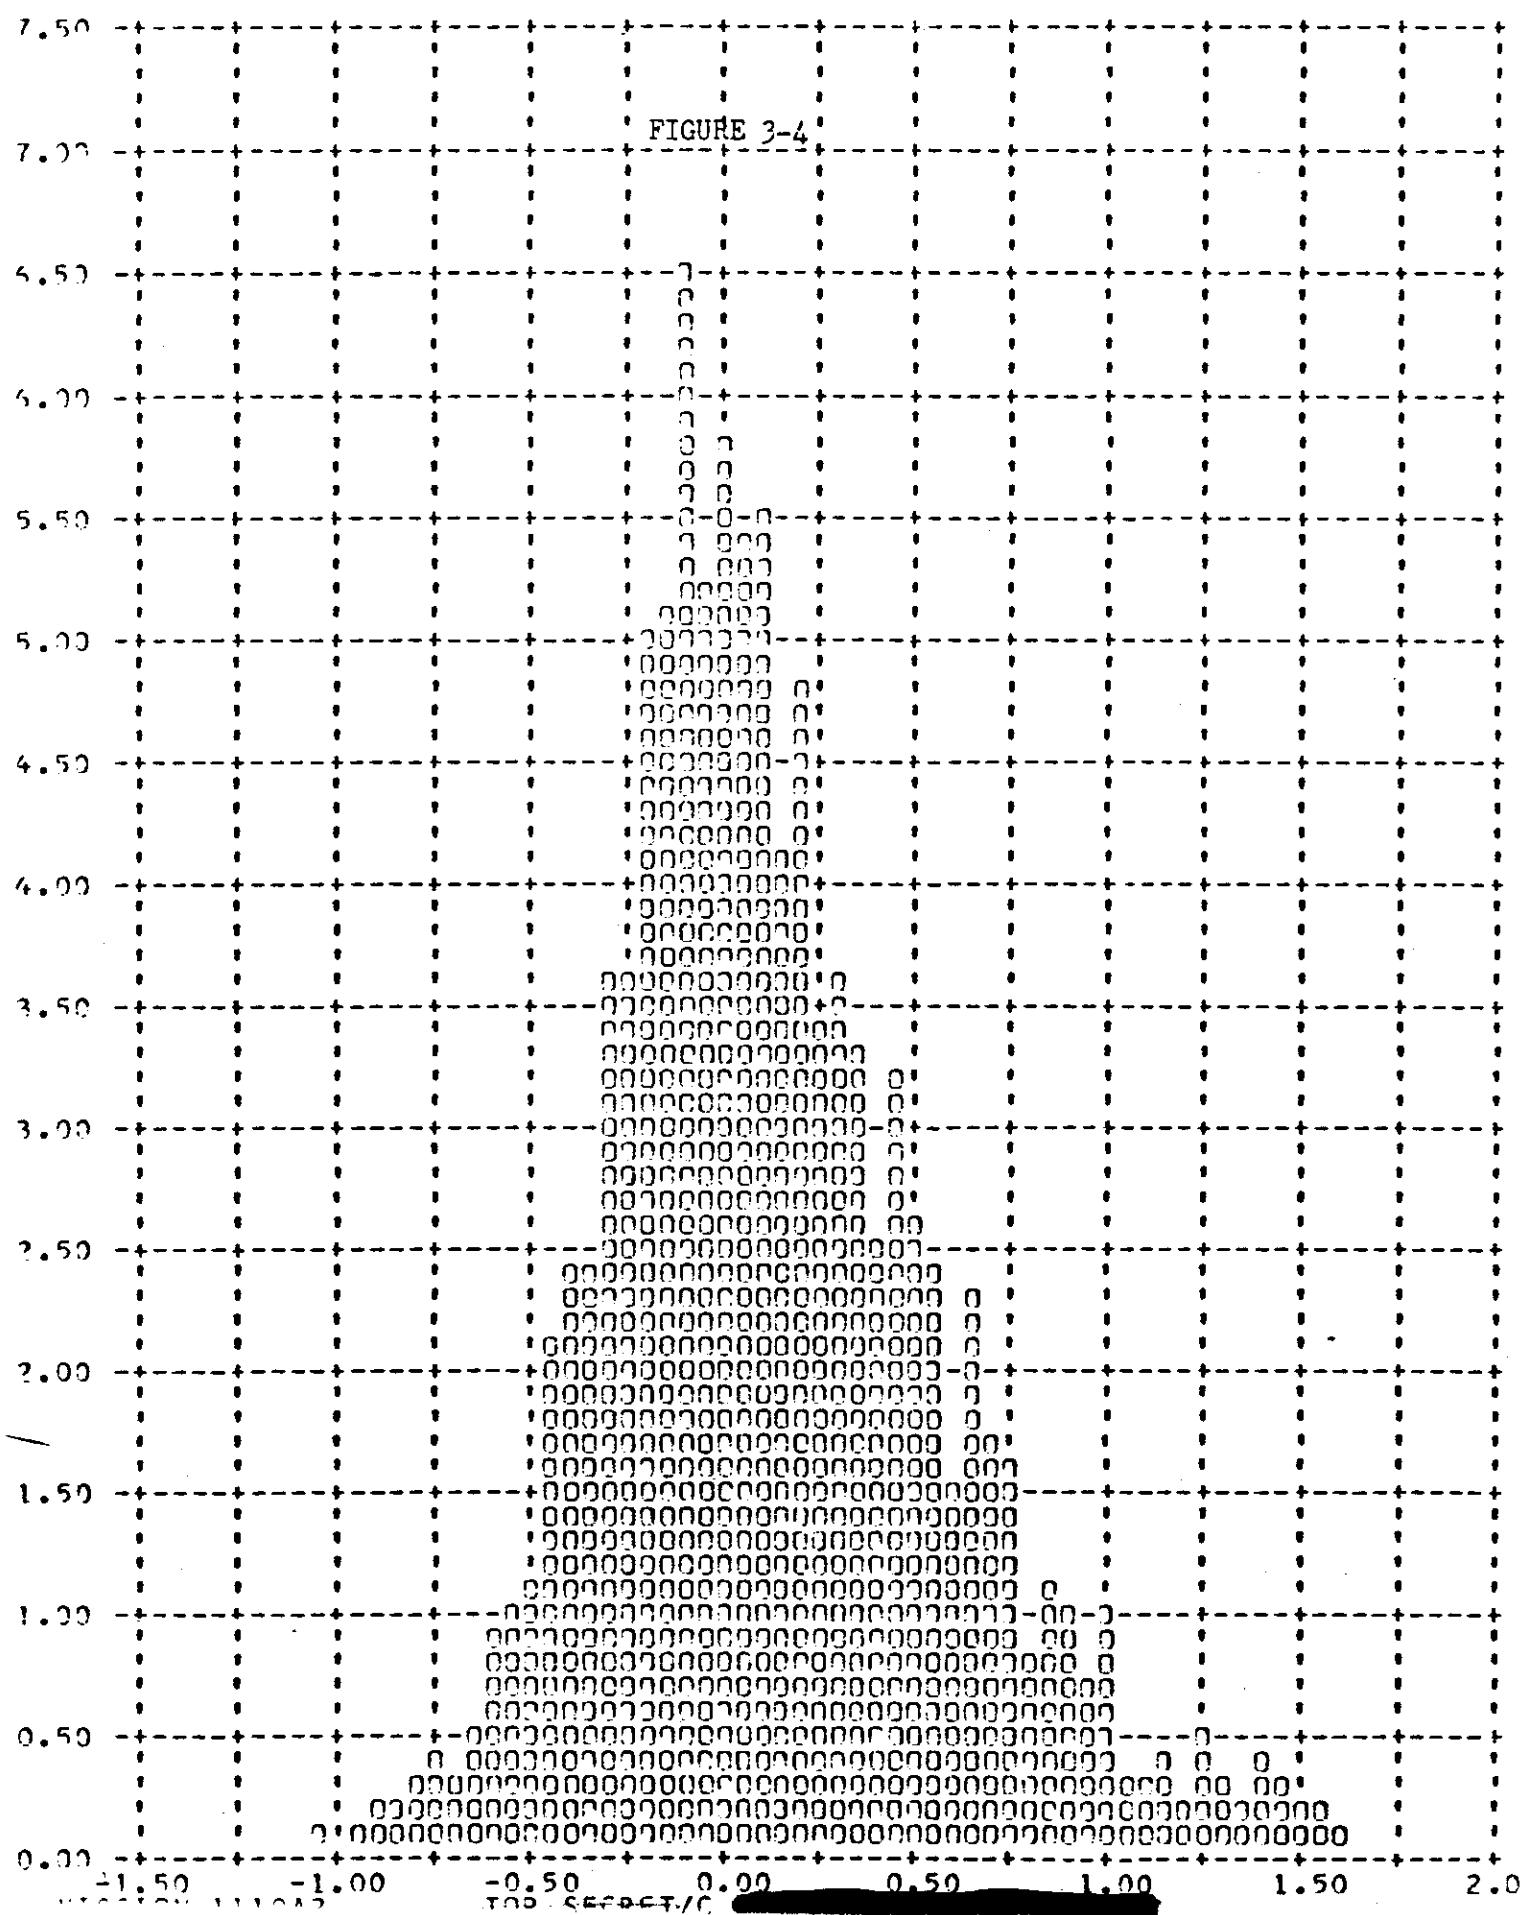
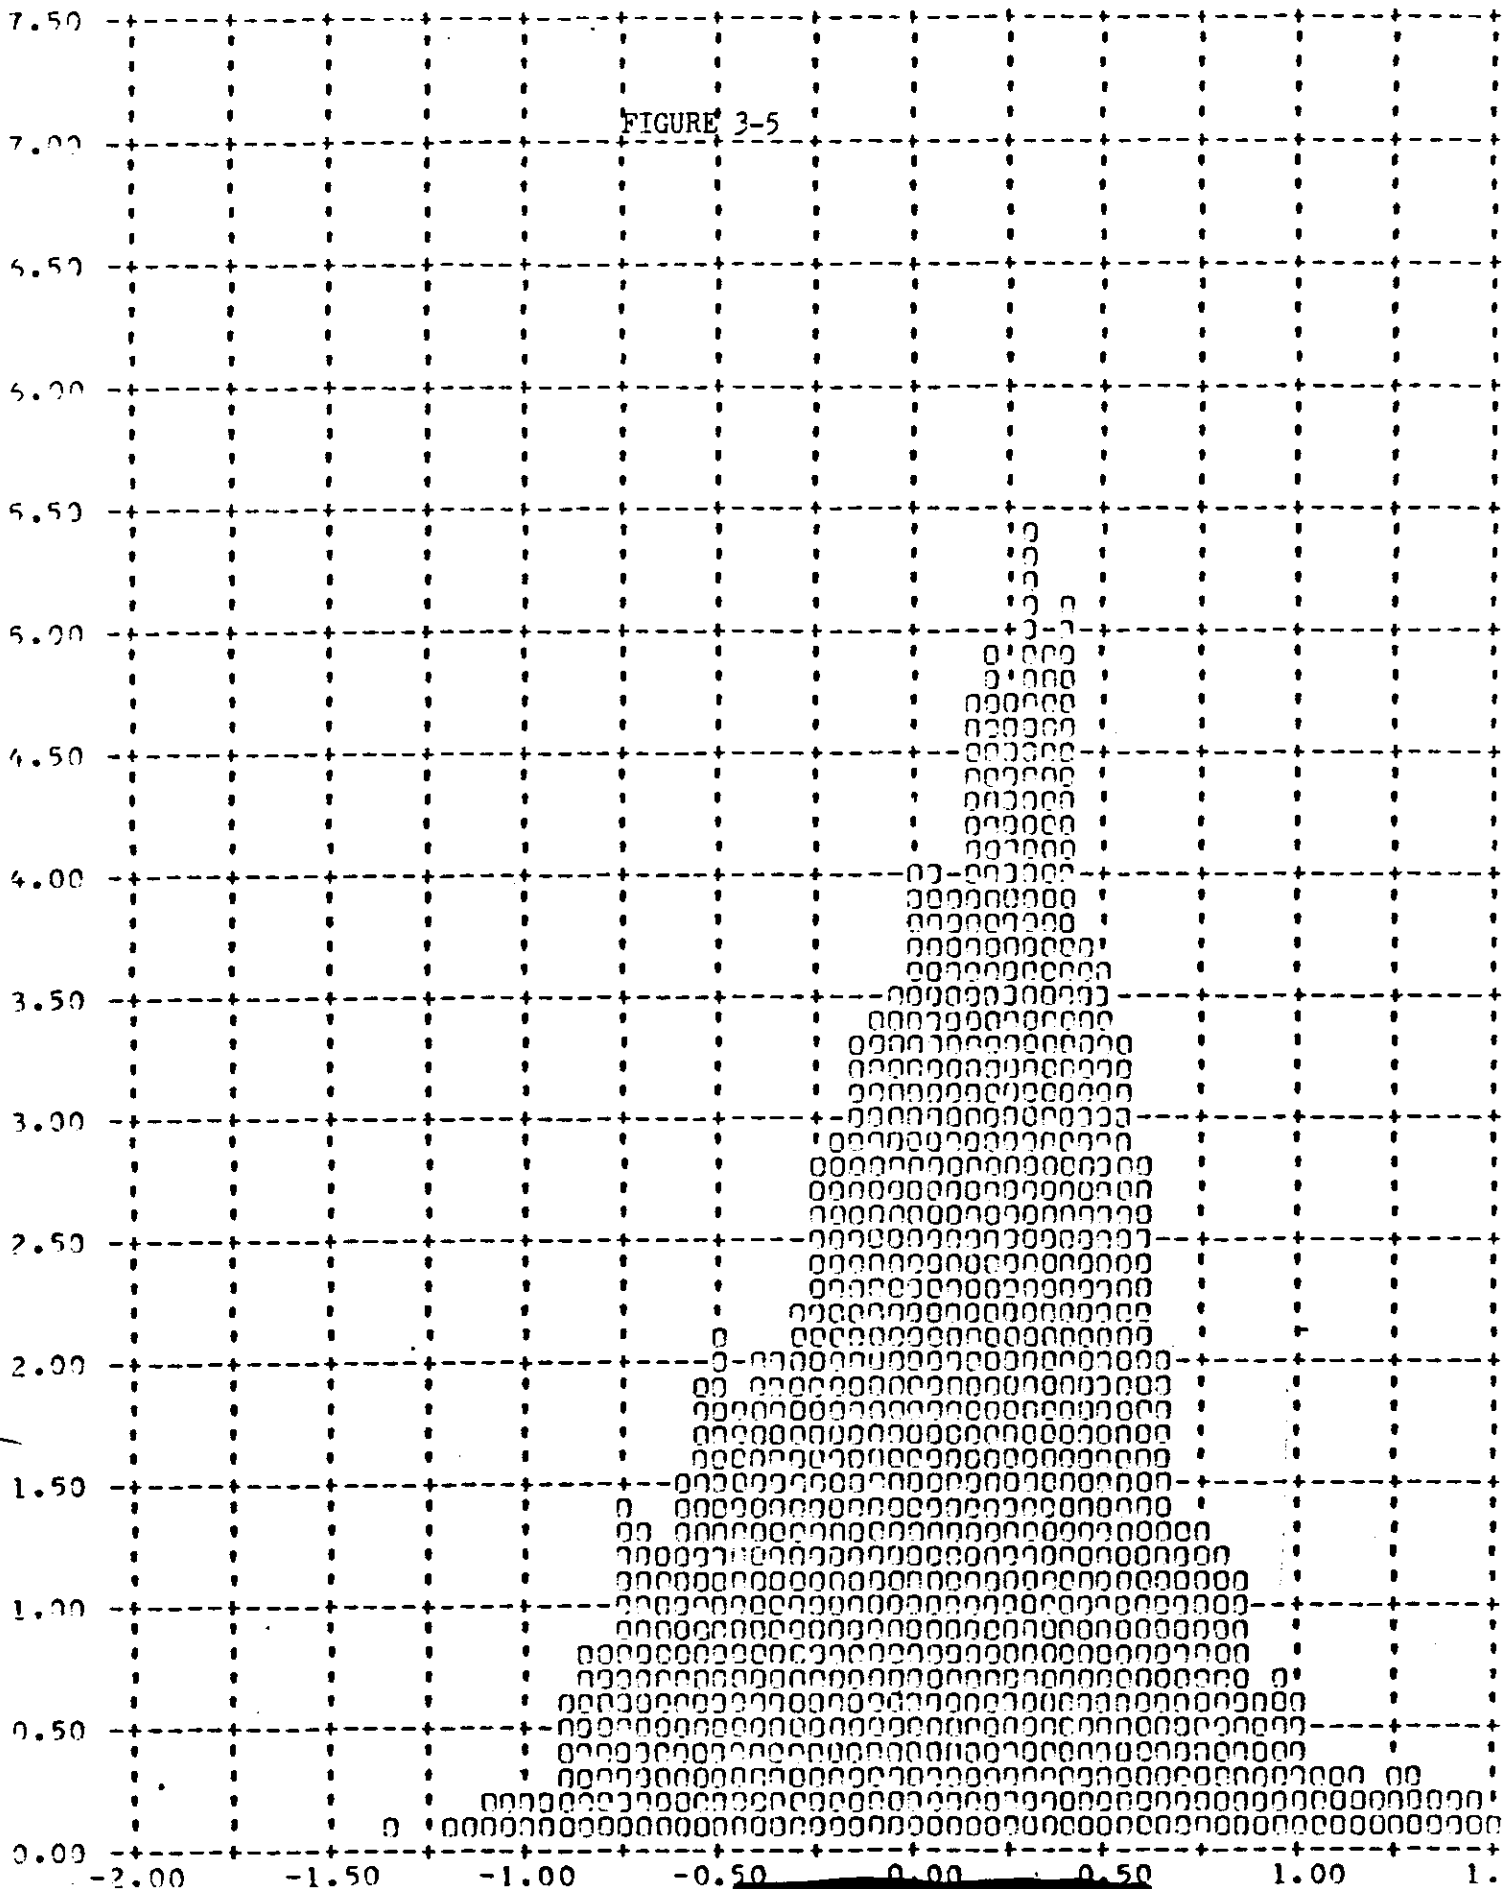
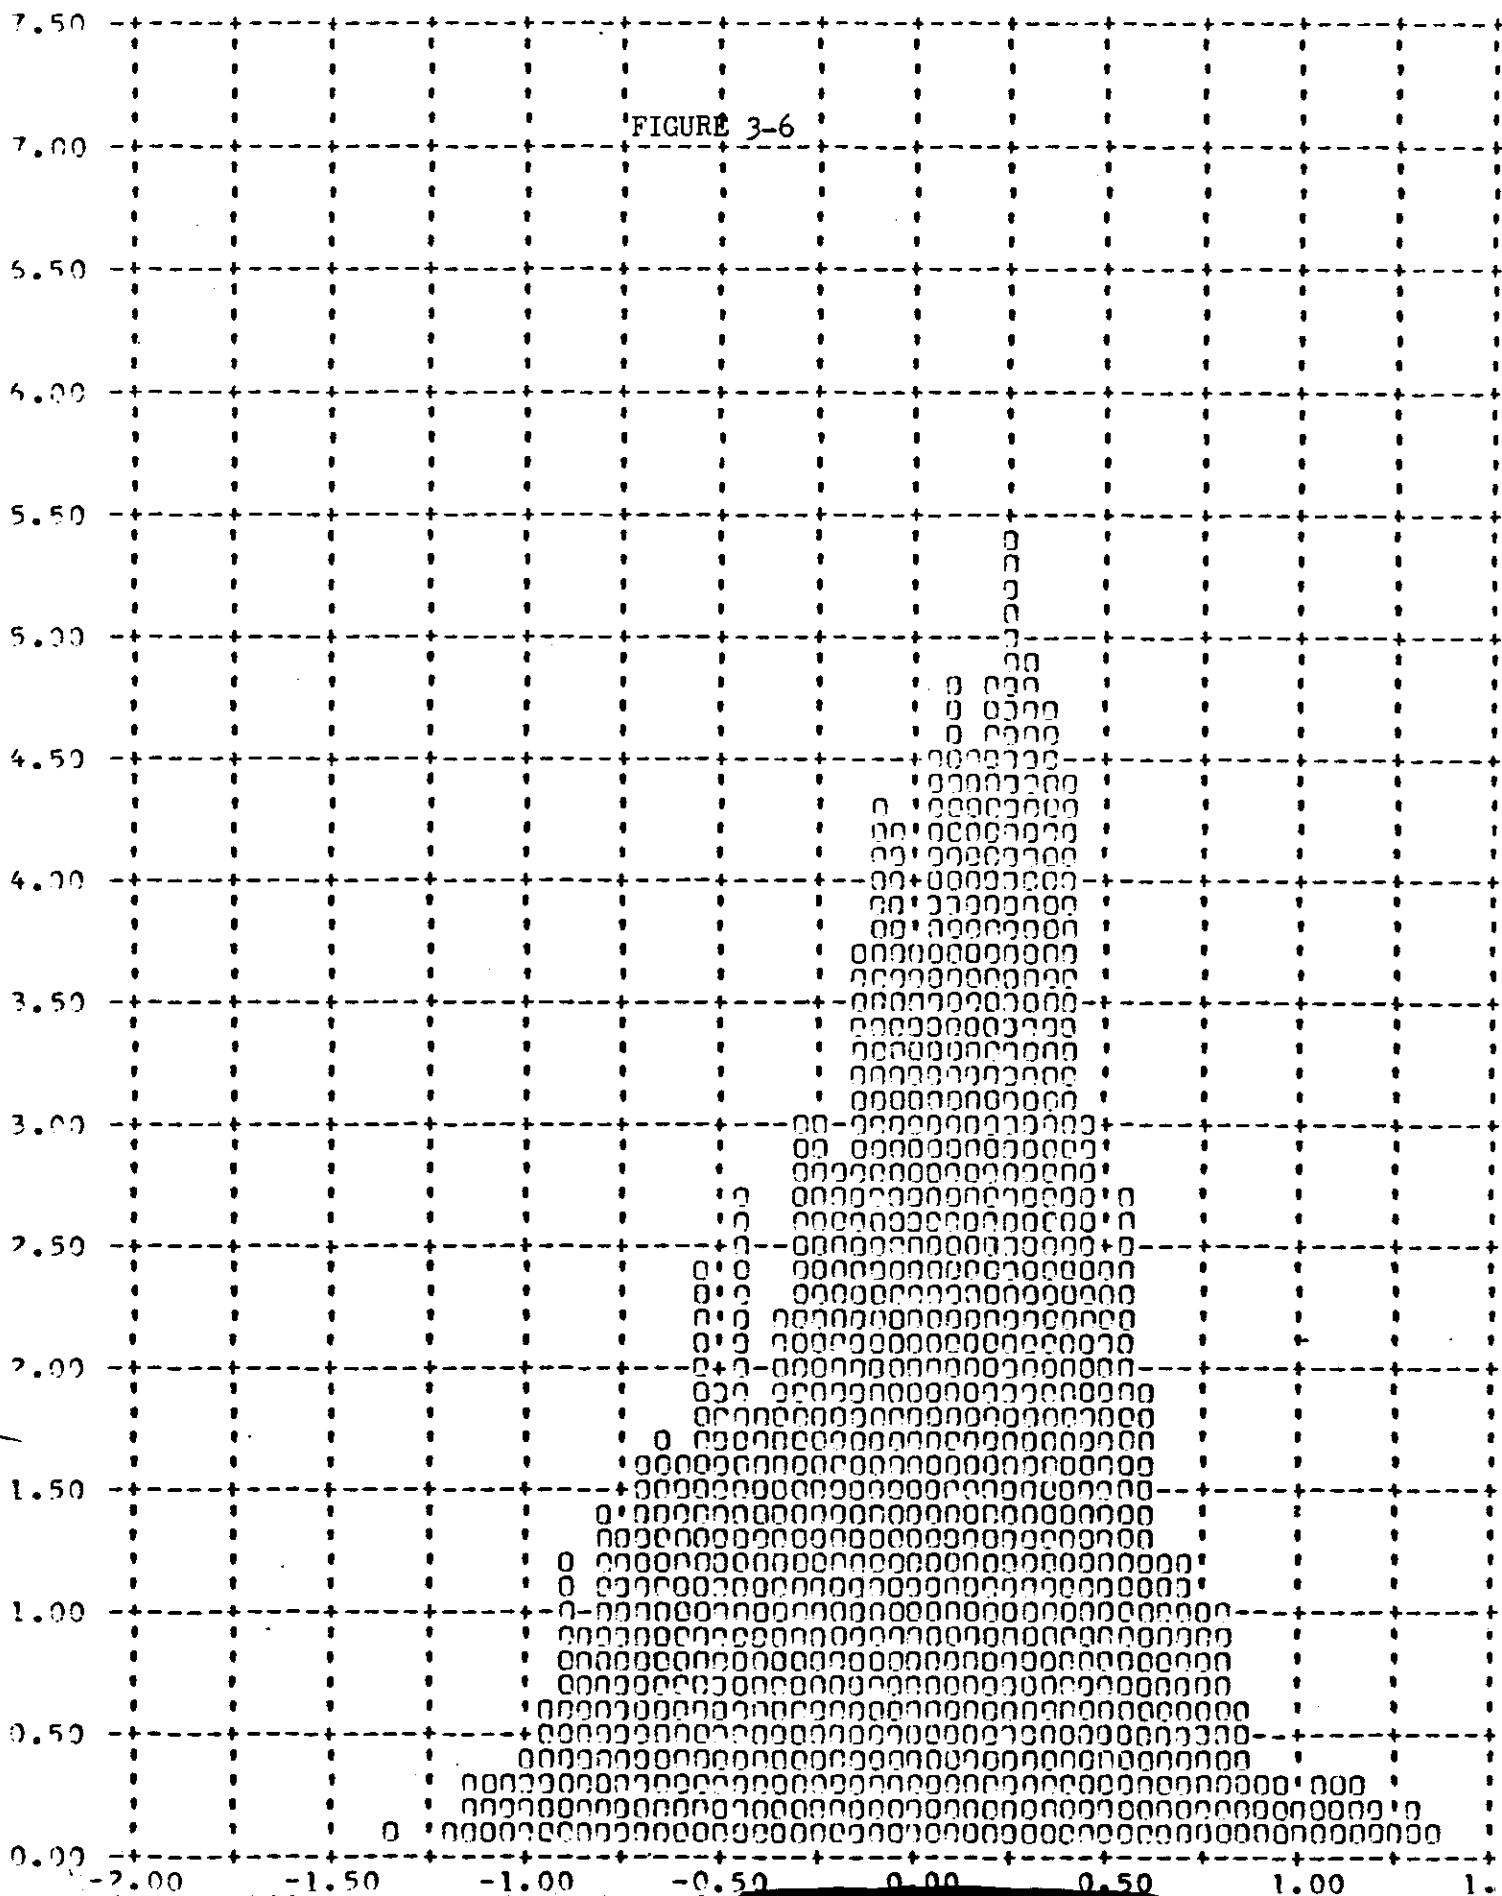
FIGURE 3-4

The FMC programmer operated satisfactorily during the entire mission. A satisfactory match to the required FMC was maintained throughout the -1 and -2 missions. Mismatch error was less than plus or minus one percent for 82.5 percent

of the -1 mission operations and 89.3 percent of the -2 mission operations. The mean error was 0.22 percent for the -1 mission and 0.01 percent for the -2 mission. The V/H match performance is shown in Figures 3-3 through 3.6.

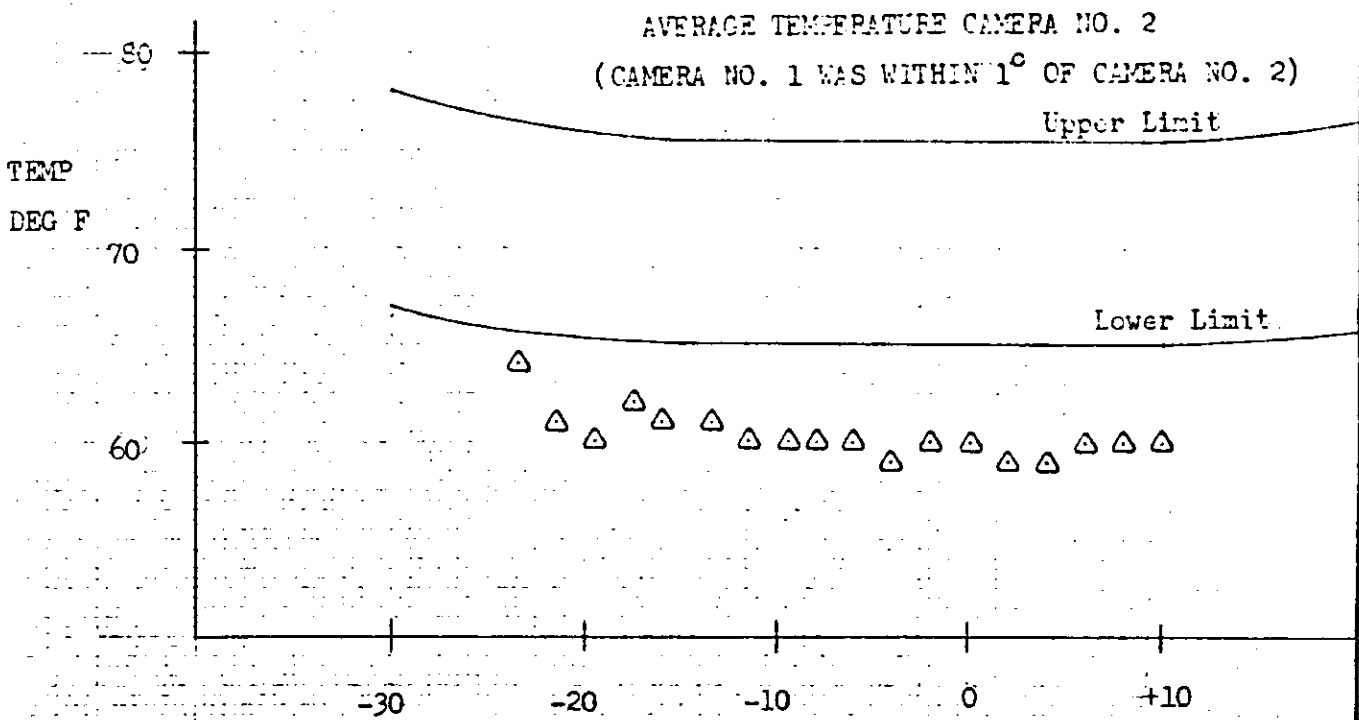
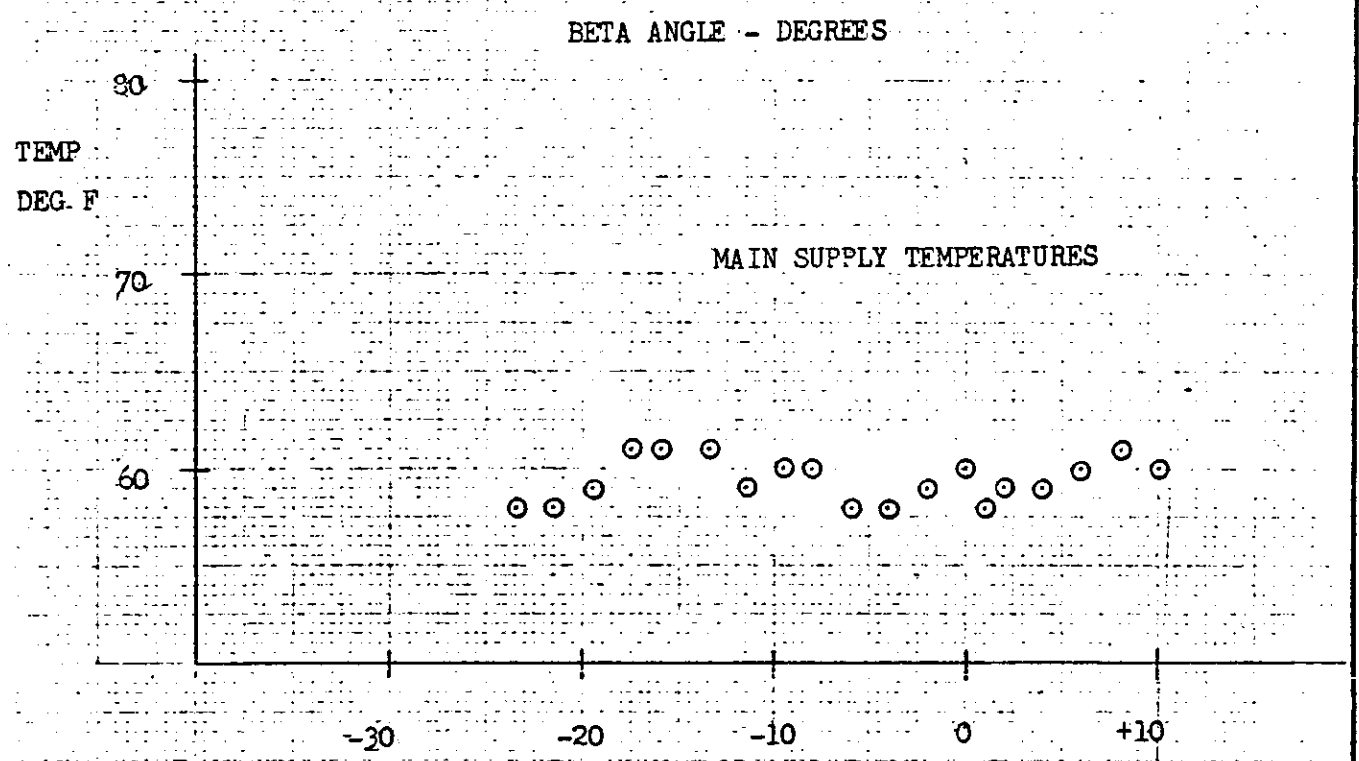
BETA ANGLE - DEGREES
FIGURE 3-7

Temperature data obtained during the flight indicated the temperature environment was below the pre-flight predictions. The average temperatures during the -1 mission were 61°F for both panoramic cameras. The average temperatures during the -2 mission were 60°F for both panoramic cameras. Figure 3-7 shows a graphical plot of the actual average camera temperature versus the predicted temperature as a function of the beta angle. Figures 3-8 and 3-9 show each camera's rail temperature for selected revs.
