CORONA J
PERFORMANCE EVALUATION REPORT
MISSION 1110-1 and 1110-2
FTV 1656, CR-11

This report details the performance of the payload system during the operational phase of the Program [REDACTED] Flight Test Vehicle 1656.

Lockheed Missiles and Space Company has the contractual responsibility for evaluating payload performance. This document is the final payload test and performance evaluation report for Mission 1110-1 and 1110-2 which was launched on 20 May 1970.

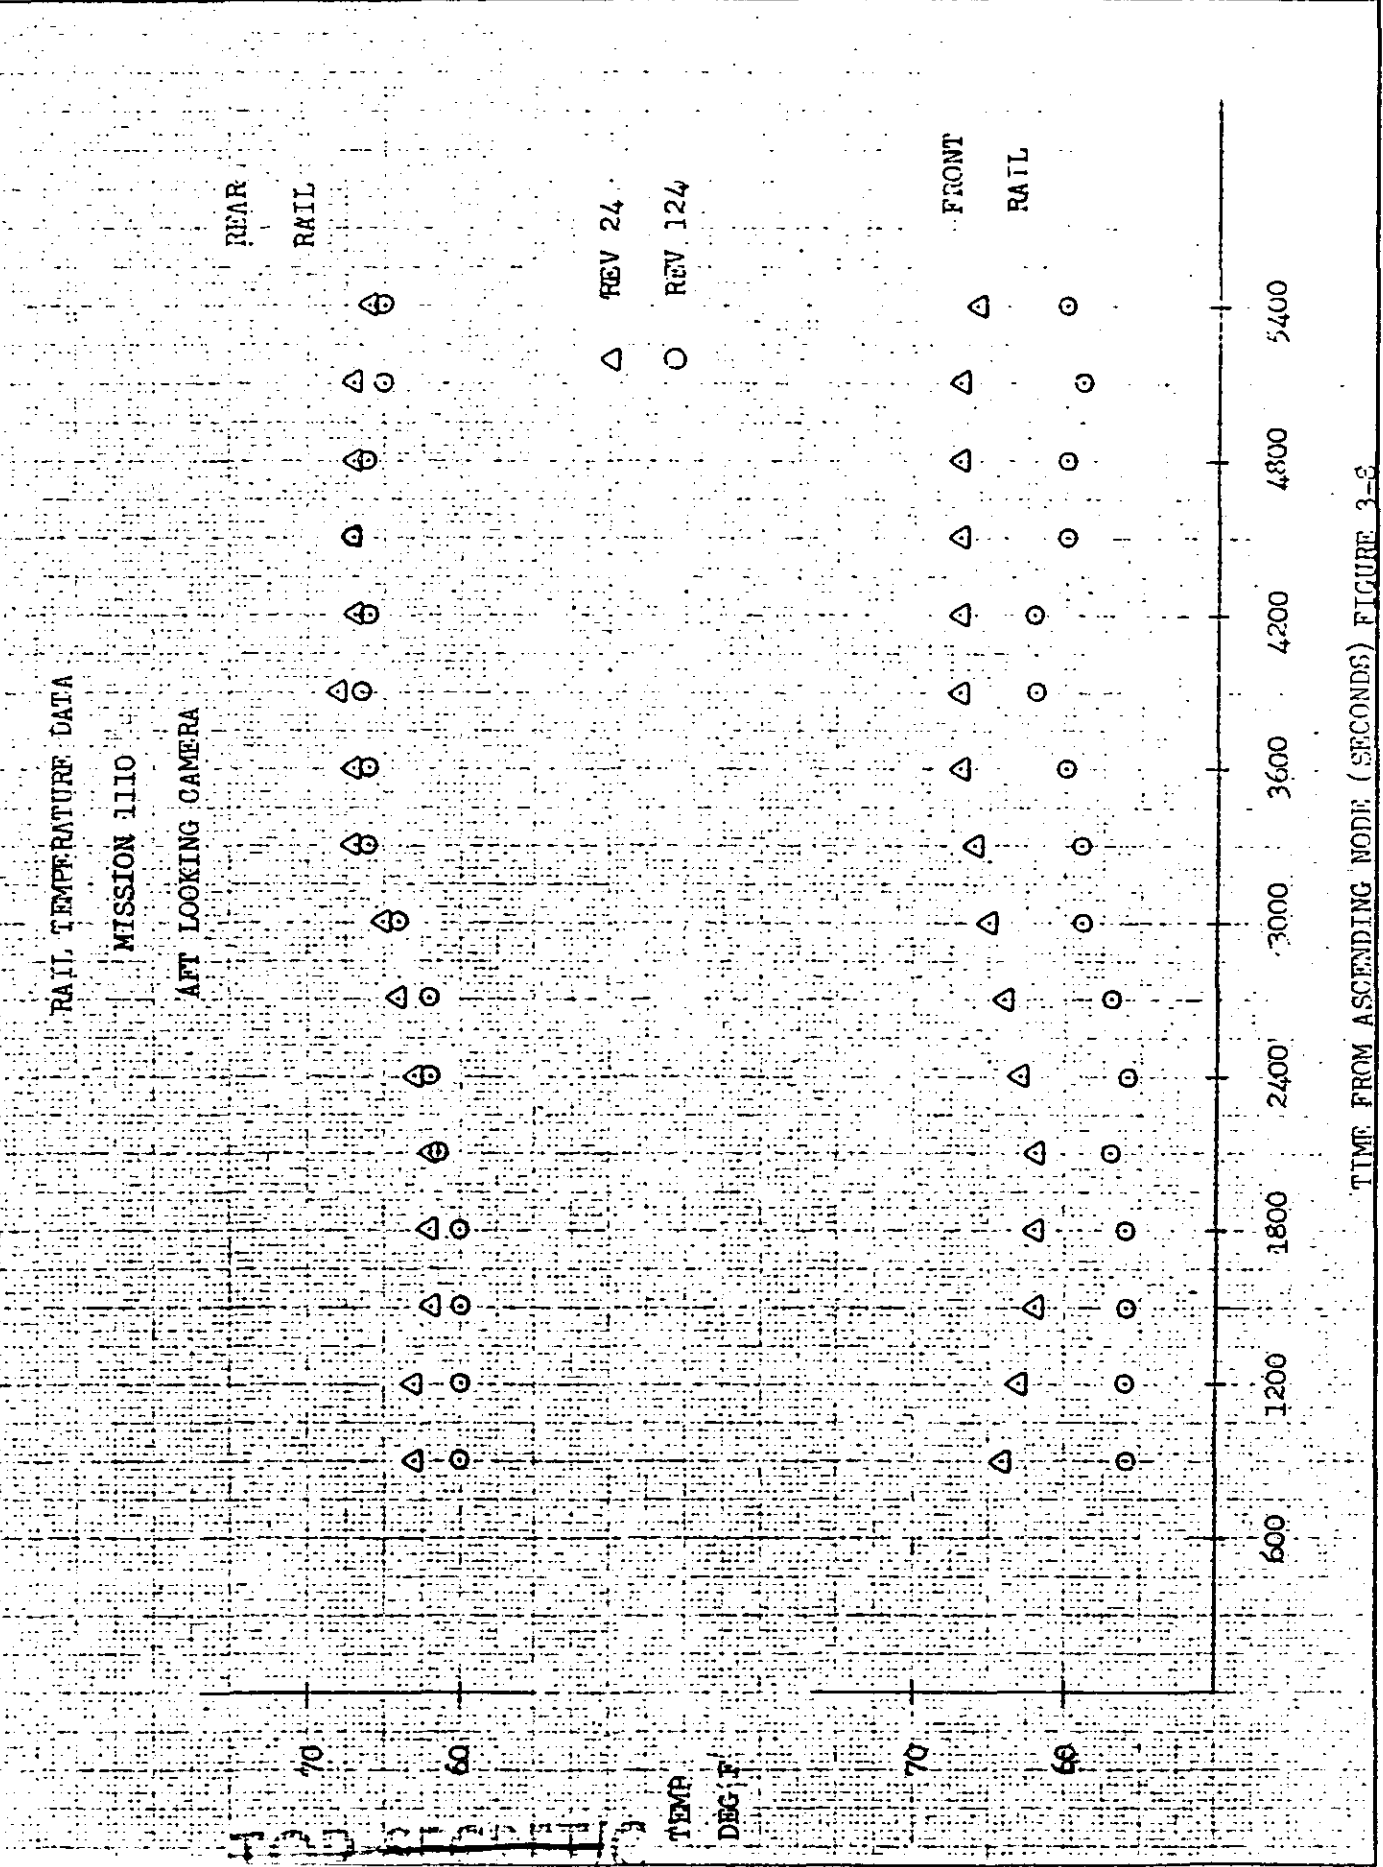
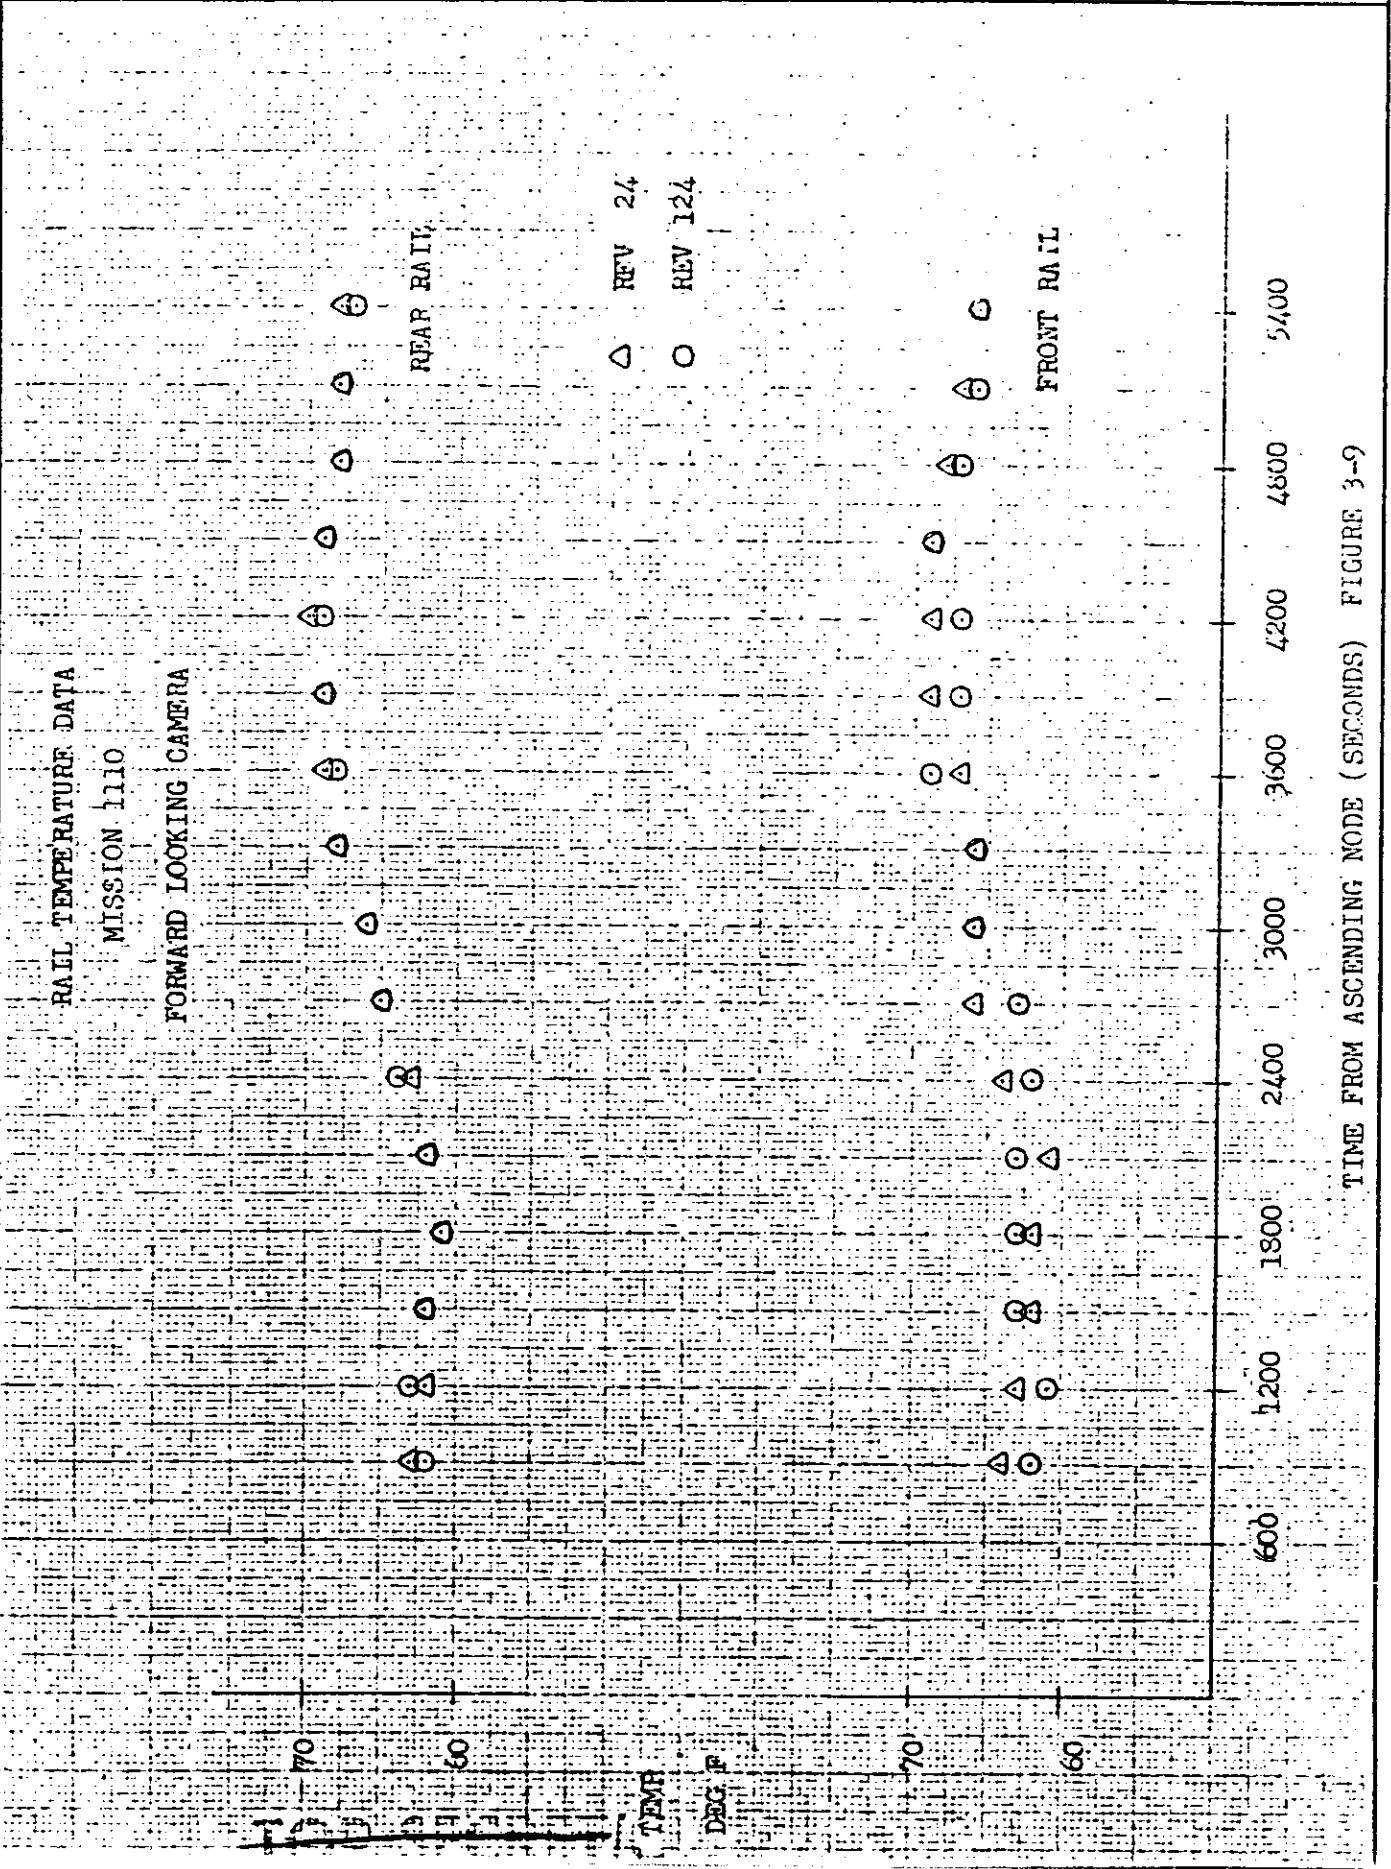
Temperature data obtained during the flight indicated the temperature environment was below the pre-flight predictions. The average temperatures during the -1 mission were 61°F for both panoramic cameras. The average temperatures during the -2 mission were 60°F for both panoramic cameras. Figure 3-7 shows a graphical plot of the actual average camera temperature versus the predicted temperature as a function of the beta angle. Figures 3-8 and 3-9 show each camera's rail temperature for selected revs.
