CORONA J-3  
PERFORMANCE EVALUATION REPORT  
MISSION 1113  
FTV 1659, CR-13

This document is the final payload test and performance evaluation report for Mission 1113.

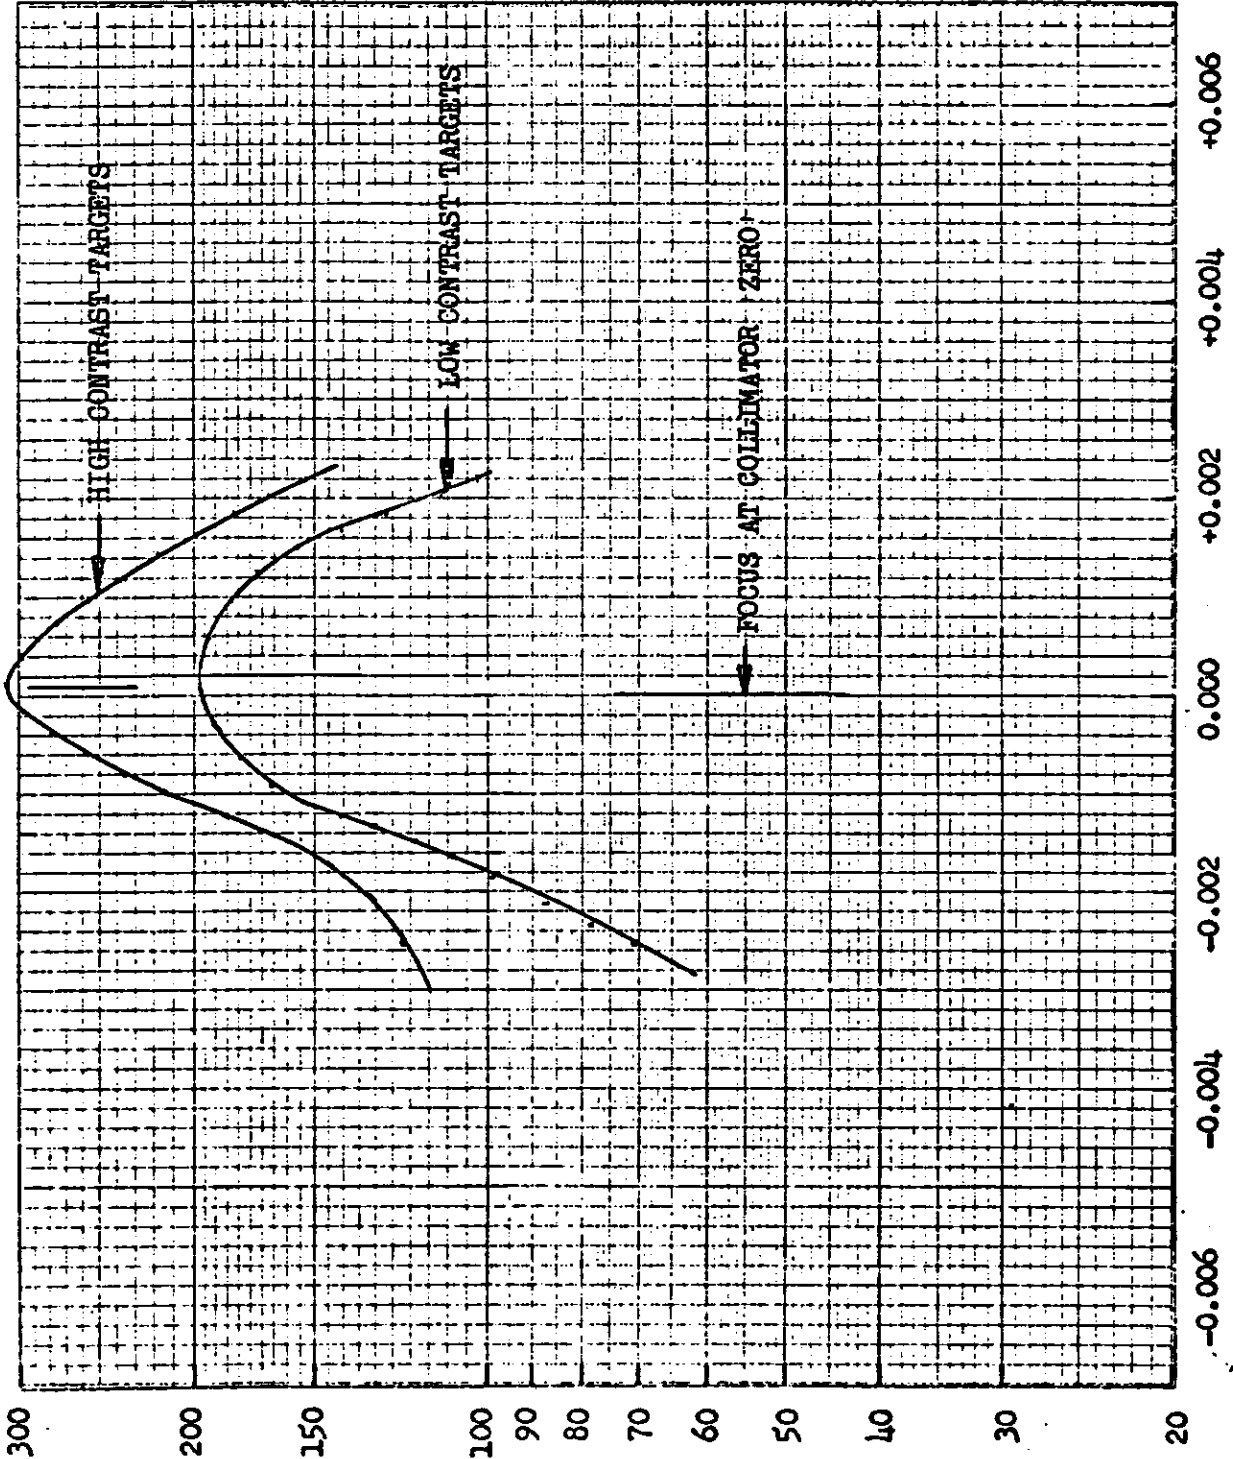
PRE-FLIGHT DYNAMIC RESOLUTION

Through focus resolution tests were performed for the panoramic cameras on June 4, 1970. Analysis of the test target data indicated that the focal point was properly adjusted in relationship to collimator zero for both instruments. The low contrast resolution value for instrument #327 was 175 lines per mille-meter (L/MM) which agreed favorably with ITEK calibration data.

Camera No: 327  
 Payload No: CR-13  
 Resolution (1/mm) \_\_\_\_\_  
 High Contrast: 310  
 Low Contrast: 200  
 Film Type: 3414  
 Test Date: 11-7-70  
 Lab No. 3830  
 \_\_\_\_\_  
 \_\_\_\_\_  
11-9-70

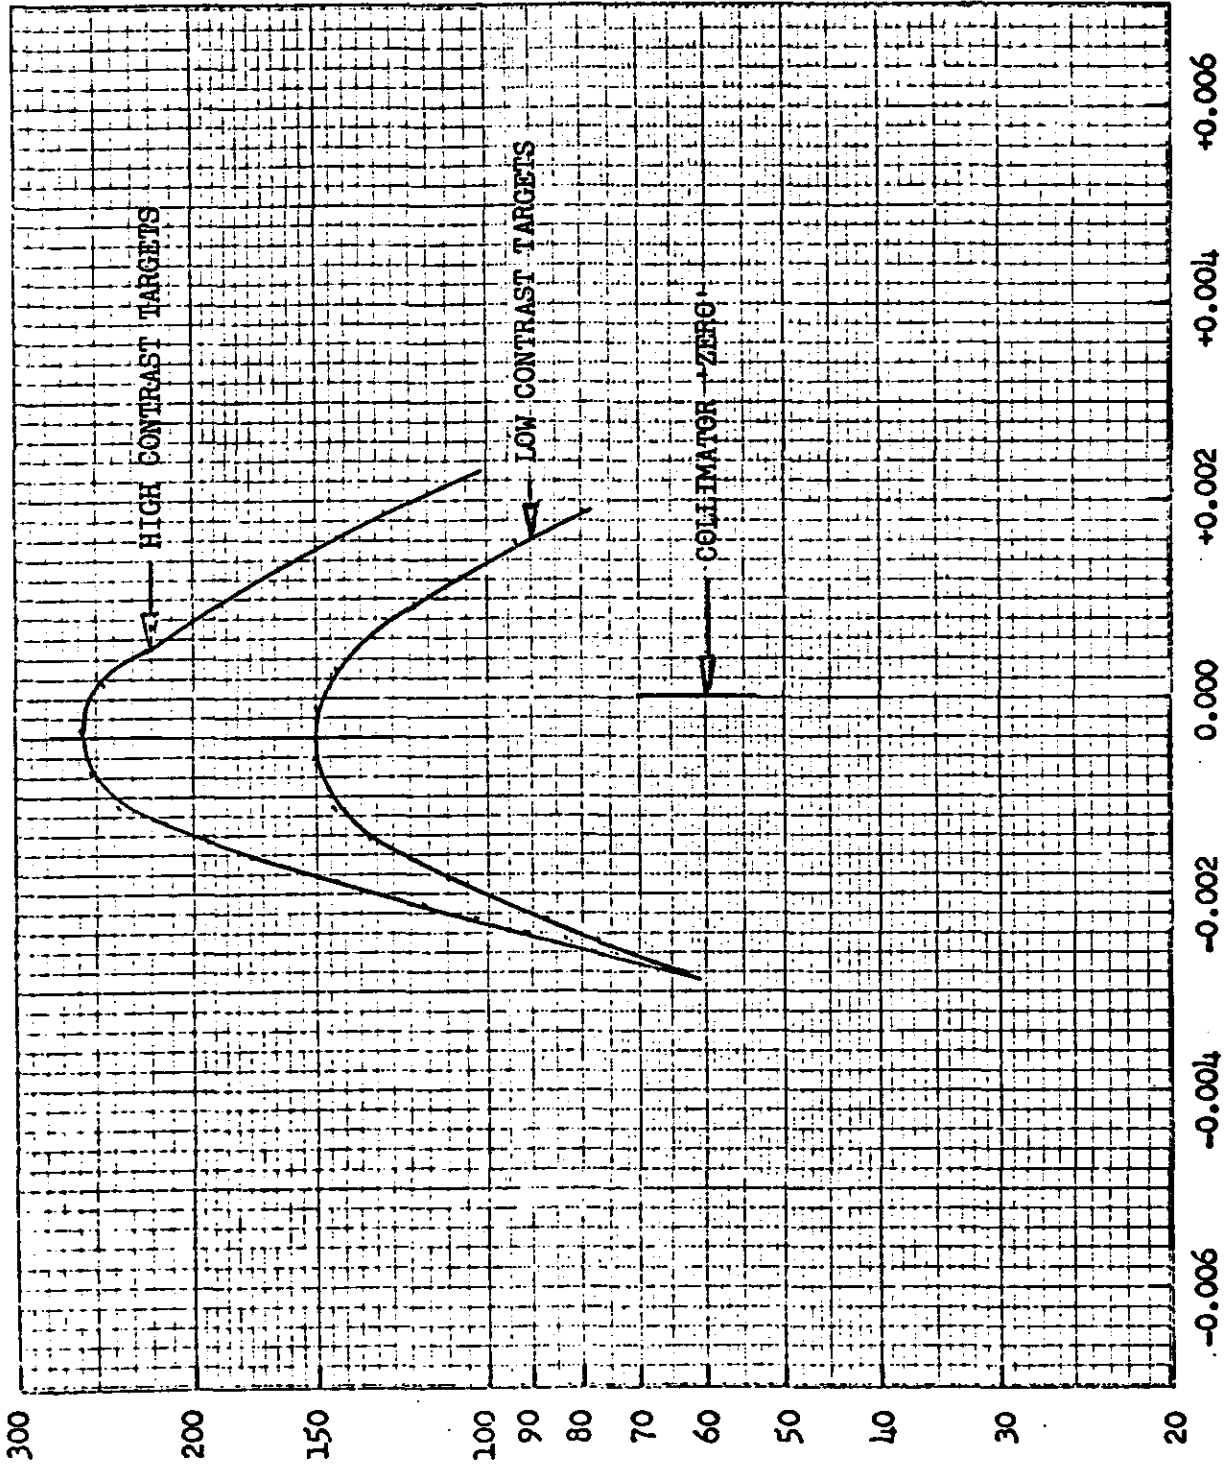
PRE-FLIGHT DYNAMIC RESOLUTION

However, analysis of instrument #326 Test Target data placed the through-focus resolution value at 135 l/mm which was considerably less than the ITEK calibration value of 163. As a result of this the lens in instrument #326 was changed from I-214 to a new lens cell I-225. New through-focus resolution tests on the CR-13 system were made 7 November 1970. Instrument No. 326 produced a peak low contrast resolution of approximately 152 lines/mm at  $-0.0004''$  from collimator 'zero' and instrument #327 produced a peak low contrast resolution of approximately 200 lines/mm at collimator 'zero'. These values and focusing positions were acceptable. Representative graphs of this resolution data are included on pages 13 and 14.

Camera No: 326

High Contrast: 264

Low Contrast: 152
